## Descriptive Schedule of Condition

of the premises known as  
**Garages at 19-23 Friars Stile Road,  
Richmond, London, T10 6NH**

for and on behalf of  
**Malins Group**

**Ref:** CBS/00753

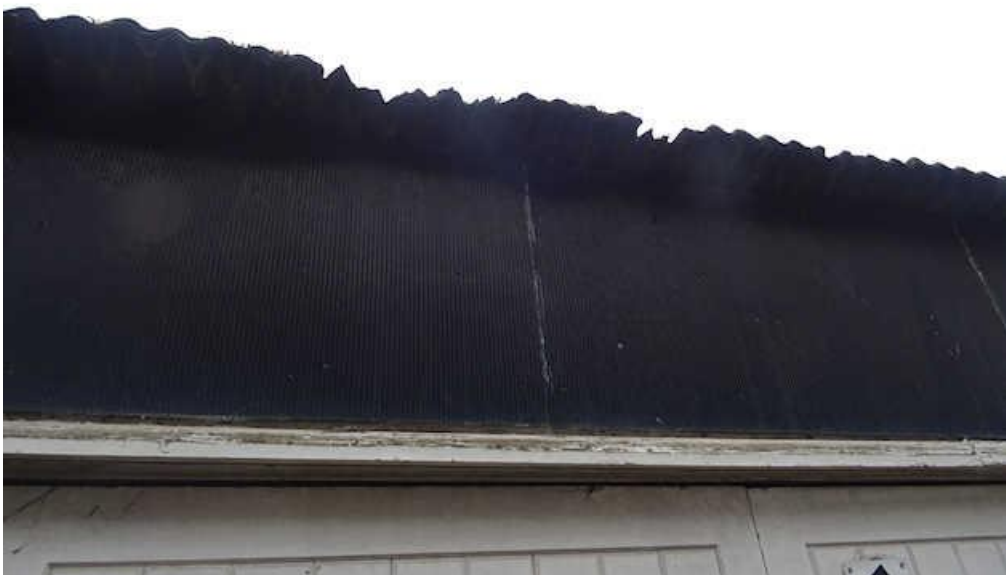
Photograph 48

2.0	Roofs – The roof parts to the garages are finished in asbestos roof sheets. There is a section toward the right-hand side of the garages that has been replaced with a plastic Perspex material. There are sections of replacement toward the centre of the roof in a plastic Perspex material	The roof is covered in staining and moss growth throughout. The asbestos sheets are clearly aged and there is corrosion throughout to the fixings. The Perspex sheet is stained in general. There is vegetation overgrowth toward the rear eaves of the roof. The rear plastic gutter detail is damaged with a large section missing to the centre. The replaced sections to the centre of the roofs appear bowed and stained throughout and have been generally fixed poorly. There are areas of damage and breaking to the edges of the asbestos sheets to the front the rear of the roof.	48-70

3.0	Conclusion	It is note that the 7 garages are at the end of their usable life. They have asbestos roofs and are not considered watertight. The cost of repairs are economically unviable and they should be demolished.
