Condition Survey Photo Record Schedule of Repairs – Karslake Interior

Client Waterfall Planning Ltd
Project Hampton Water Works
Subject Karslake Condition Survey Photo Record – Schedule of Repairs
Date 26.05.2023
Revision A
Job no. 1685
Reference 1685-A-P612 Karslake Condition Survey – Schedule of Repairs

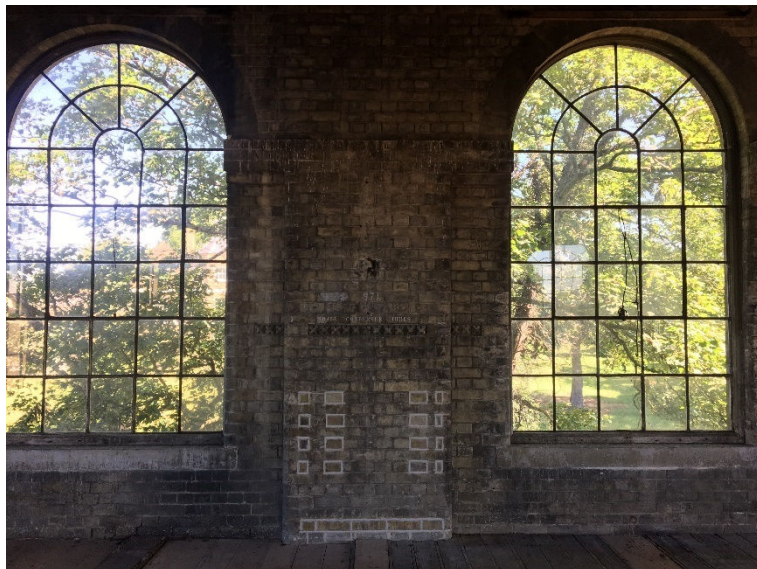
Location: **Karslake – Former Bean Engine House**
Description: General view of interior brick work detailing

Condition:	3
Damage:	Unknown
Proposal:	Retain in situ and renovate. Apartment feature.
Methodology:	Tbc by condition.
Heritage Comments:	HS High significance
