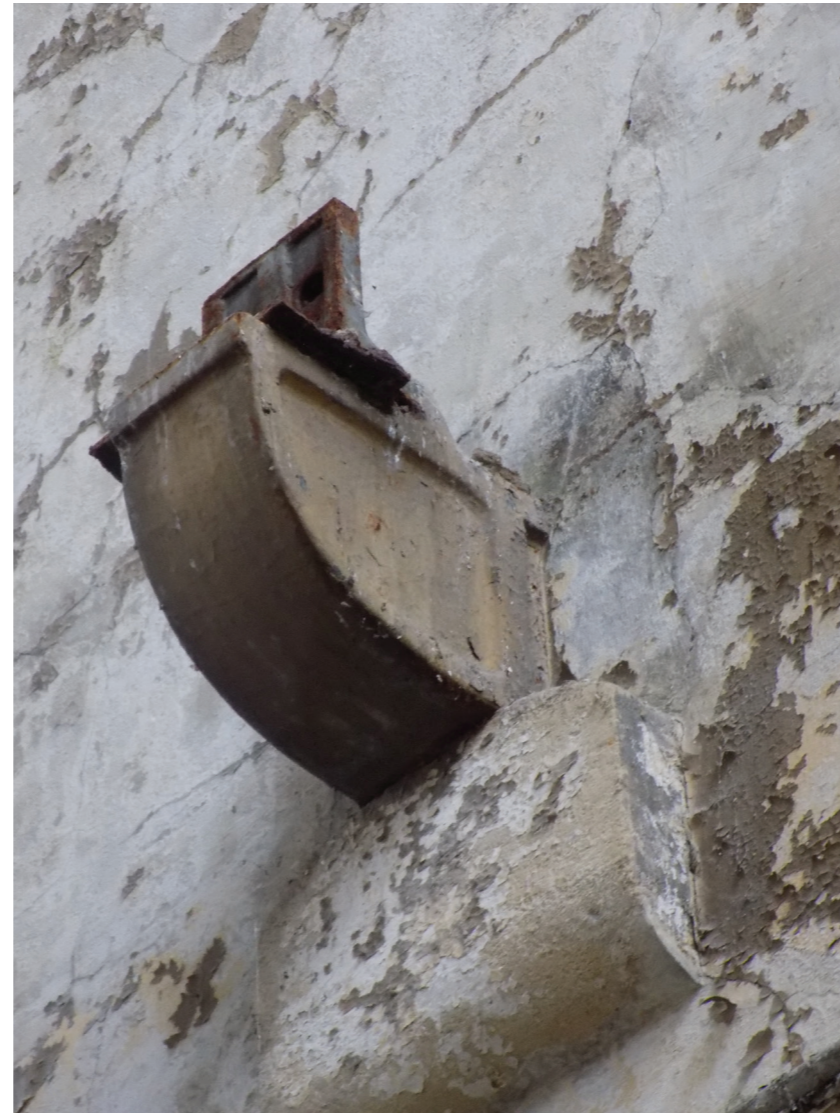
Figure 139: Interior detail showing corbels for engine lifting beams. These are the last remnants of the Bull Engine and therefore have relatively high level of interest.
