**Japanese Gateway**  
Kew Gardens  
Copper Repoussé Trails  
October 2023

Dorothea Restoration was commissioned by Acanthis Clews Architects, on behalf of Royal Botanic Gardens Kew, to inspect the replica gate of Nishi Hongan-ji (Western Temple of Original Vow) the original located in Kyoto, Japan. The structure was created for the Japan-British Exhibition held at White City in London in 1910. The structure is grade II listed and was first listed in 1950 by Historic England.

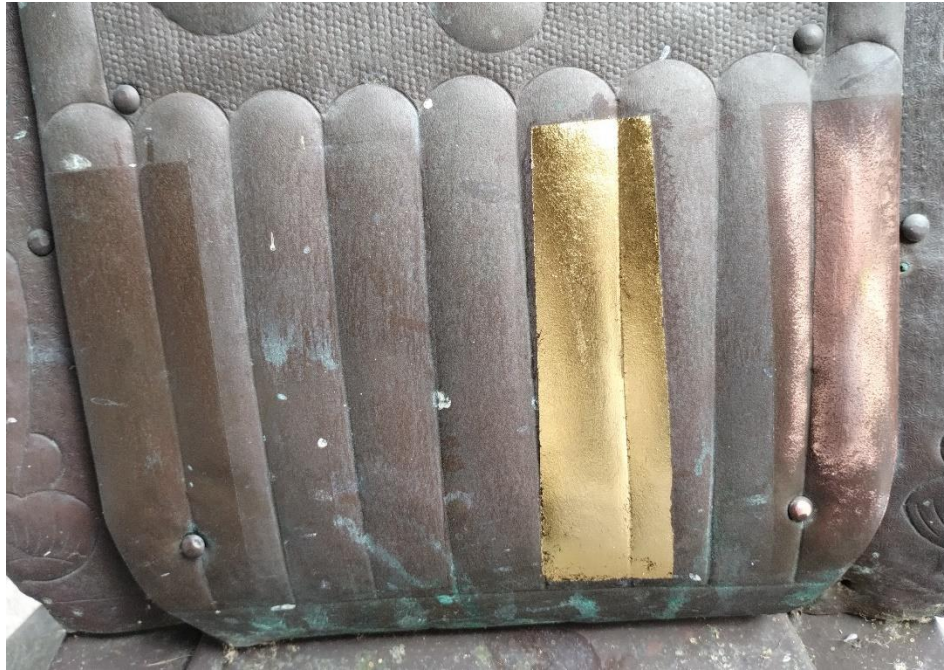
Once cleaned the surface was treated with cold renaissance wax, applied with a lint free cotton cloth. The wax was left to dry naturally.
