Timber assessment of the Japanese Gateway

ROYAL BOTANICAL GARDENS, KEW.

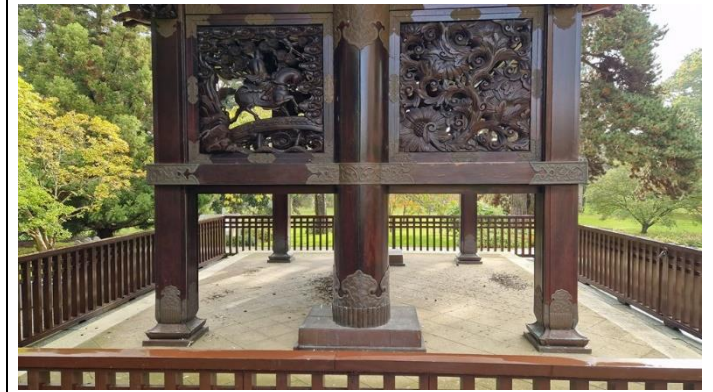
As previously reported, the bases of the posts are all concealed by decorated copper plates which are tacked to the timber.

In many places the copper plates are not continuous, or the tacks have fallen out, making limited access to the timber possible with the microdrill.

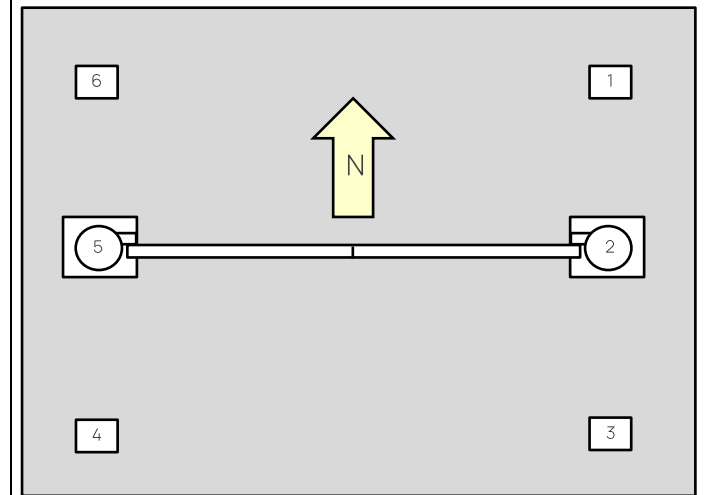
The elements of the gateway are numbered as shown opposite.

Note the gates open to the S. As such the vertical stop bars are on the N side of the doors – the pivot hinges on the S.
