PLANNING
PROJECT
8 Montpelier Row
Twickenham
TW1 2ND

DRAWING
PROPOSED PLAN REPAIRS: SHEET 2 OF 2
SECOND FLOOR & ROOF JOISTS

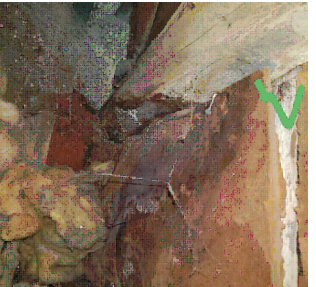
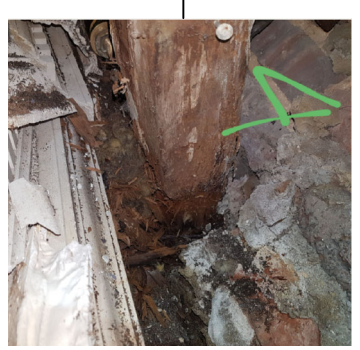
Action required
Location of Parapet gutter causing water ingress and subsequent decay, ends of rafters providing minimal bearing. Localised spliced repairs required in accordance with survey

Action required
Localised spliced repairs required in accordance with survey

Immediate action required
Area of valley completely decayed, ends of rafters and ceiling joists currently providing zero bearing within red hatched area and minimal bearing elsewhere.

Chimney treatment
To receive raking and repointing to all joints, following which all scalers and flashings to be renewed in code 4 leadwork in accordance with ISA guidelines

Existing path of internal open timber gutter. Gutter to be retained but new drainage pipework laid inside it to discharge the valley's collection to the rear hopper accordingly

Proposed location of steel beams to support existing valley during repair and to remain thus after
