STRUCTURAL IMPACT ASSESSMENT

NORFOLK HOUSE, 8 MONTEPELIER ROW, TWICKENHAM TW1 2NQ PROPOSED ROOF REPAIRS

Job No: P1008
26th June 2024

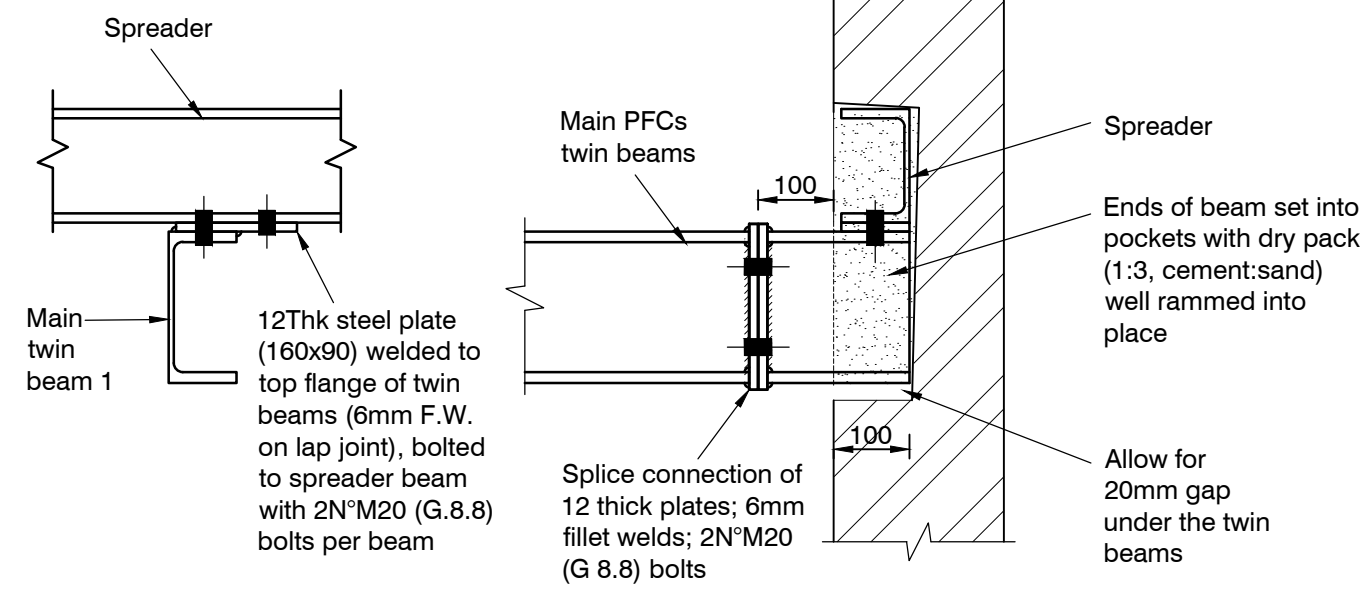
**Typical Splice Detail at End of Steel Beam
Between Party Walls (to aid installation)
Where Damage to Original Ceiling is to be
avoided)**
