49 & 51 KEW GREEN

Parapet and Flank Wall repairs

July 2024

- 1.1 Martin Ashley Architects (MAA) have prepared the below document for remedial masonry and lead works at 49 & 51 Kew Green, on behalf of the Royal Botanic Gardens Kew.

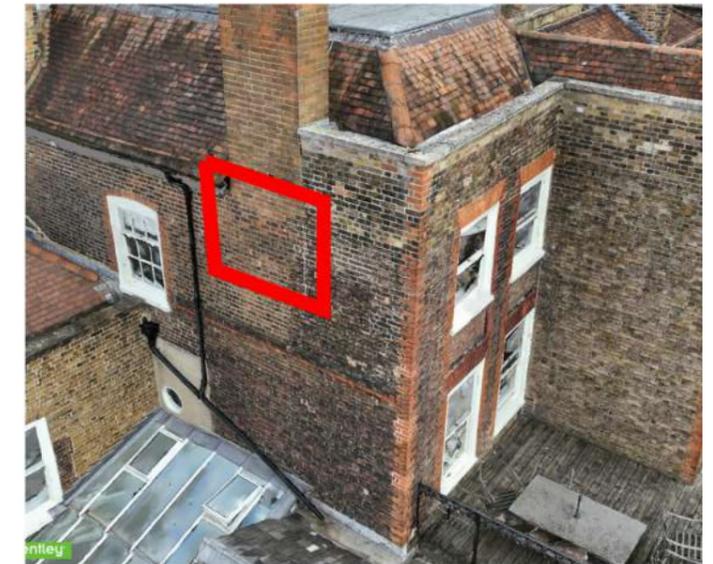
EXTENT OF BULGING BRICKWORK

ELEVATION
NTS

Dwg Title: BRICKWORK REPAIR DETAIL
