49 & 51 KEW GREEN

Parapet and Flank Wall repairs

July 2024

Address: 49 & 51 Kew Green

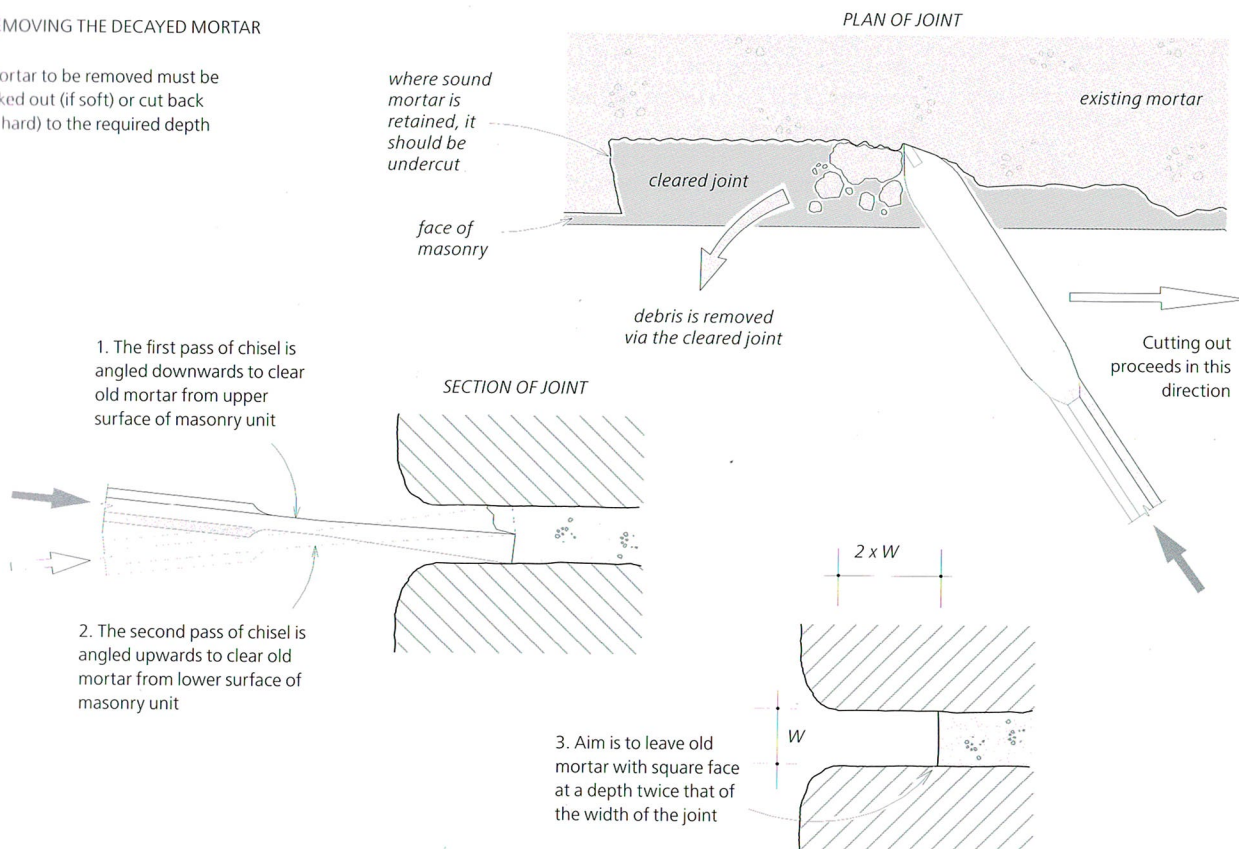
REMOVING THE DECAYED MORTAR

Mortar to be removed must be raked out (if soft) or cut back (if hard) to the required depth

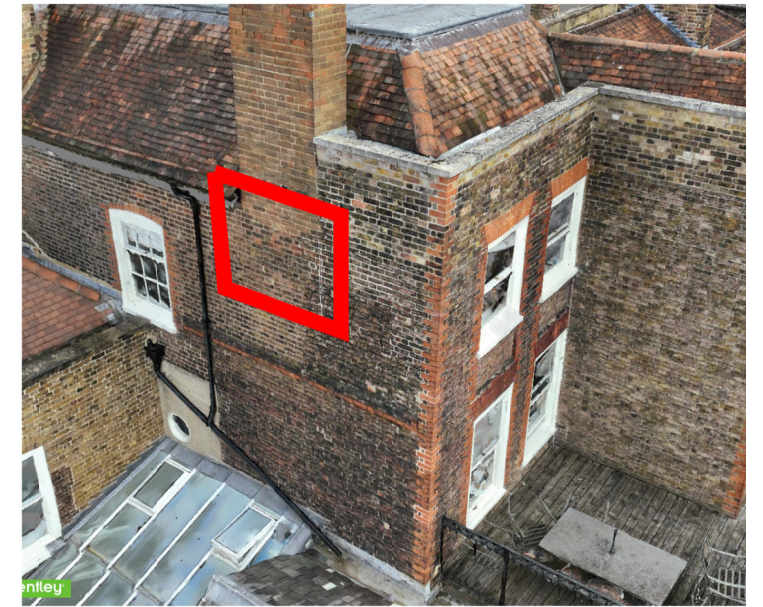
ELEVATION
NTS

EXTENT OF BULGING BRICKWORK
