STRUCTURAL IMPACT ASSESSMENT

59 PETERSHAM ROAD, RICHMOND TW10 6UT

**PROPOSED SINGLE STOREY REAR EXTENSION AT GARDEN LEVEL WITH
UPPER POD TO LOWER GROUND FLOOR, AND PROPOSED FRONT
LIGHTWELL AND STEPS (PLUS ASSOCIATED ALTERATIONS)**

**Job No: G1100
18th September 2024**

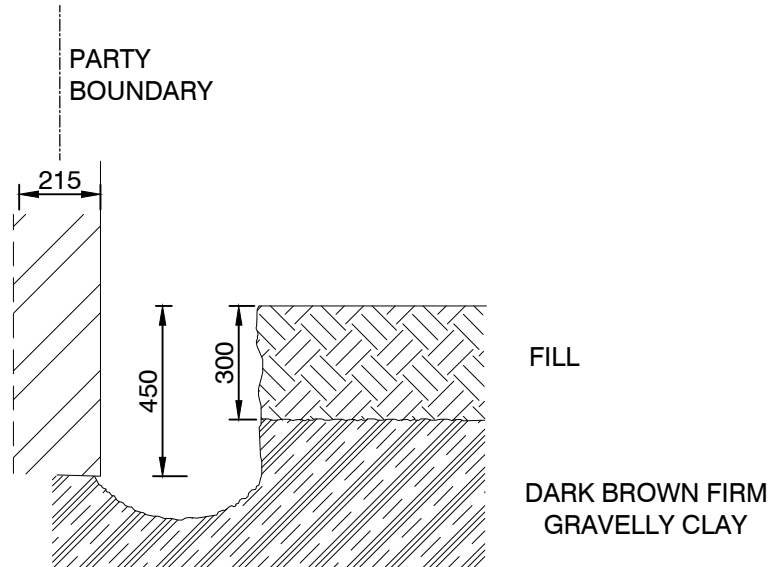
TP02
(SCALE 1:20 @ A1)

Reference to the trial pits carried out (Appendix B) shows the brick walls to the rear are founded relatively deeply at 1.8m onto the underlying gravelly clay. No corbelling at the base of the wall was found.

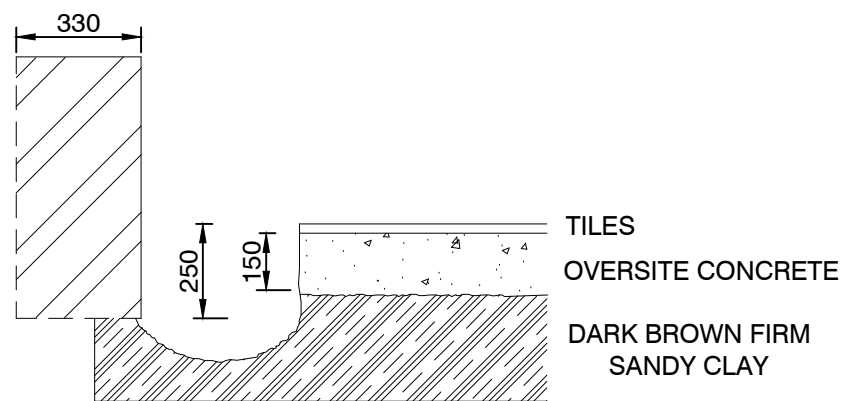
TP04
(SCALE 1:20 @ A1)

To the front the walls were founded at about 250mm below ground level into the underlying clay.

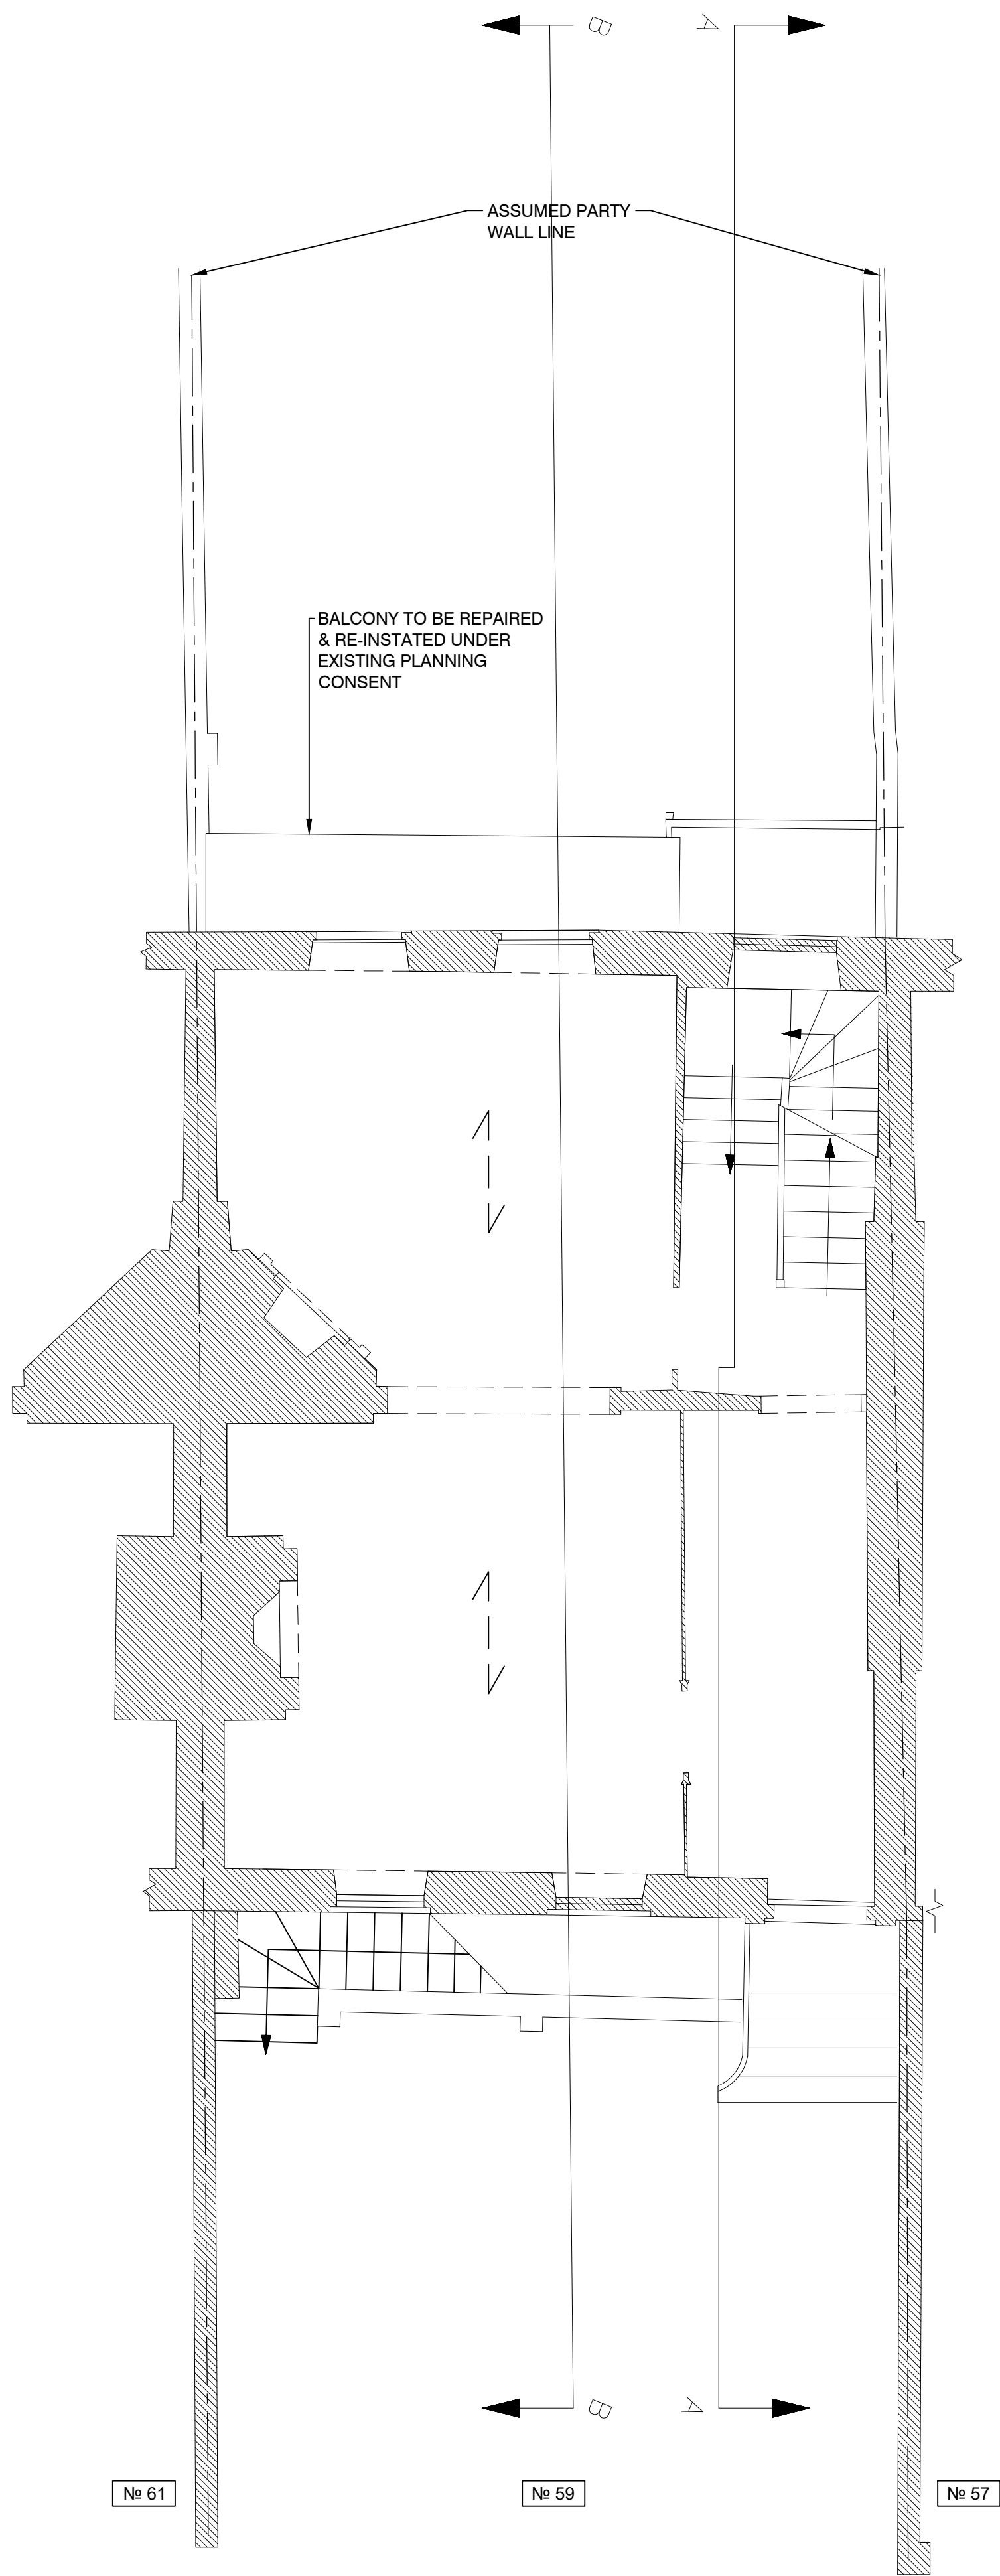
Scale:	As Shown @A1	Do not scale from drawing
Drawing Number:	G1100-1600-001	Rev:

Reference should be made to drawings G1100-001 to 005 (Appendix C) where these observations are recorded. Many of the rooms are clad in panelling – concealing the underlying condition of the structure.
