STRUCTURAL IMPACT ASSESSMENT

59 PETERSHAM ROAD, RICHMOND TW10 6UT

**PROPOSED SINGLE STOREY REAR EXTENSION AT GARDEN LEVEL WITH
TERRACE OVER, AND PROPOSED FRONT LIGHTWELL AND STEPS (PLUS
ASSOCIATED ALTERATIONS)**

**Job No: G1100
18th September 2024**

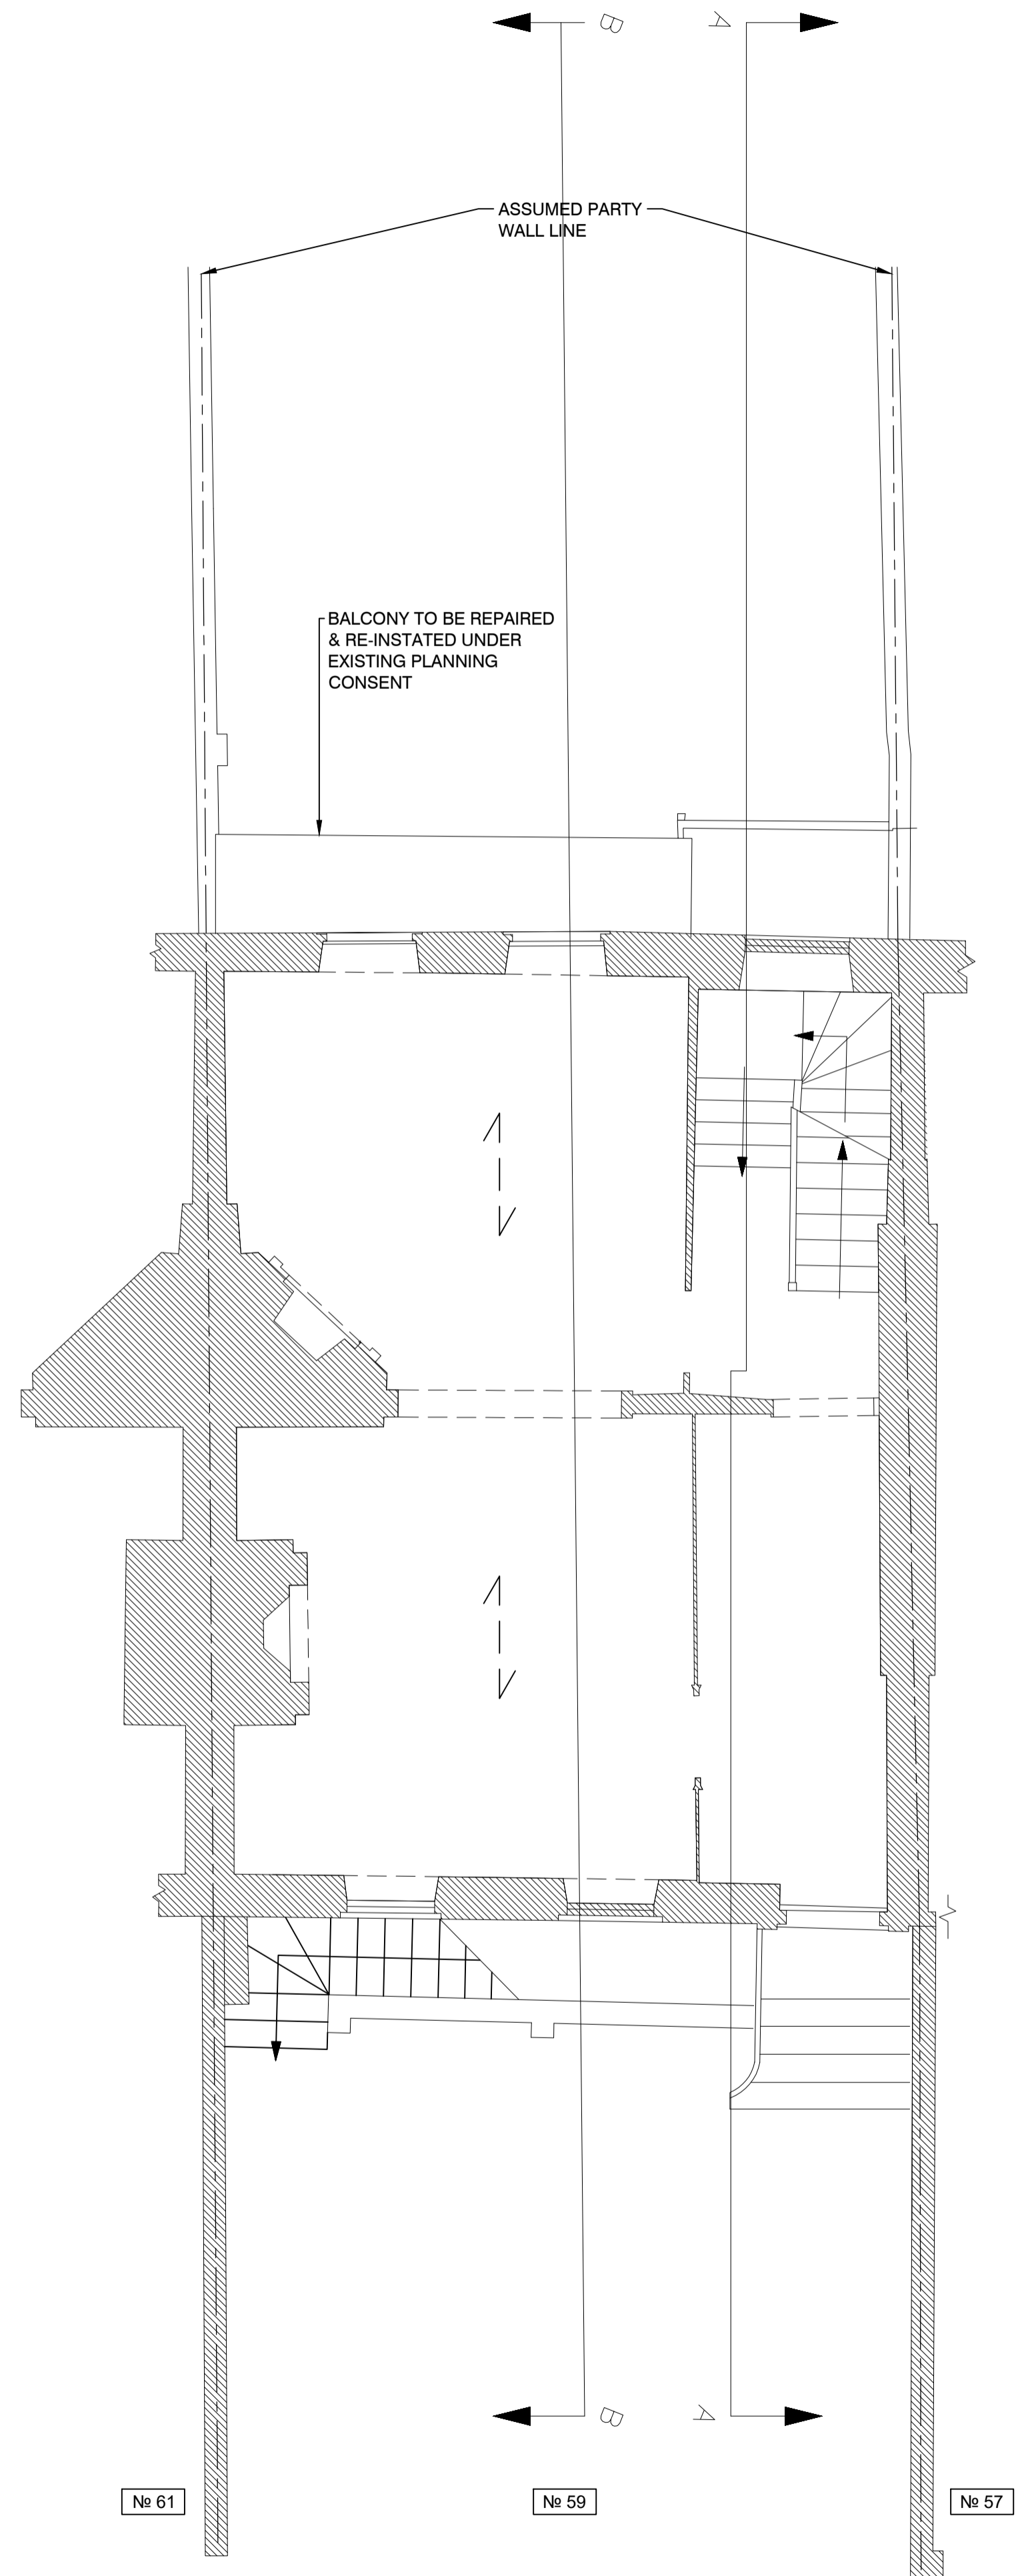
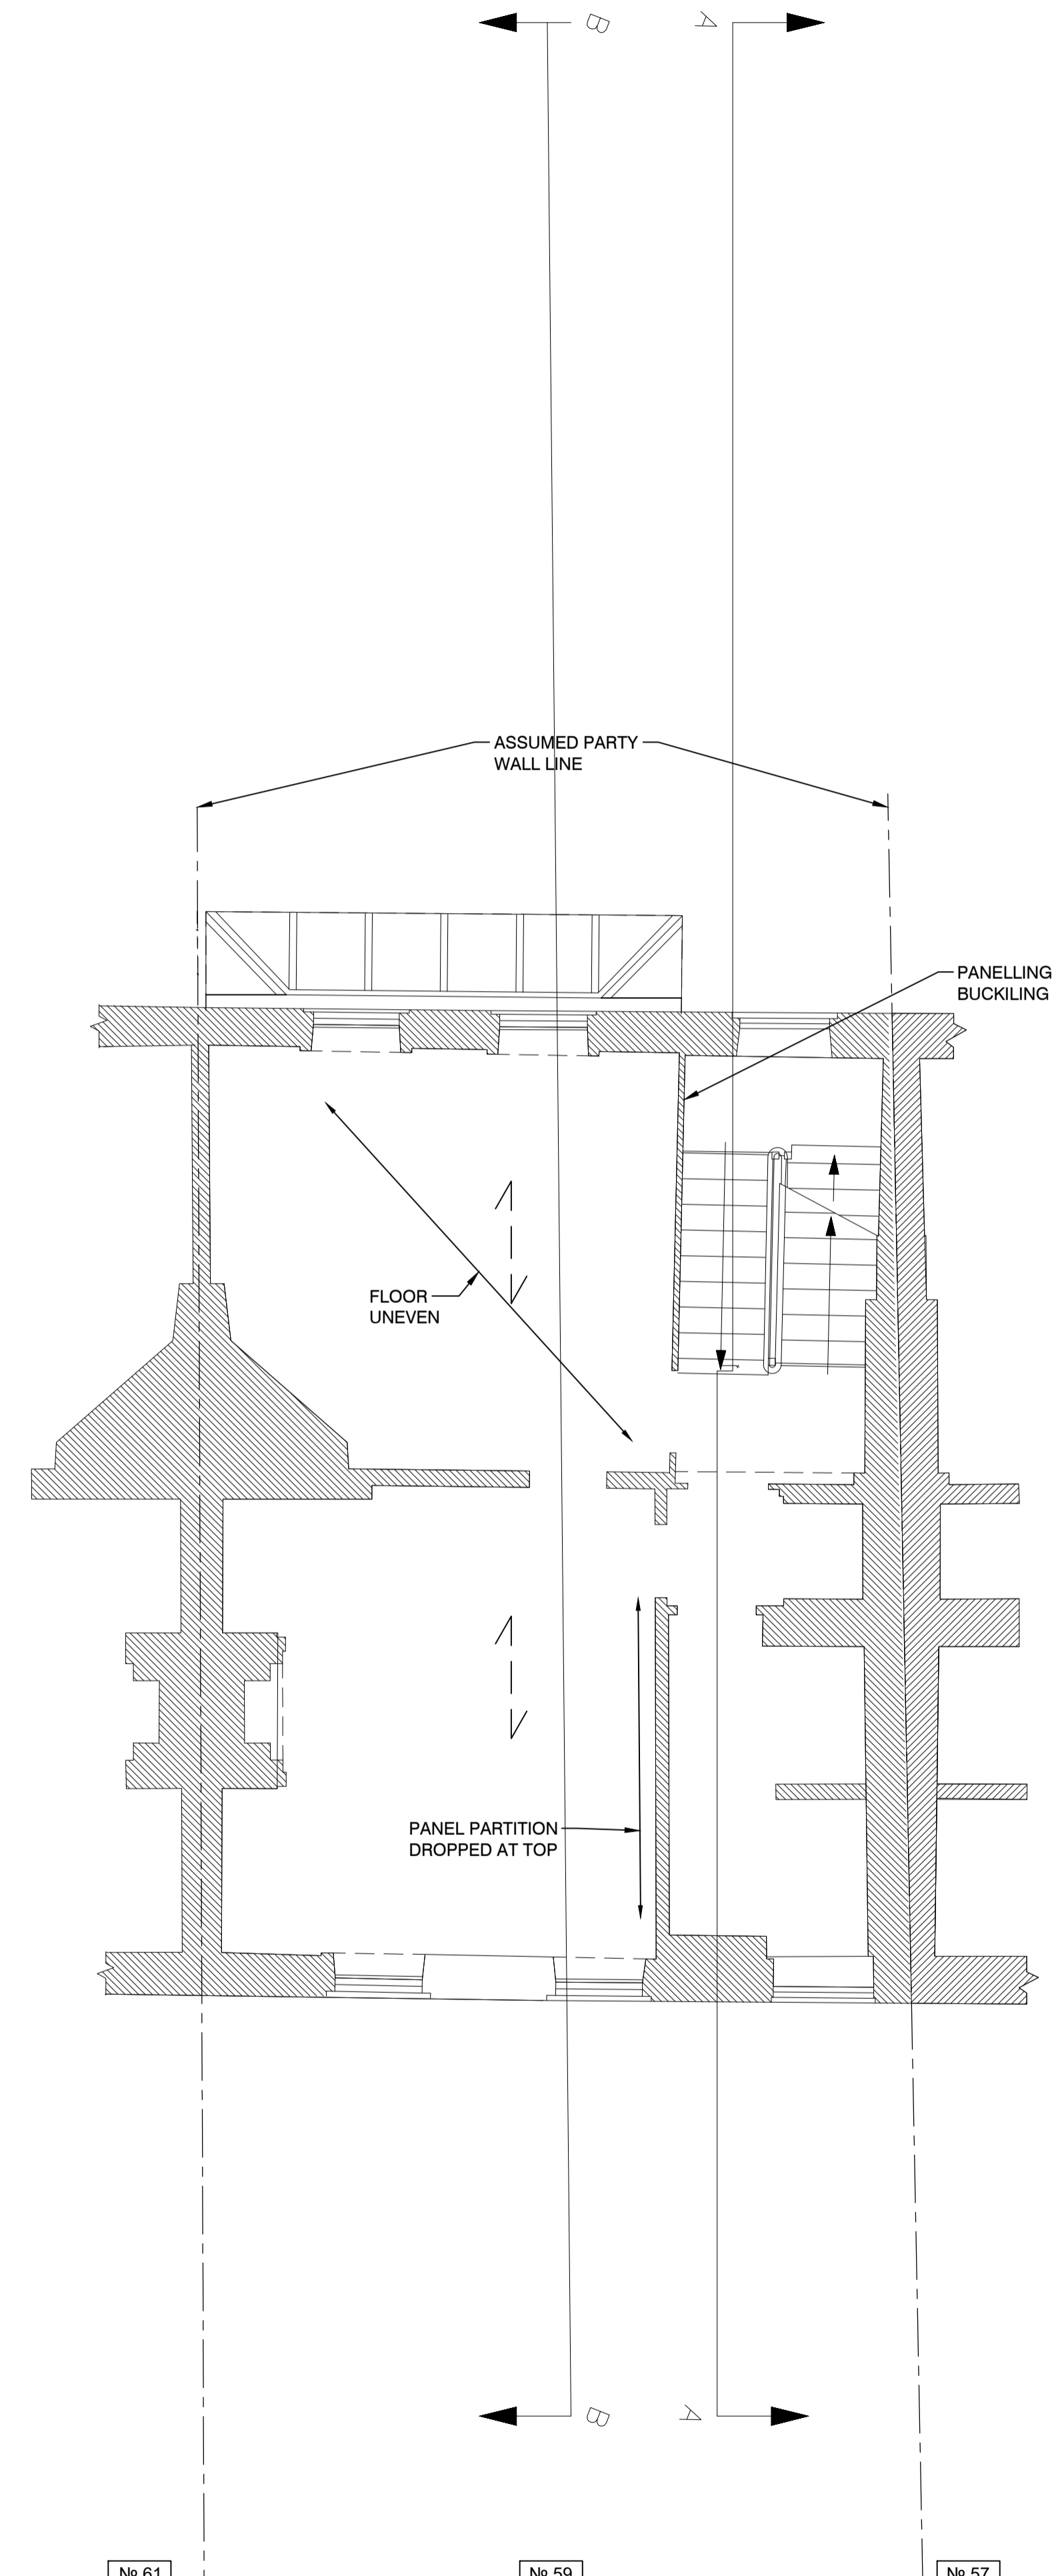
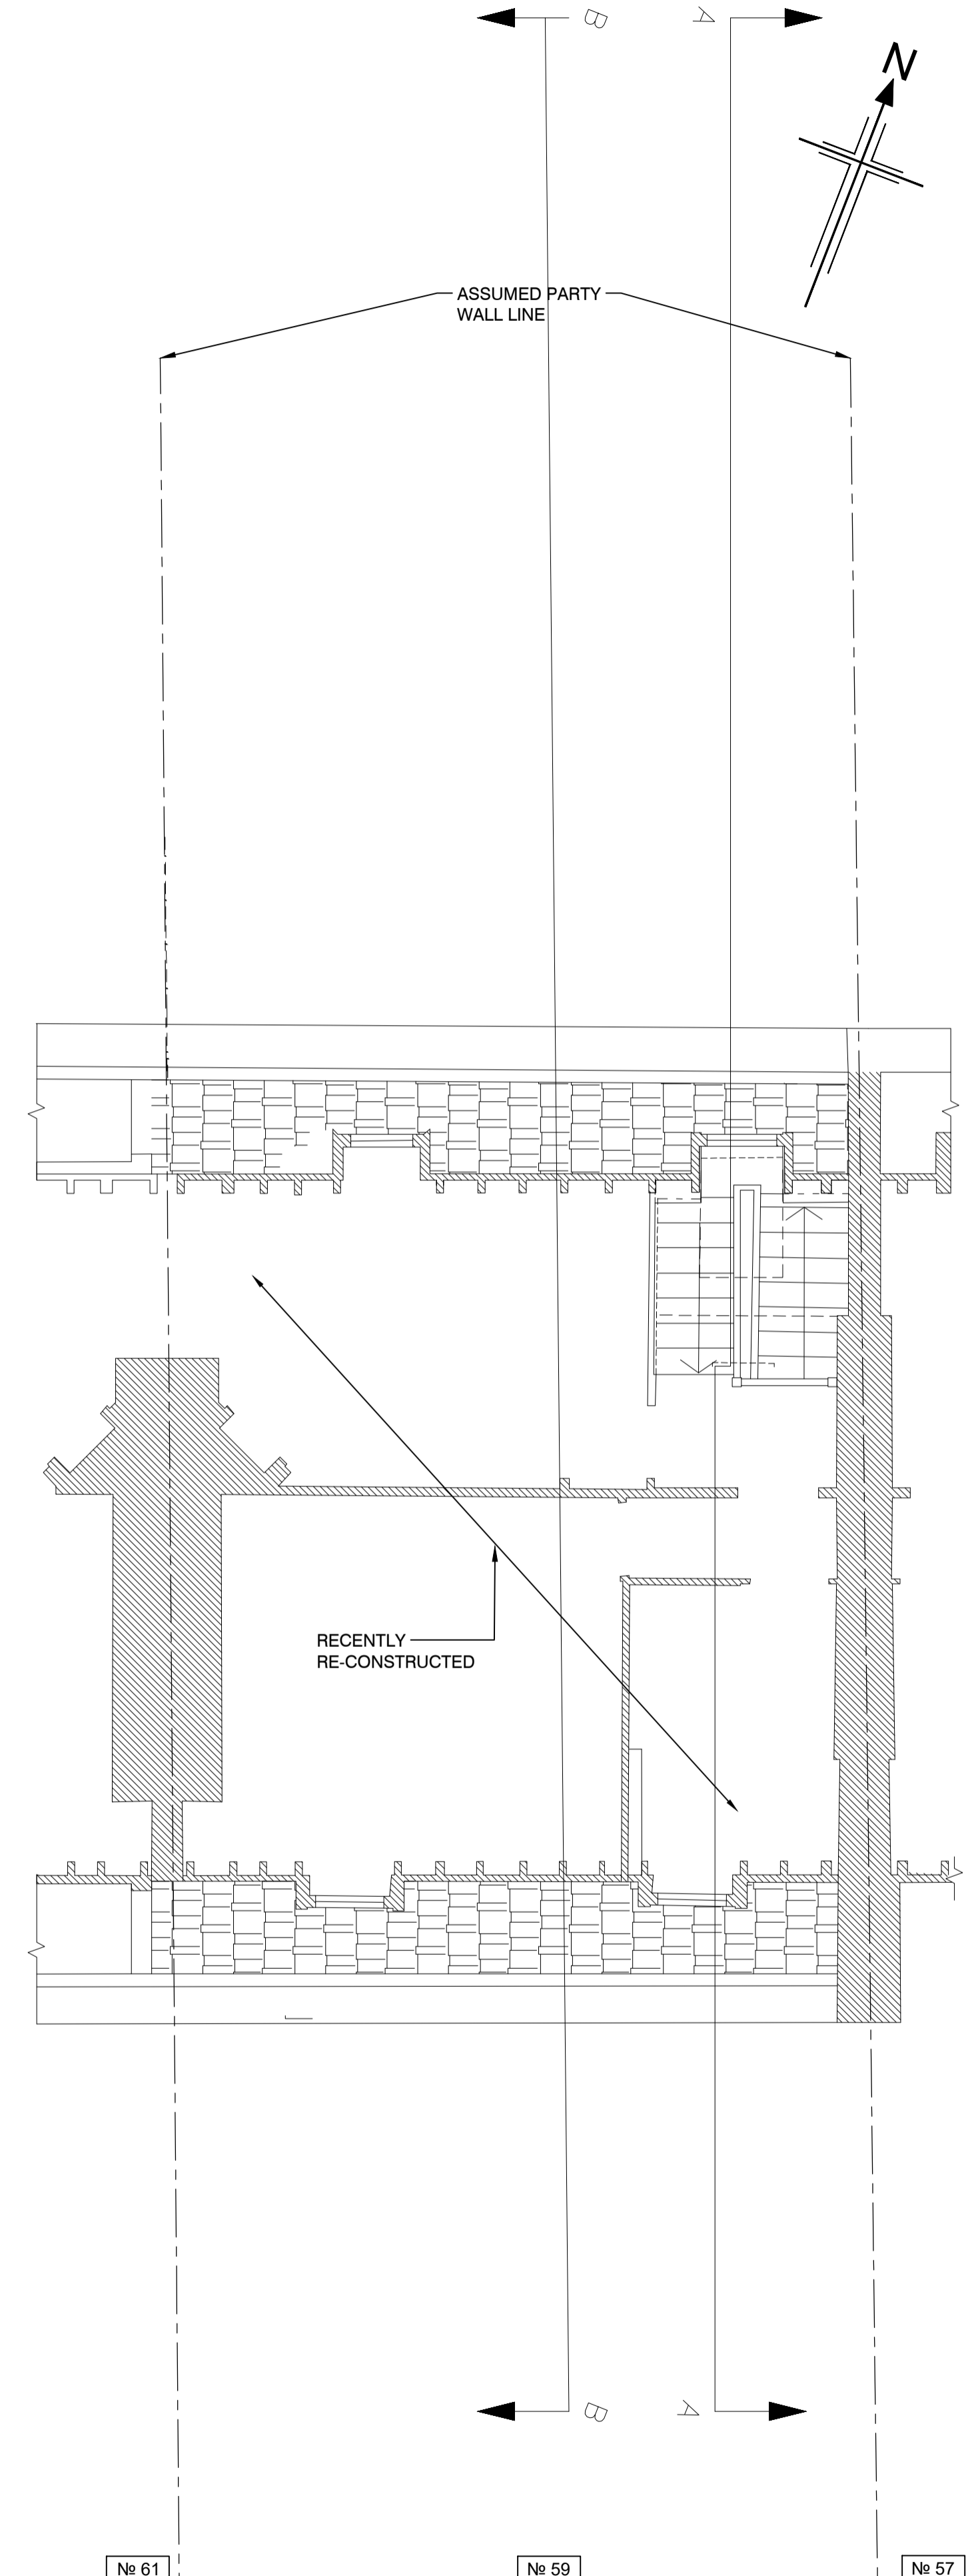
Drawing Title:
Existing Upper Ground, First and Second Floor Plan

Reference should be made to drawings G1100-001 to 005 (Appendix C) where these observations are recorded. Many of the rooms are clad in panelling – concealing the underlying condition of the structure.
