LISTED BUILDING APPLICATION

JOB TITLE:
KNELLER HALL

DRAWING TITLE:
WEST ELEVATION - PROPOSED EXTERNAL REPAIRS

SCALE: 1 : 100	DRAWING SHEET SIZE: A1	
JOB CODE: 001506	DRAWING NUMBER: ADP-01-XX-DR- A-1219	REVISION: D2 P 7

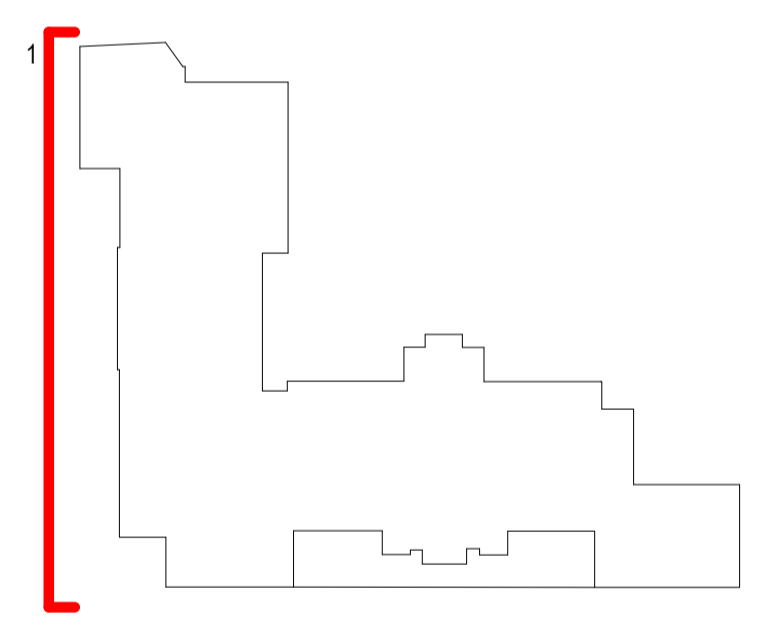
1 WEST ELEVATION PROPOSED EXTERNAL REPAIRS
1 : 100

External Repairs Schedule - West (Application Rev 01)			
Reference	Purpose	Notes	Decoration
H&S1	Health & safety	Proposed location for lightning protection. Refer to suppliers drawing for further information.	—
MR91	Water ingress	Defective York stone window cill to be replaced with Portland stone cill	
MR92	Water ingress	Defective York stone window cill to be replaced with Portland stone cill	
MR93	Water ingress	Defective York stone window cill to be replaced with Portland stone cill	
MR94	Water ingress	Defective York stone window cill to be replaced with Portland stone cill	
MR95	Water ingress	Defective York stone window cill to be replaced with Portland stone cill	
MR96	Water ingress	Defective York stone window cill to be replaced with Portland stone cill	
MR97	Water ingress	Defective York stone window cill to be replaced with Portland stone cill	
MR98	Water ingress	Defective York stone window cill to be replaced with Portland stone cill

MR99	Water ingress	Defective York stone window cill to be replaced with Portland stone cill	
MR100	Water ingress	Defective York stone window cill to be replaced with Portland stone cill	
MR101	Water ingress	Defective York stone window cill to be replaced with Portland stone cill	
MR102	Water ingress	Defective York stone window cill to be replaced with Portland stone cill	
MR103	Water ingress	Defective York stone window cill to be replaced with Portland stone cill	
MR104	Water ingress	Stone band to be re-pointed and isolated render repairs to be carried out where render is defective and loose. Stone on corner of West elevation to be replaced as methodology item 1

1. Repair to brickwork and stonework to be minimal and limited to structural defects. Repair where necessary to reduce future weathering and water ingress.
Repointing to stonework and brickwork to be undertaken using a lime based mortar to match the tone and texture of existing mortar. Sample to be prepared on site for approval. Profile to match existing.
Stonework repair to fall under the categories;

- Lime mortar/plastic repair
 - Stone indent
 - Stone replacement
2. The method of cleaning to all brickwork is to be light touch, non abrasive & the treatment to be of minimal impact to the underlying materials.

3. Tap testing of existing stonework & quoins is required to ensure it is structurally sound when scaffold is in place.
4. General scope of works to include the cleaning, unblocking of rainwater hoppers and inspection of downpipes and if required, replacement of downpipes with like-for-like cast iron downpipes.
