Our Ref: SME/CM/224260

Re: 32 The Green, Richmond, TW9 1LX

Conservation Accredited Engineer: Structural Overview of the roof and floor structures, foundation and basement floor.

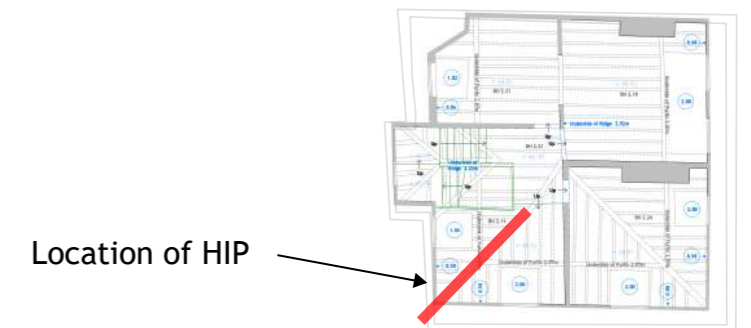
CONCERN THAT ADDING LOAD TO ROOF WILL EXAGGERATE THIS DEFLECTION PATTERN

SCHMATIC ELEVATION showing supports to HIP RAFTER (similar movement pattern associated with purlin deflection)

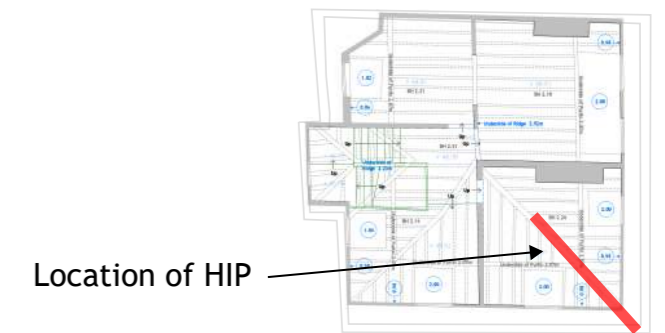
Location of HIP

CONCERN THAT ADDING LOAD TO ROOF WILL EXAGGERATE THIS DEFLECTION PATTERN

SCHMATIC ELEVATION showing supports to HIP RAFTER (similar movement pattern associated with purlin deflection)

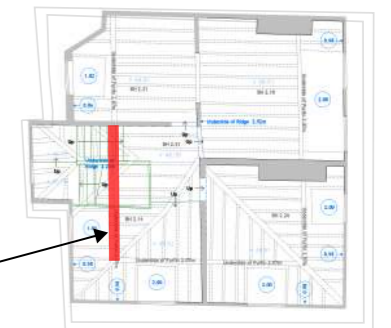
Location of Purlin

The stair wall immediately below where support is required.

To prevent future deflection a mid span support is recommended. This might take the form of a post or a stair wall.
