Japanese Gateway, Royal Botanic Gardens,  
Kew, London

Results of Architectural Paint Research

28/03/2024

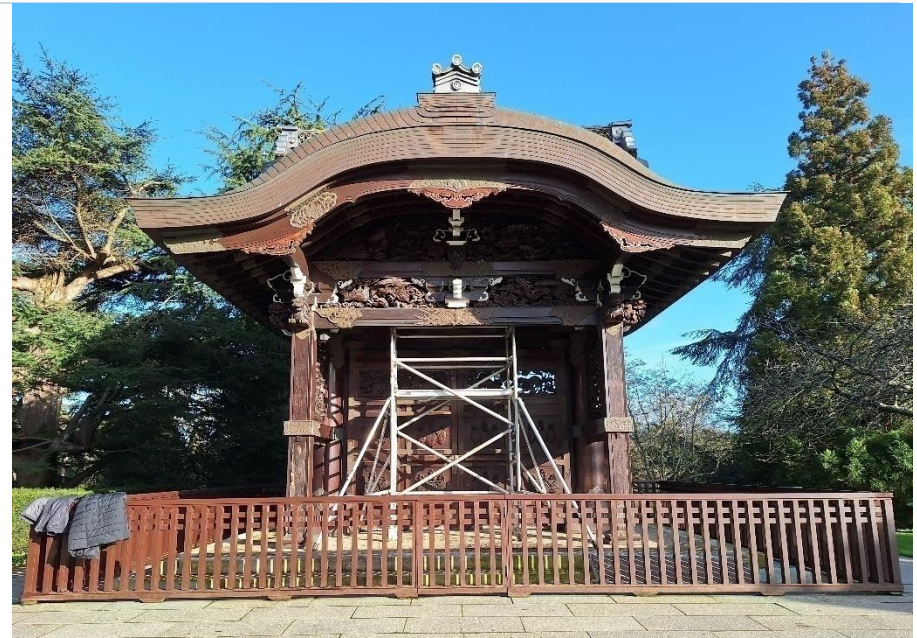
*Figure 1: Image taken in January 2024 of the south elevation of the Japanese Gateway.*

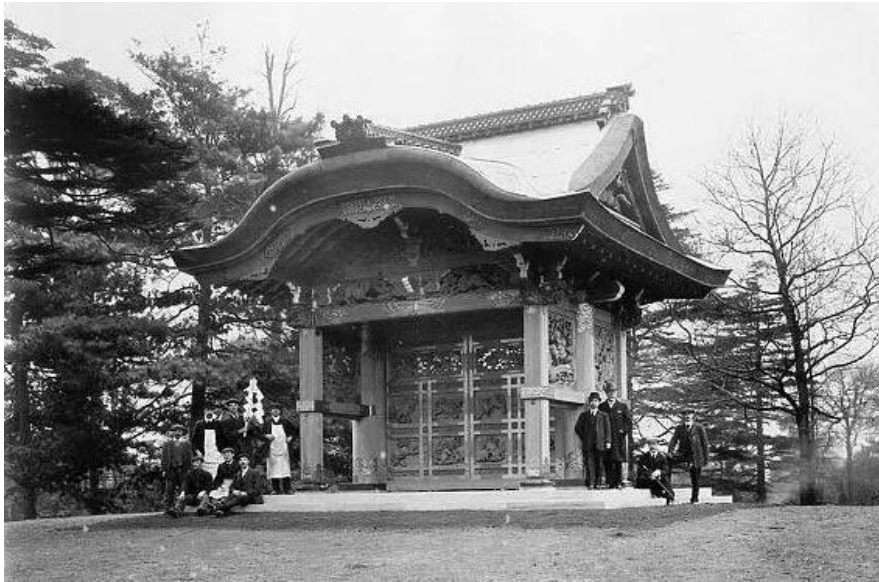
From the archive image, Figure 3, it should be noted that the appearance of the upright posts looks as though it is lighter in colour than that of the rest of the structure.

*Figure 3: Japanese Gateway c.1910, after its relocation to Kew. (© Royal Botanic Gardens Kew)*

The early image, Figure 3 in the archive section, appears to indicate that there is some variation in the appearance of the main structural (corner) bases than seen to the upper elements. Whilst it is a black and white image, and therefore not possible to determine colour (and may also have some association with the direct sunlight), there does seem to be some colour variation across the structure. The use of a lighter coating to the cloud carving is evident though analysis would suggest that this has now been painted in a brighter white than was first intended.

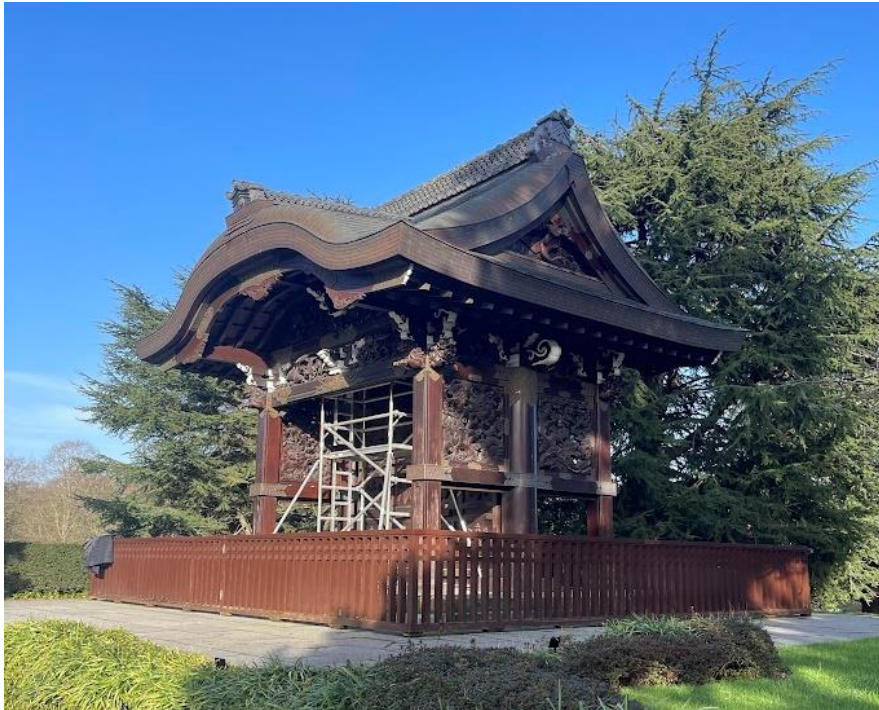
*Figure 4: View from the south of the Japanese Gateway, January 2024.*

At the time of sampling, the Japanese Gateway had scaffolding within the south elevation of the structure to enable access to higher levels (see Figure 4). Full access to the interior of the roof was not possible due to the height and nature of the scaffold, analysis was therefore limited to the central area of the interior.

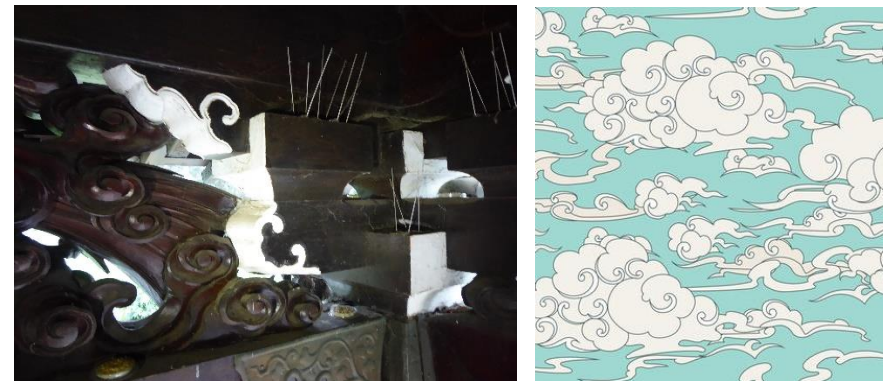
Details on the ridge-piece, beam ends, and brace are picked out in a white paint, these areas are carved with scrolls, reminiscent of clouds often seen in Japanese imagery (Figure 5).

*Figure 5: Image showing the similarity in the scroll detailing as to that in Japanese cloud art imagery.*

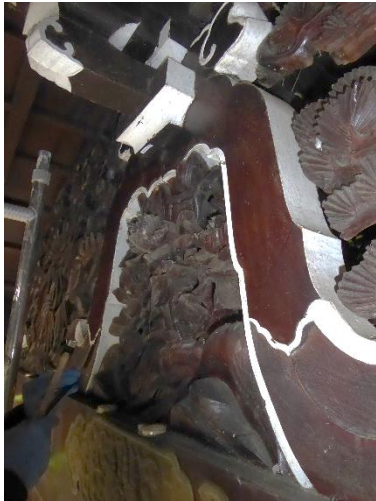
When looking at the Japanese Gateway, as it is today, there are areas that have been clearly picked out in white paint to highlight their decorative beauty, as noted before it is reminiscent of the clouds found in Japanese art. Of note is the internal brace on the south elevation, see Figure 16.

*Figure 16: South elevation, decorative brace, showing the areas picked out in white paint.*

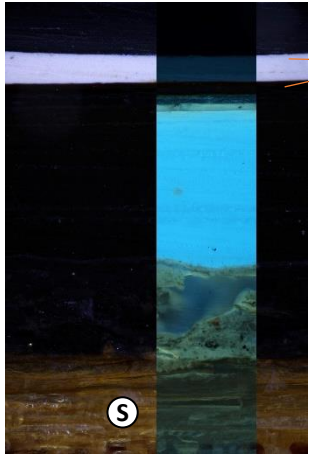
**Sample 01 (200x mag)** – South elevation, south side of central façade, base of ridge-piece, arris, timber substrate.

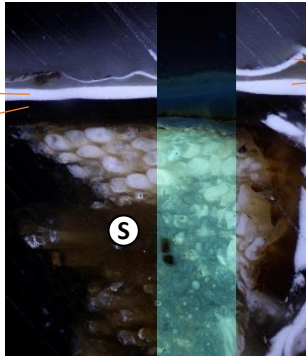
Sample 04 was taken from an underside position of the brace that is currently painted white. The cross section in Figure 17 (left), shows that the timbers look fresher/cleaner, than in other samples, which may suggest that this may be a later repair. Although, due to its position and function it a number of factors such as a variation in the use of timber, its protected position at the top of the inside of the Gateway, suggests it has not weathered in the same manner as other samples.

**Sample 04 (200x mag)** – South elevation, south side of central façade, base of ridge-piece, arris, timber substrate.

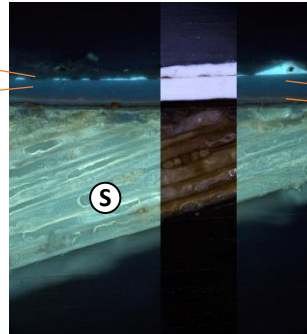
underlying paint residue in the cellular structure of the substrate. There is also evidence of an intermediary varnish film above this fragmented scheme. This would suggest that this chamfered section of the decorative brace may not always have been painted white. This is comparable to a similar chamfered facet found in Sample 08, seen in Figure 17 (right). This is also true of Sample 01, which was taken from the base of the ridge-piece. A single white paint film, similar to the first seen in the other comparable cross sections, was observed over approximately eight earlier varnish films.

**Sample 08 (200x mag)** – South elevation, south side of central façade, carved motif, chamfered edge, timber substrate (main image is UV light, insert is in direct light).

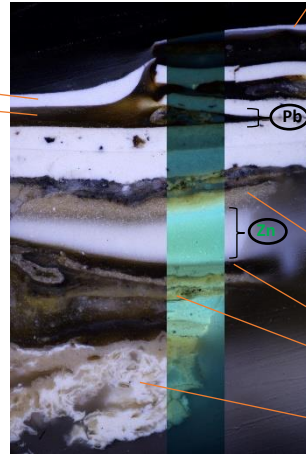
A number of samples have been rejected from the final analysis as these were taken to ensure a full decorative history could be recorded in the programme of research. However, samples such as 06, 13 and 18 retain some evidence of the earlier schemes, though samples 08 and 23 have only fragmentary evidence suggesting significant loss. Losses can be through natural paint failure, abrasion as part of preparation for redecoration or through impact damage.

**Sample 06i (200x mag)** – South elevation, south side of central façade, brace, left section, moulding, underside at side, timber substrate (not shown).

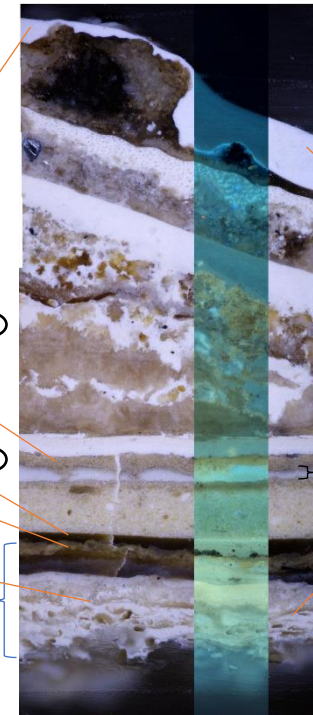
The later white undercoat, to a buff topcoat, is likely to be a white, zinc-based oil paint film; due to the fluorescence observed and the appearance of the barytes inclusions. This scheme is comparable to one found in Sample 13, from the high-level central strut on the south elevation. No reaction for lead was seen in the this white paint film when; however it could contain lithopone pigments, which were used from the 1870's as a substitute for lead carbonate (white lead), further analysis would be required to confirm this.

**Sample 13 (200x mag)** – South elevation, inner side of southern façade, central strut, under side, arris, timber substrate (not shown).

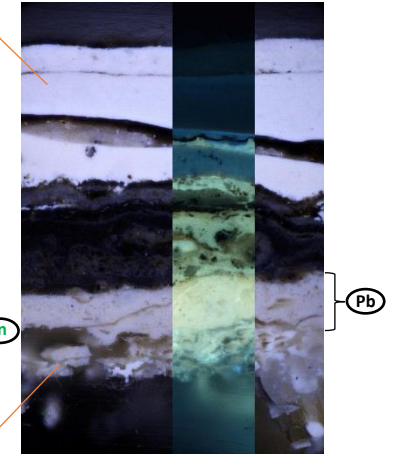
**Sample 12 (200x mag)** – South elevation, inner side of southern façade, central strut, top, arris, timber substrate (not shown).

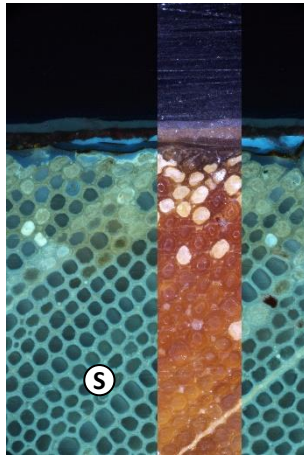
**Sample 09 (200x mag)** – South elevation, south side of central façade, upper main horizontal beam, above gate, timber substrate.

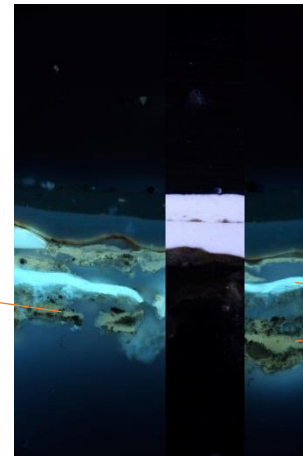
**Sample 14 (100x mag)** – South elevation, inner side of southern façade, central strut, west side, carved decoration, top, timber substrate (not shown).

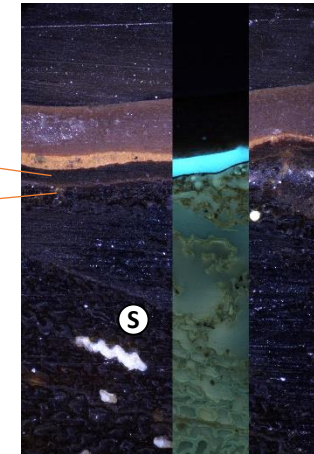
**Sample 16 (200x mag)** – South elevation, south-east post, south side, right chamfer, timber substrate.

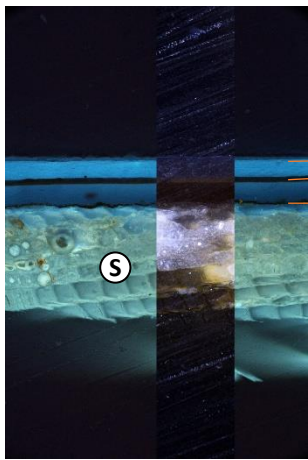
**Sample 25 (200x mag)** – South elevation, doorway, right door, bottom left panel, wood enrichment, top of leaves, timber substrate.

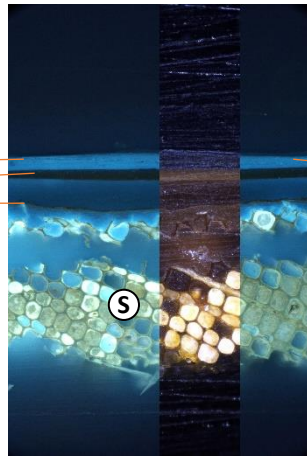
**Sample 26 (200x mag)** – South elevation, doorway, left door, top right panel, wood enrichment, top of leaves, timber substrate.

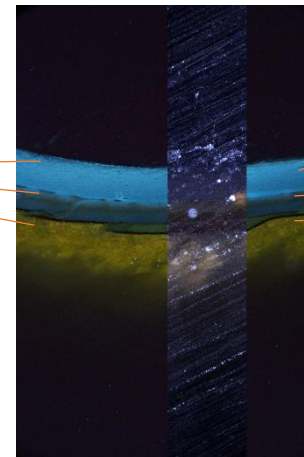
**Sample 28 (200x mag)** – North elevation, doorway, left door, upper central panel, wood enrichment, top of leaves, timber substrate (not included).

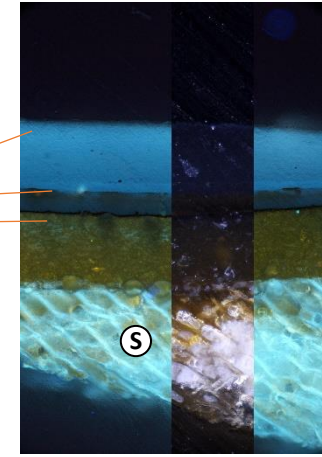
**Sample 29 (200x mag)** – North elevation, doorway, left door, upper central panel, wood enrichment, top of leaves, timber substrate.

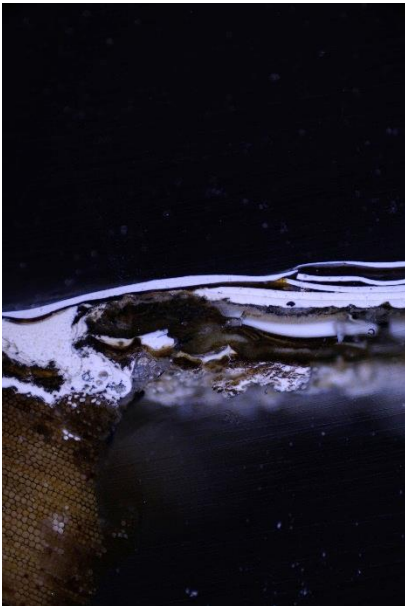
*Sample 06 – South elevation, south side of central façade, brace, left section, moulding, underside at side: following test for the presence of lead (positive). Earlier buff schemes have turned black following solution of dilute sodium sulphide.*

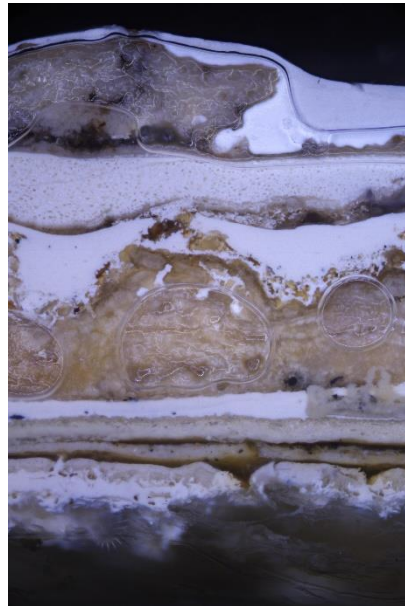
*Sample 13 – South elevation, inner side of southern façade, central strut, under side, arris: following test for solubility (positive). Earliest scheme and buff schemes have reacted positively, along with the white paint films showing signs of softening and movement.*

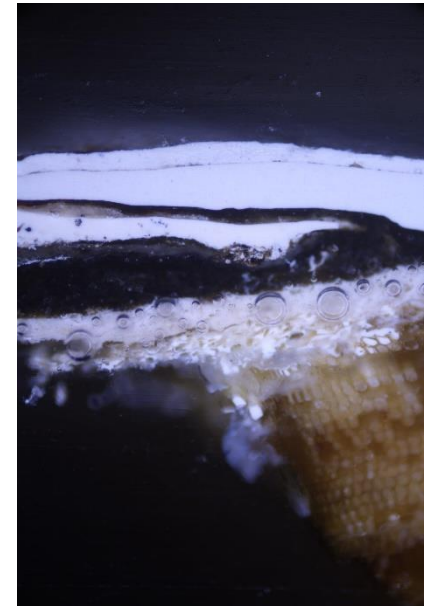
*Sample 12 – South elevation, inner side of southern façade, central strut, top, arris: following test with a mild acid (HCl), evidence of carbonation and bleaching shows the likely presence of French Ultramarine pigmentation in the earlier paint film.*
