4 Maids of Honour Row: Phase 2, Timber condition investigation

Site note 5 for 30 August 2023, job no. 157-65

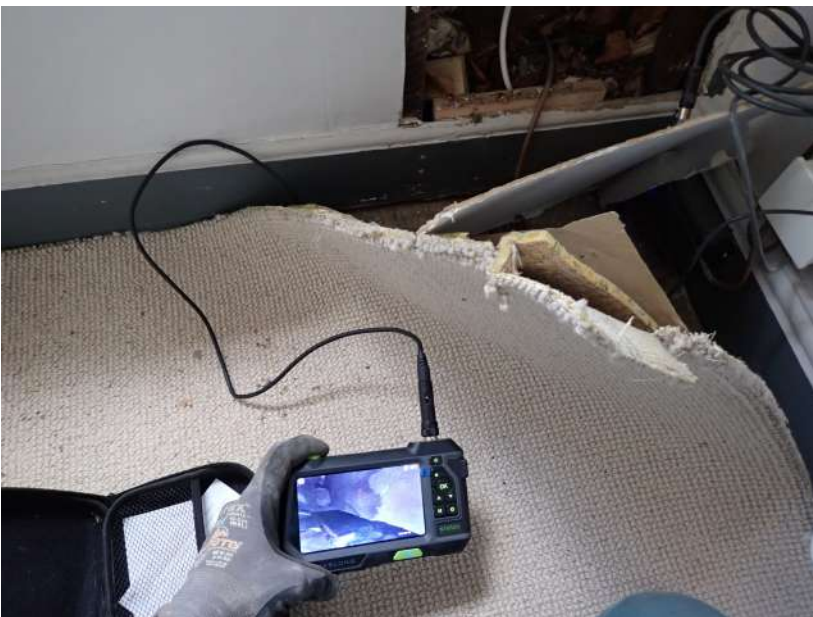
Fig 12:

P15, second floor; showing view to the north-east floor structures under investigation via video borescope analysis

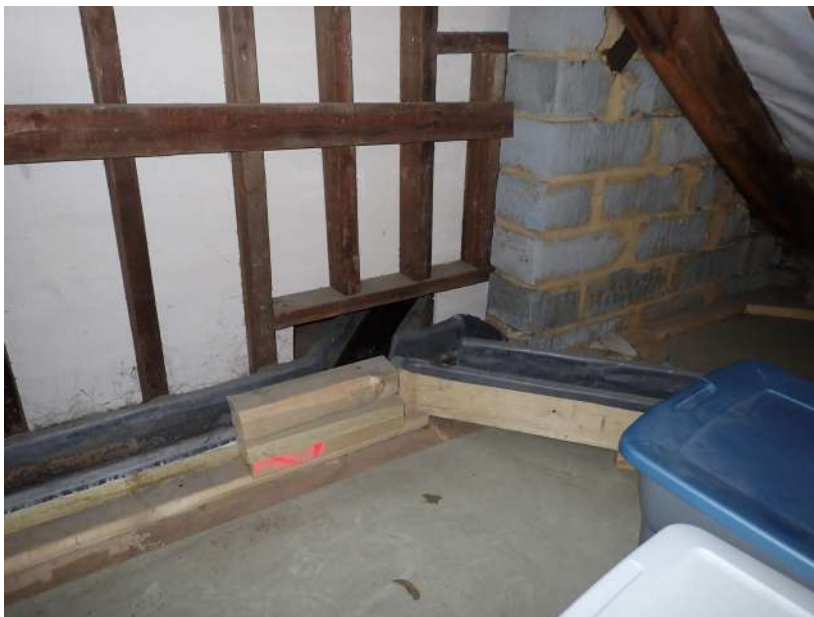
Fig 14:

Roof; showing view towards the internal division east party wall to the north pile roof. Note significant fire break formed between the party wall structure due to the shared internal trench gully.

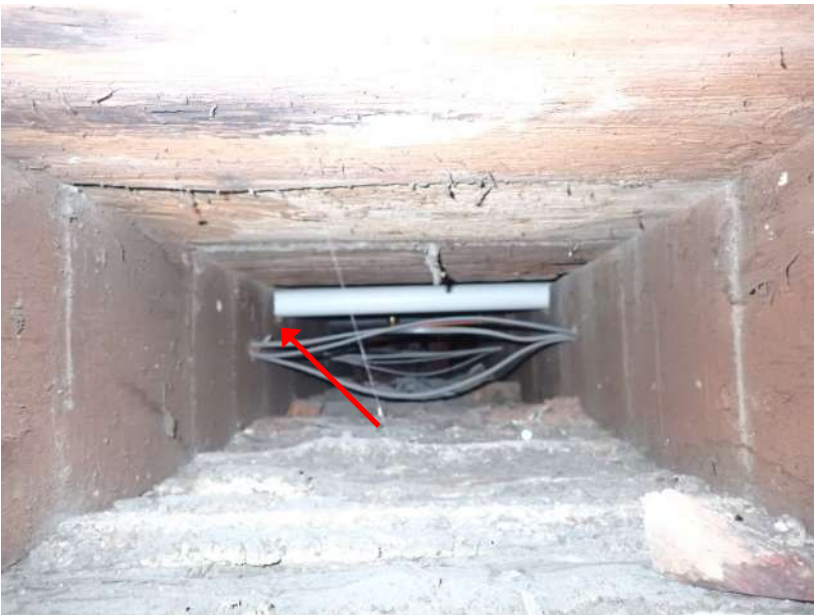
Fig 18:

P12, second floor; showing representative view to the floor void. Note no apparent provision for floor void insulation or for noggins/herringbone struts to provide lateral support to existing historic floor structures. Also note some evidence for possibly fairly significant service notching to the upper face of the historic floor joists

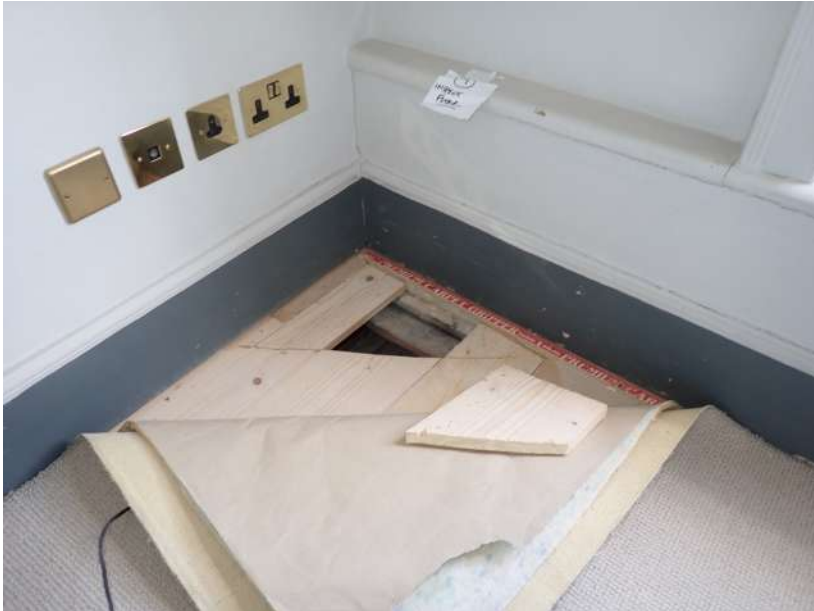
Fig 19:

Second floor, north-west corner; showing localised opening to the non-historic floorboards to gain access to the historic floor joists beneath

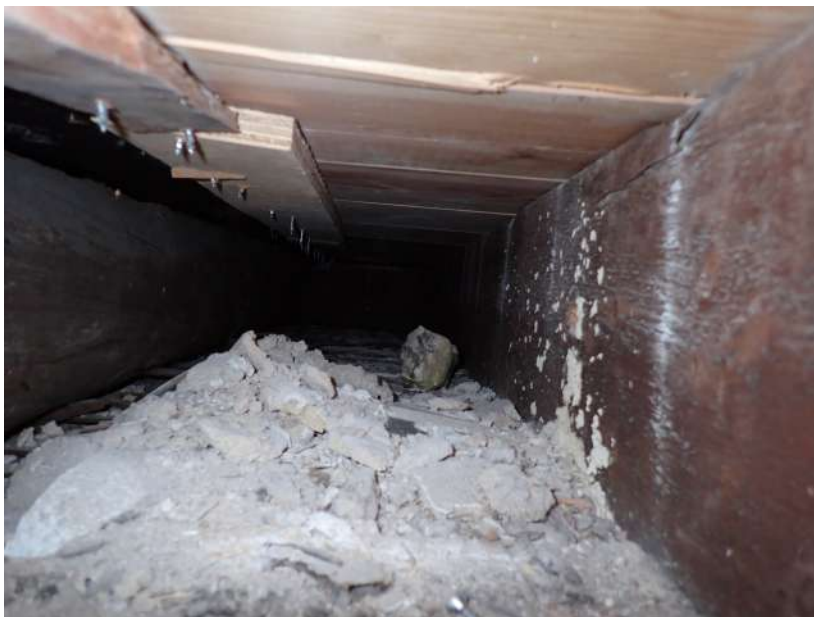
Fig 20:

Second floor, north-west corner; showing representative view to the floor void looking east. Note no apparent provision for pugging material/insulation or noggin/strut members to provide lateral support to the floor structures. However, no significant movement or bounce to the floor structures identified when traversed

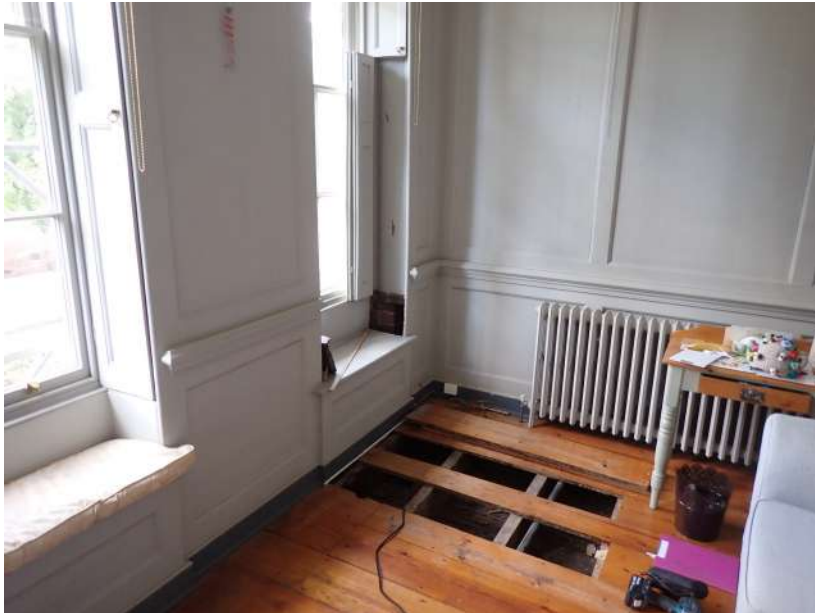
Fig 23:

P6, first floor, north-east corner; showing a general view towards the partially exposed floor/wall structures and openings to the panel elements to allow for investigation to timber elements

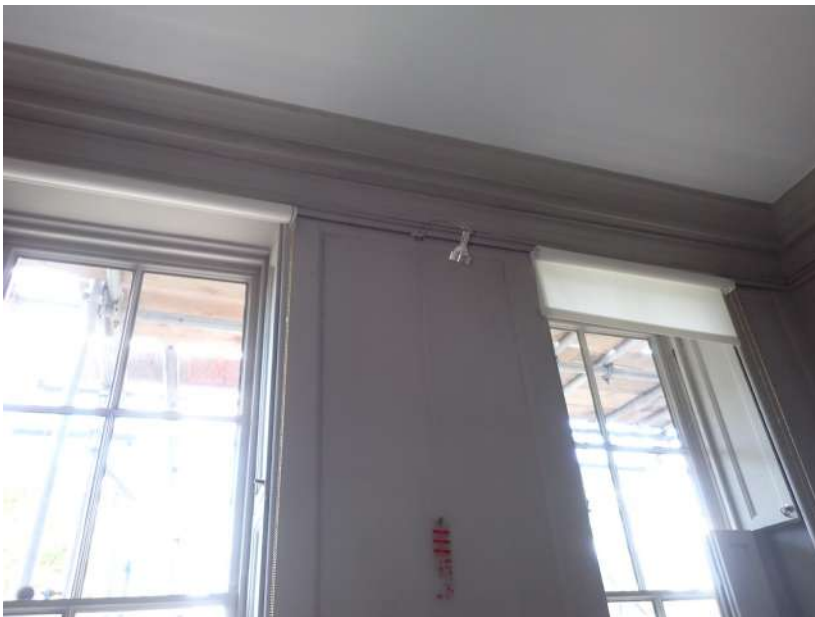
Fig 24:

First floor; showing general view towards the upper lintels over the north perimeter wall window apertures. Note no provision for access at time of investigation to determine the construction and condition to the internal timber lintels

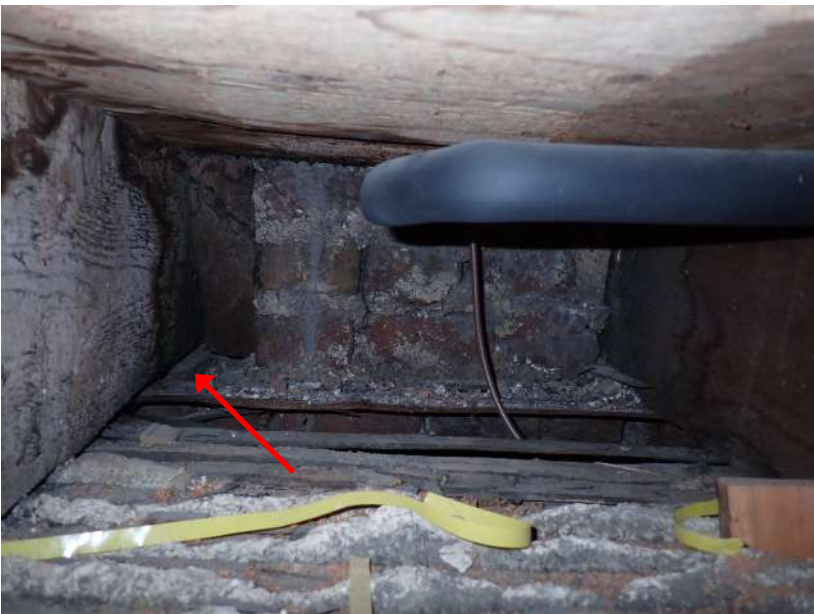
Fig 26:

P6, first floor; showing representative view to an additional floor void between joist centres looking east to the internal division party wall. Note no apparent provision for a perpendicular supporting continuous wall plates beneath the embedded floor joists. Floor joists were apparently embedded directly into the masonry with small timber packing elements to allow for variations in depth of joist tenon

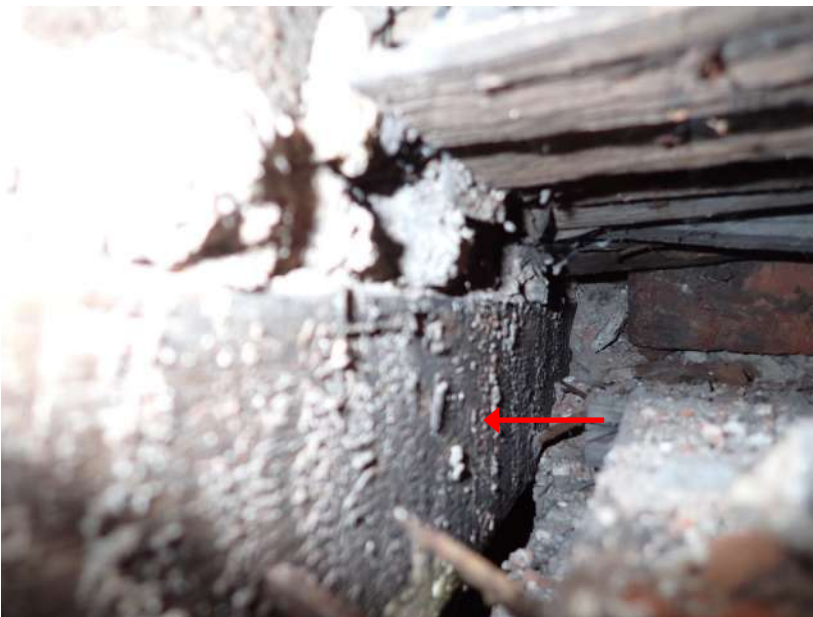
Fig 28:

P6, first floor; showing closer view towards the accessible north-east lintel over the ground floor window aperture. Lintel was deep resistance drilled and moisture probed. No decay detected

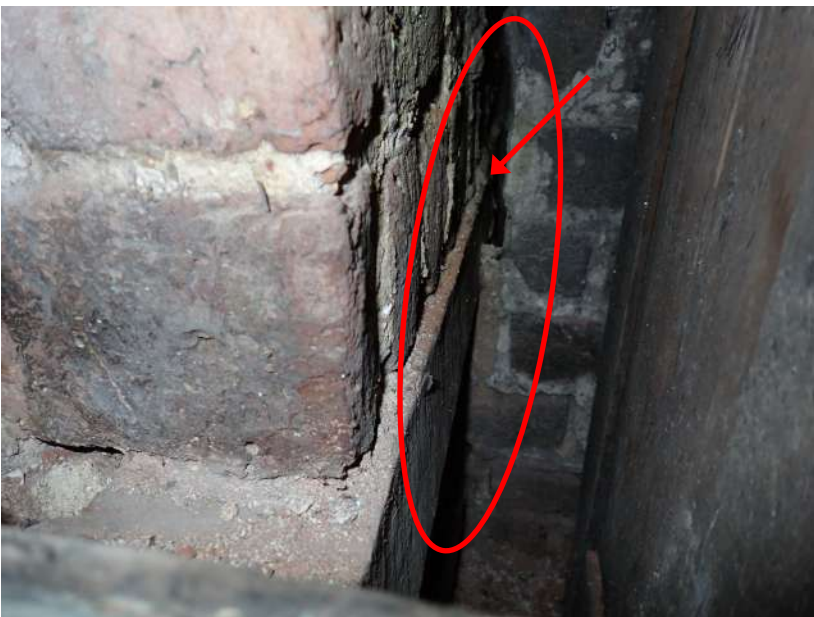
Fig 30:

P7, first floor, north-east corner; showing view towards the identified embedded bonding timber looking east. Note bonding timber apparently continues towards/into the party wall and neighbouring property. Also note partial historic debonding of the internal division masonry wall from the external north façade wall by up to ~40mm. Structural Engineer to comment

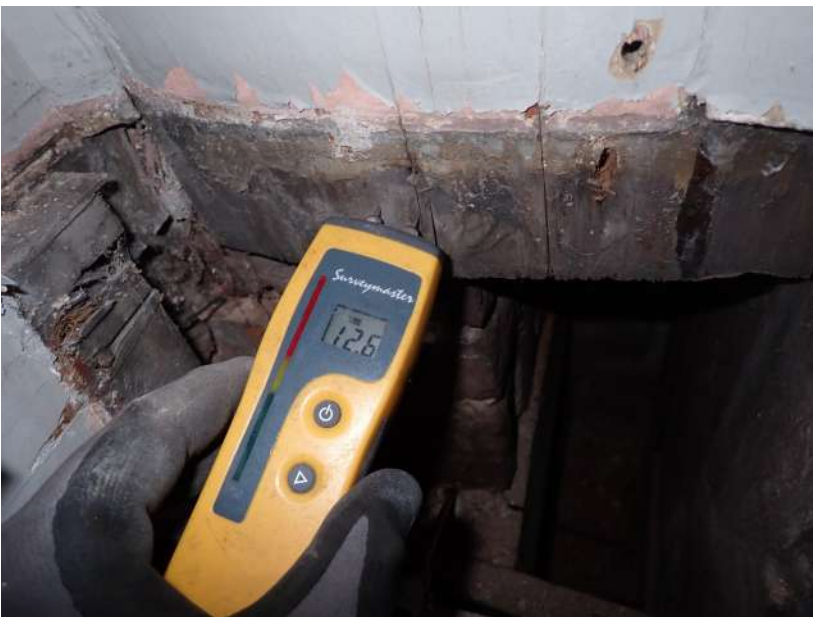
Fig 32:

P7, first floor; showing representative surface moisture content to an historic exposed window reveal to the north-east corner recorded as dry at 12.6%

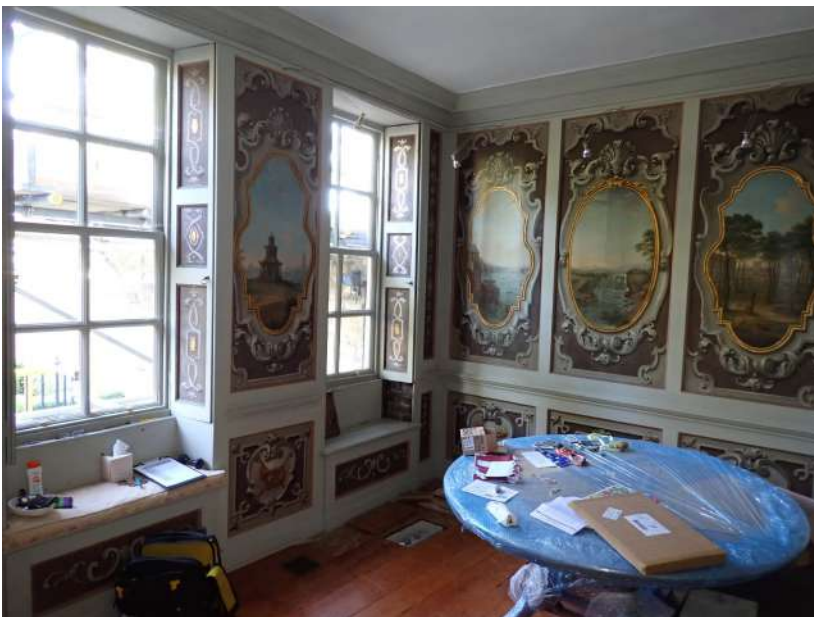
Fig 34:

P5, ground floor; showing general view towards the north-east corner to the entrance hallway. Note localised openings to the historic panelling and floorboards to allow for investigation to potentially vulnerable timber elements subject to intermittent moisture penetration from the failed external lead and cast iron downpipe to this area

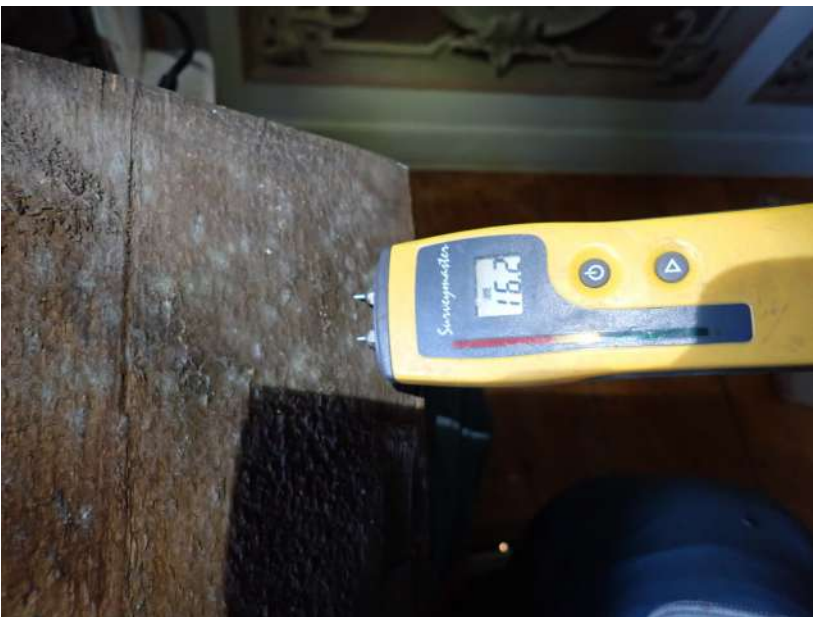
Fig 36:

P5, ground floor; showing a representative surface moisture content from a panel member subject to surface mould spores to its rear face. Surface moisture content recorded at 16.2% which although not significant, is considered elevated and therefore vulnerable to potential infestation by wood boring beetle to any remaining sapwood bands

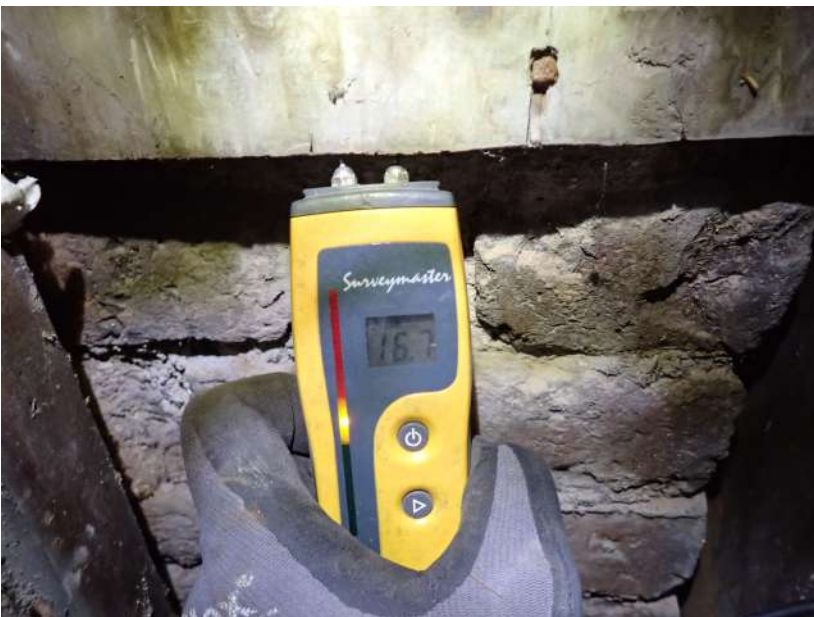
Fig 38:

P5, ground floor; showing a representative moisture content to the panelled window reveal to the north-east window recorded as elevated at 16.7%

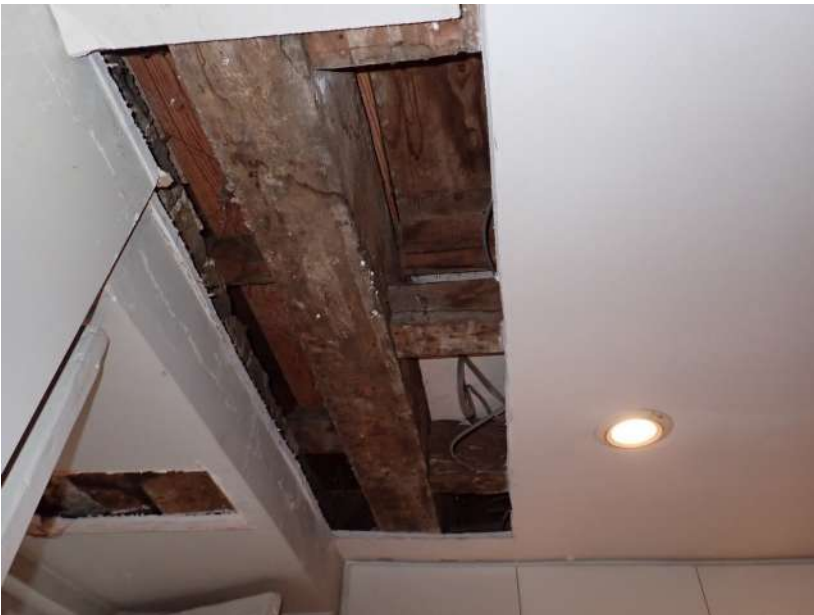
Fig 40:

P4, ground floor as seen from basement kitchen level; showing general view towards the exposed floor structures to the north-east corner. Note interesting constructional arrangement whereby the north-south orientated floor joists and ceiling joists were not embedded into the vulnerable external north façade elevation but were carried instead onto a secondary beam element which itself bore onto the internal flank east wall and to the primary beam member

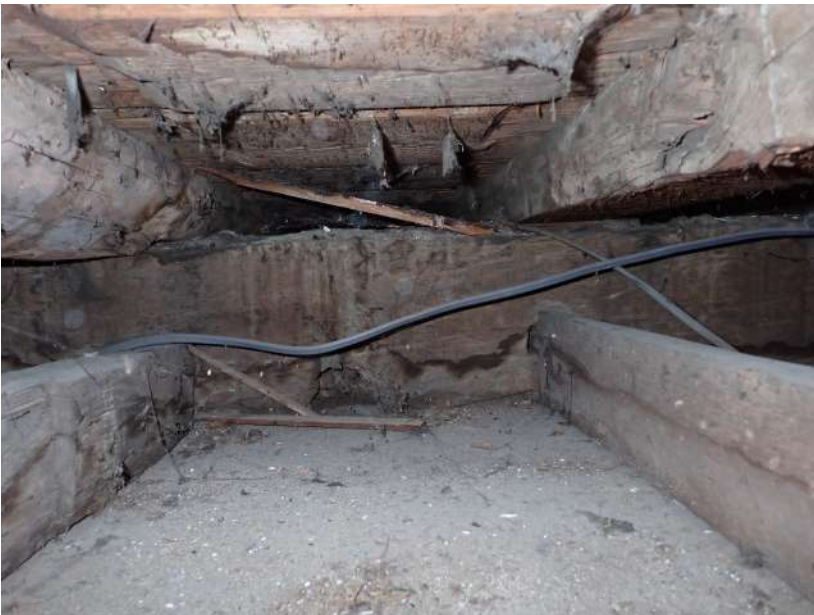
Fig 42:

P4, ground floor; showing additional view to the historic floor void looking west. Note historically interesting construction arrangement whereby the floor joists were of poorer quality than the ceiling joists with significant remaining sapwood bands. Also note ceiling joists apparently tenoned into the secondary beams at both ends suggesting that the ceiling joists were introduced during the original construction phase/assembly whereas floor joists were added after

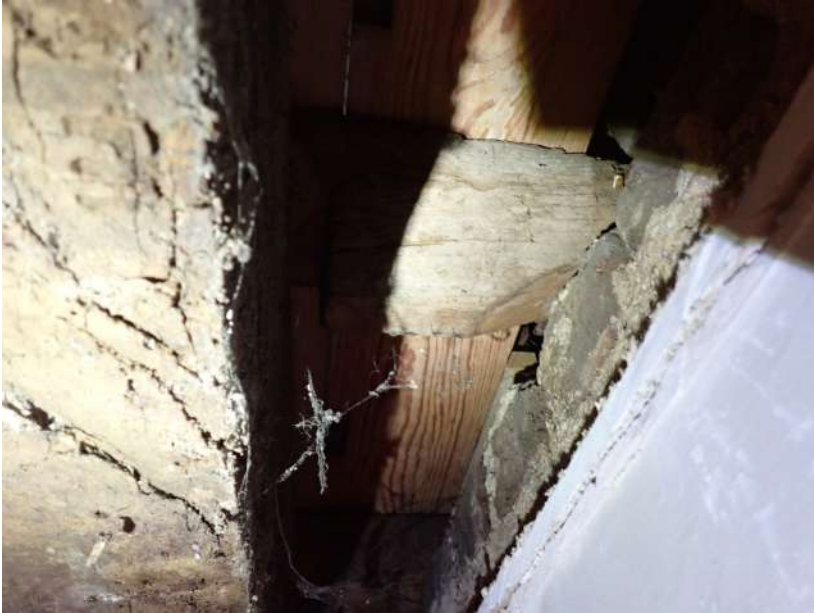
Fig 45:

P4, ground floor; showing construction detail of the north perimeter floor joist bearing onto the masonry wall head with scalloped ends to allow for suitable levelling to the floor structures above

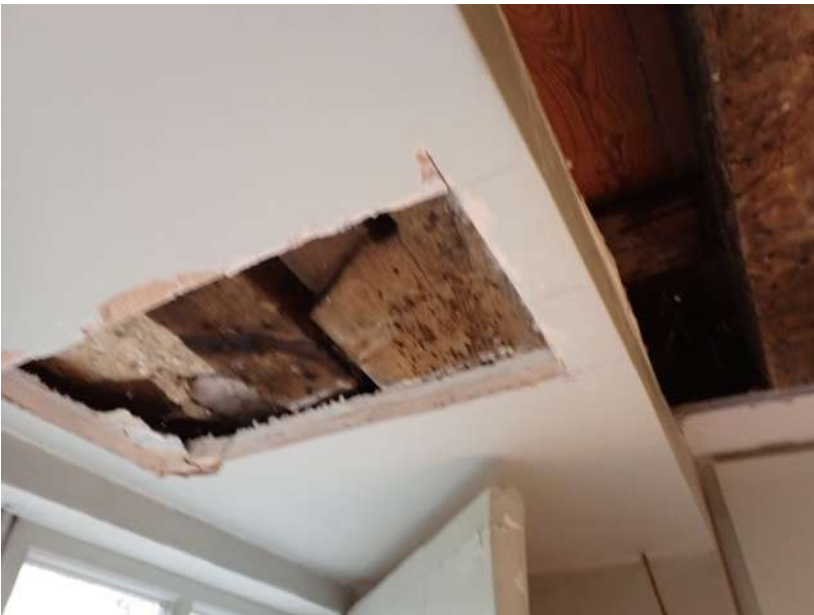
Fig 46:

P4, basement; showing view towards the partially exposed oak timber lintels over the vulnerable north-east window aperture. Note inner oak lintel forming the main structural support to the structures above and apparently of reclaimed stock

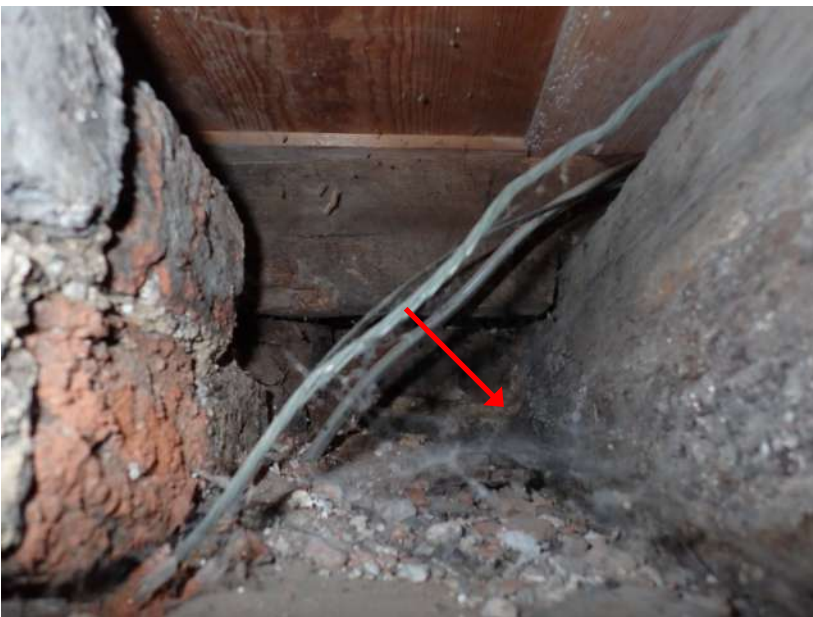
Fig 48:

P4, ground floor; showing view towards the north-east corner where the secondary beam embeds into the internal division masonry wall adjacent to the vulnerable and actively failing external downpipe. Secondary beam embedded bearing end could not be resistance drilled and deep moisture probed at the time of the investigation. However, no significant or concerning decay organisms or indications for significant decay issues visually identified

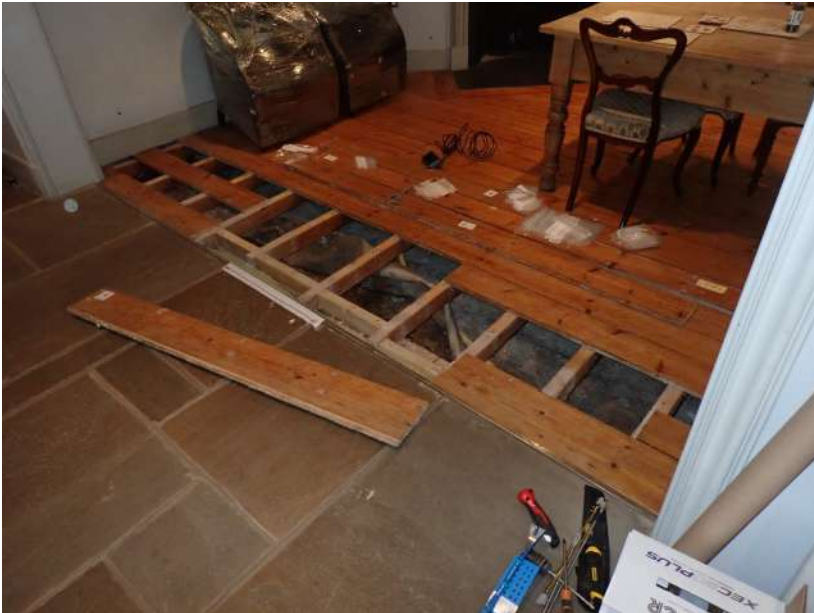
Fig 49:

P2, basement; showing general view towards the exposed suspended timber floor structures to the west area

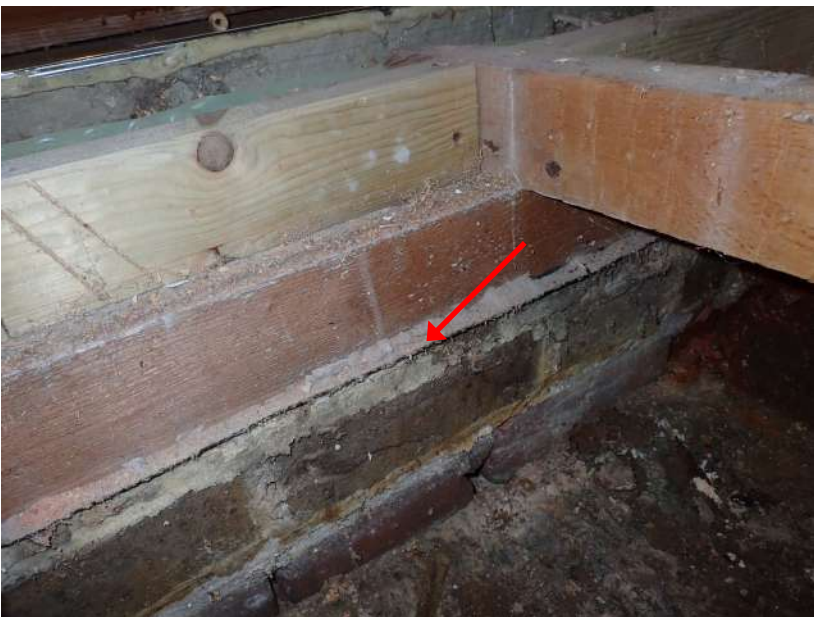
Fig 50:

P2, basement; showing view towards the modern softwood floor structures. Note floor plate supported onto an historic masonry dwarf wall and separated by a suitable bituminous damp-proof membrane

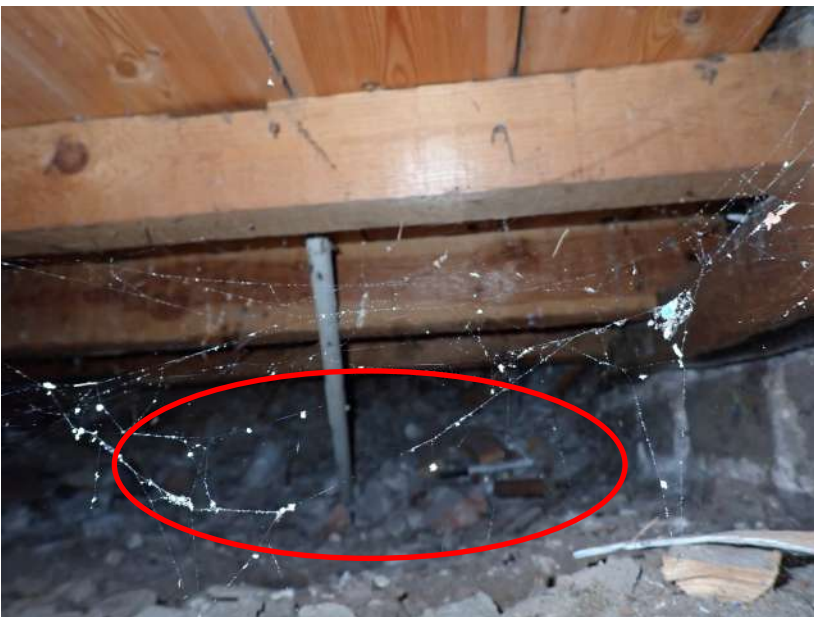
Fig 52:

P2, basement; showing representative view towards the floor void looking towards the north-east corner (beneath the dumb waiter location). Note evidence of significant debris build-up to this area which is likely to be reducing ventilation to the floor plate and floor build-up to this location. However, no decay issues identified or presumed at time of investigation

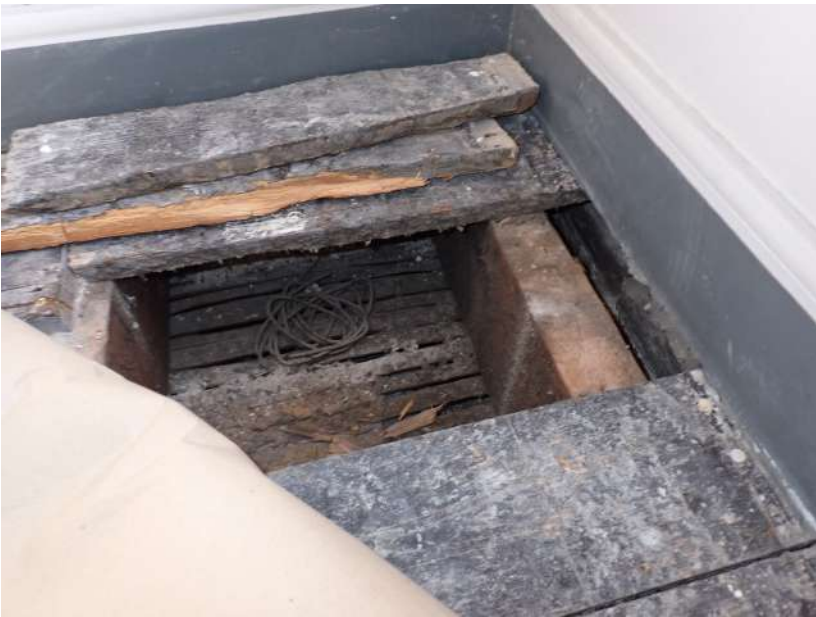
Fig 54:

P9, second floor; showing representative view towards the exposed floor joists in east-west orientation

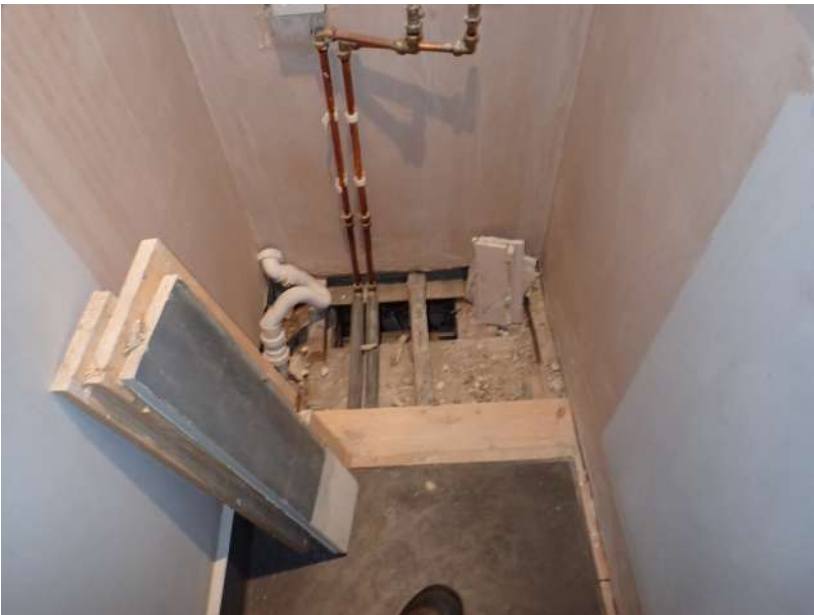
Fig 56:

P14, second floor; showing general view of the partially exposed floor structures to the internal covered lining. Timbers were investigated for construction and condition. No decay or structural issues identified
