Ground Floor Plan Notes

CLIENT
English Heritage

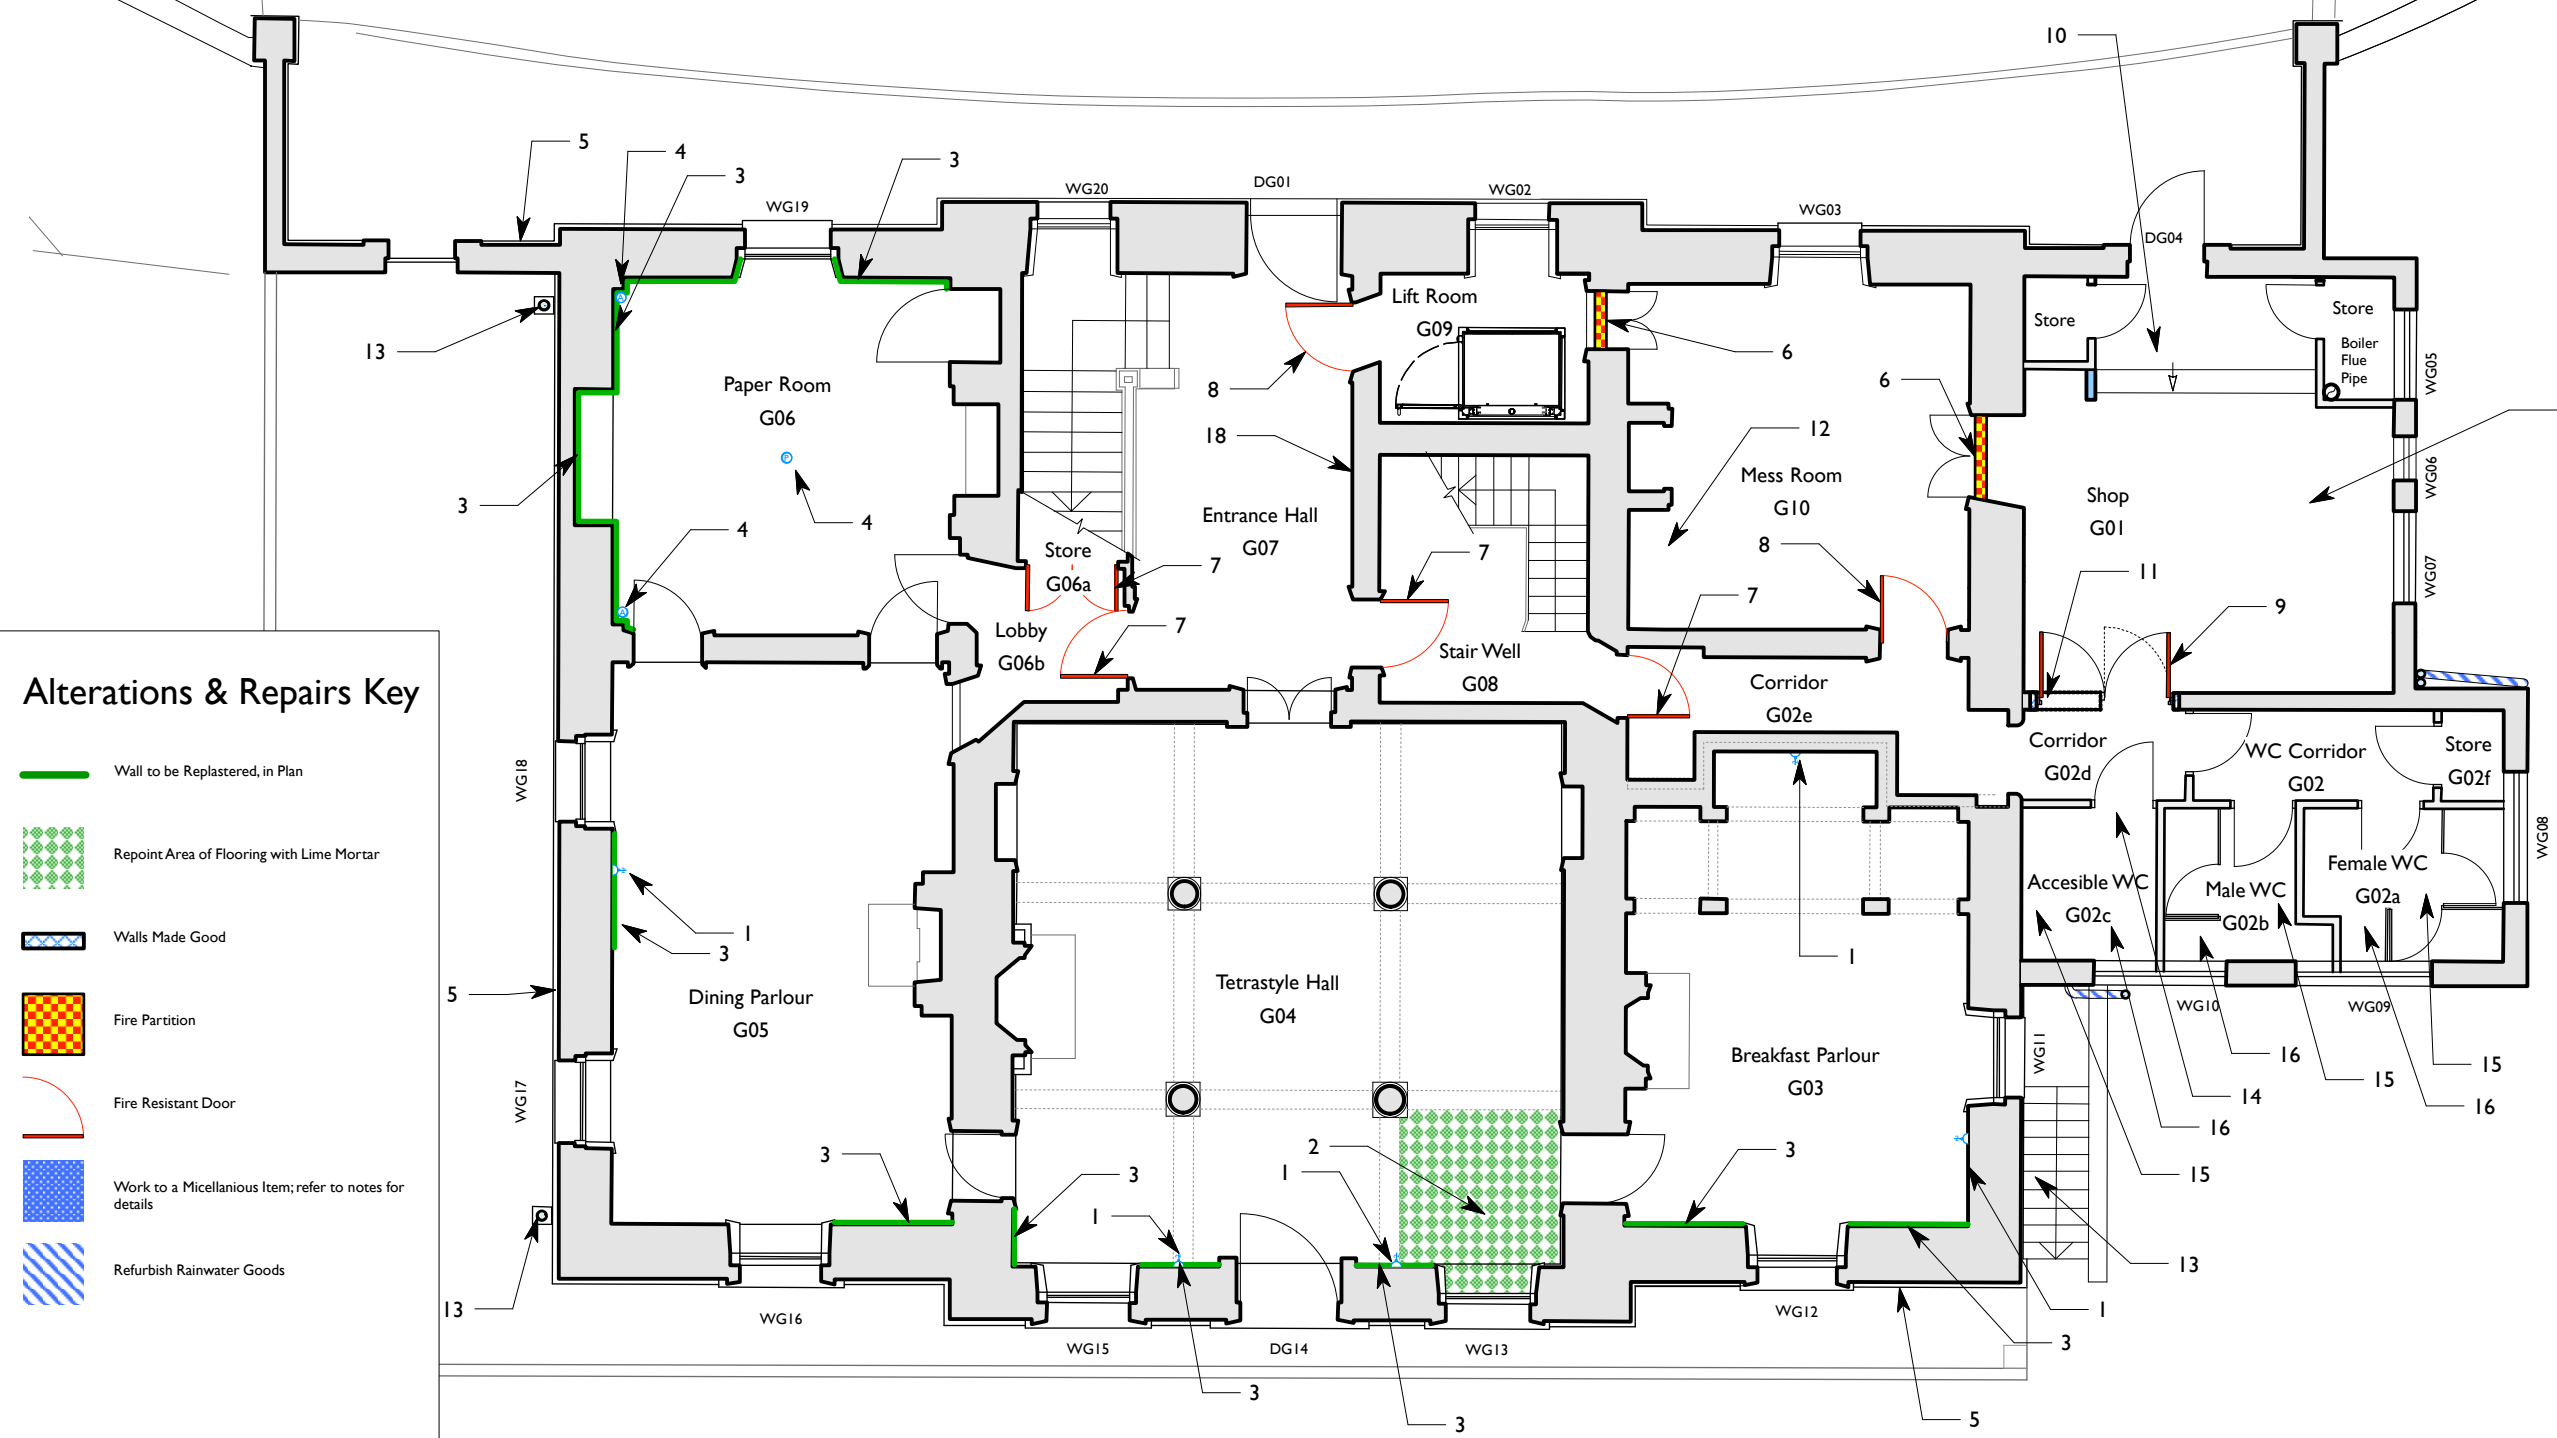
1. New/replacement electrical socket. This is to be fitted with a plastic backbox, where this is replacing a failed route, the original wiring is to be removed and a new 20 mm PVC conduit installed in the chase. The conduit is to be mortared in place with new lime putty mortar.

2. Damp affected paving slabs; carefully rake out all mortar joints and repoint with lime putty mortar.
3. Failed wall cementitious/gypsum plaster to be removed, the masonry is to be pointed with lime putty mortar and then plastered with a lime putty three coat plaster. Within the Dining Parlour, the Hall & the Breakfast Parlour the plaster affected by damp is only a Dado Level.

4. New overhead projector installed utilising the existing metal conduit boxes in the ceiling. This is to be accompanied by audio speakers.
5. For works to the external walls, refer to the elevation proposal drawings.

6. New fire partition; refer to detail drawing
7. Existing asbestos clad fire resistant door, this is to have its asbestos removed and new fire resistant material added.

8. Existing door rehung to open outwards and its fire resisting features enhanced; refer to drawing.
9. New fire resisting doors; refer to detail drawing showing general approach.

10. Existing screen removed and the existing steps modified.
11. Existing doorway widened and made good or existing opening retained as existing. THIS ITEM MAY BE OMITTED, THE DOORWAY IS PERHAPS HISTORIC.

12. Room G10 (Mess Room); this is to be fitted with all the security and electrical controls
13. Rainwater pipes; these are to be taken down and fully refurbished and reinstalled. They are to be put back in their original locations, they will be repainted with micaceous iron oxide undercoat and a Dulux Metalshield topcoat (colour to be determined, assume white as existing or lead grey), all joints are to be left uncaulked. The gully is to be replaced with a new accessible gully, the downpipes are to be fitted with a shoes.

14. WC door fitted with a closer
15. WC space fitted with a baby changing unit.
16. WC walls and floors to be painted with a conventional paint system and have tiles cleaned and regrouted where grout has failed.

17. Works to entrance and interpretation room, refer to the interpretation report.
18. Intumescent grill to replace the existing metal grill. New grill to be as sensitive as possible.
