First Floor Plan; as Proposed

DRAWN	
HS	
DRAWING N°	
211

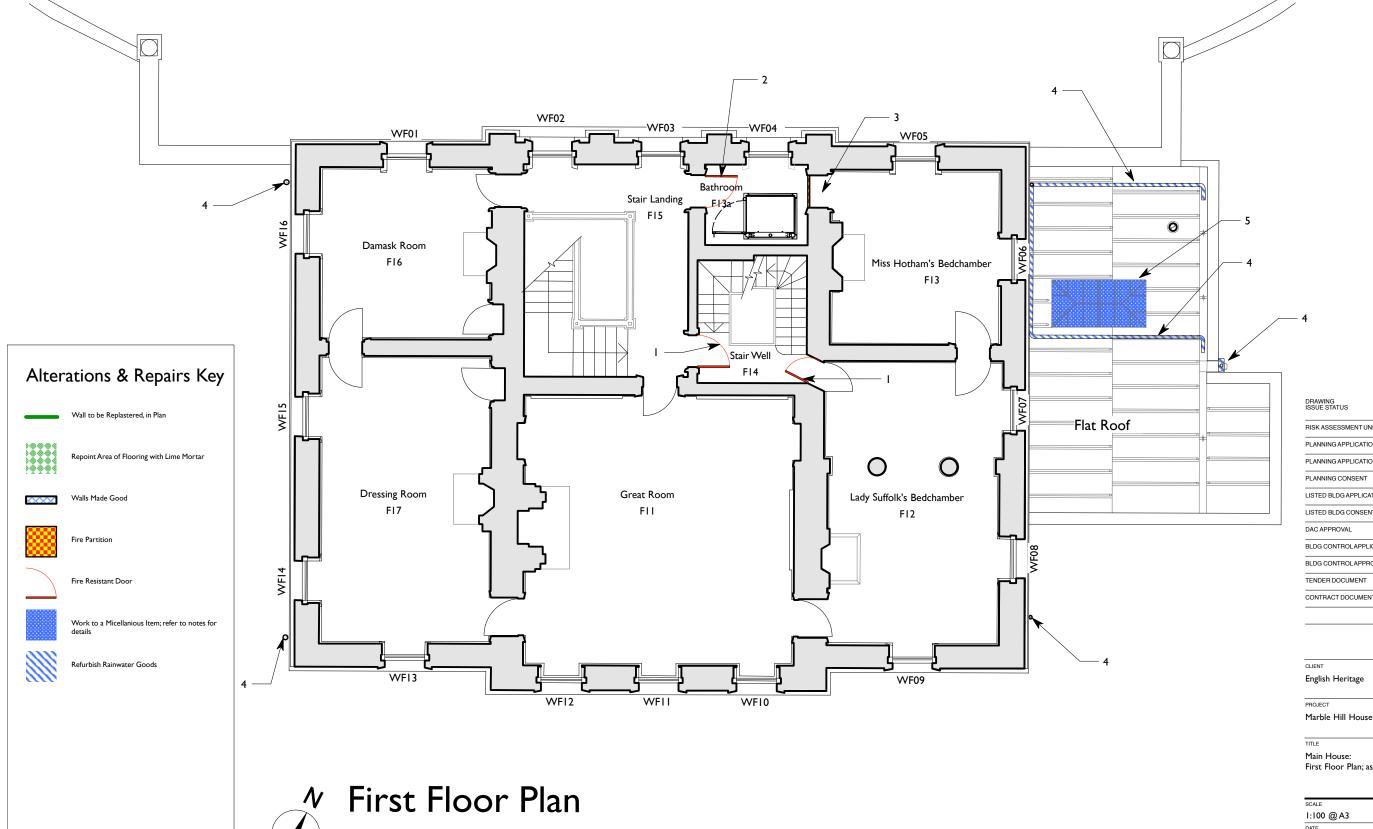
First Floor Plan Notes

- Existing asbestos clad fire resistant door, this is to have its asbestos removed and new fire resistant material added.

- resistant material added.
 Existing door rehung to open outwards and its fire resisting features enhanced; refer to drawing.
 New fire partition; refer to detail sketch
 Rainwater pipes; these are to be taken down and fully refurbished and reinstalled. They are to be put back in their orgional locations, they will be repainted with micaceous iron oxide undercoat and a Dulux Metalshield topcoat (colour to be determined, assume white as existing or lead grey), all joints are to be left uncaulked. The gulley is to be replaced with a new accessible gulley, the downpipes are to be fitted with a shoes.
 Rooflight, this is rotten and non-historic, allow to replace with an aluminium rooflight
