PROJECT Marble Hill House

Main House: Second Floor Plan; as Proposed

SCALE	
I:100 @ A3	
DATE	DRAWN
December 2016	HS
JOB N°	DRAWING N°
16_132	212

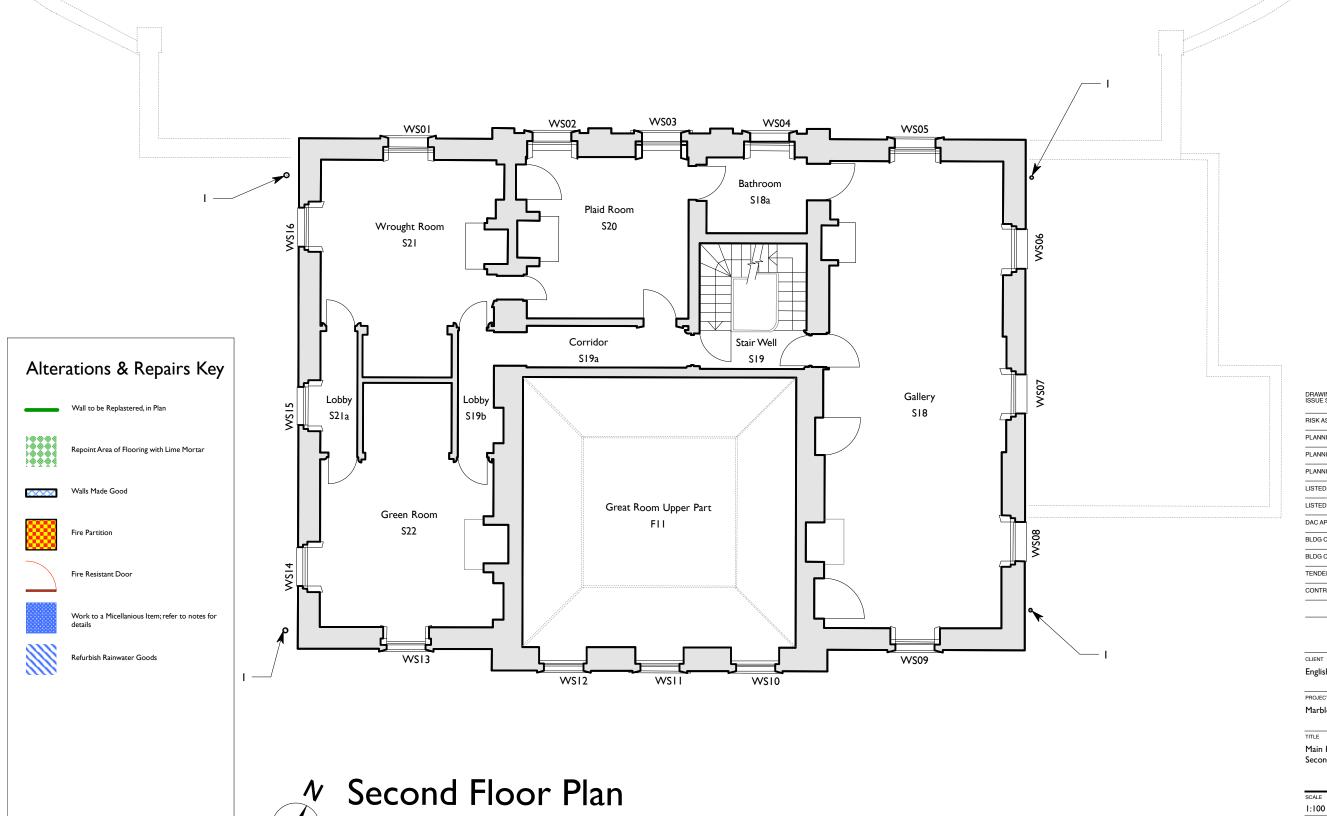
Second Floor Plan Notes

Rainwater pipes; these are to be taken down and fully refurbished and reinstalled. They are to be put back in their orgional locations, they will be repainted with micaceous iron oxide undercoat and a Dulux Metalshield topcoat (colour to be determined, assume white as exisiting or lead grey), all joints are to be left uncaulked. The gulley is to be replaced with a new accessible gulley, the downpipes are to be fitted with a shoes.
