8.20 STABLE BLOCK & CAFE - STRUCTURAL REPORT & DRAWINGS

**EXECUTIVE SUMMARY
STRUCTURAL STAGE 3 DRAFT REPORT
FOR PROPOSED WORKS
AT
MARBLE HILL HOUSE, LONDON**

Ref: 17549/JC/Stage 3 Exec Summary

**STAGE 3
STRUCTURAL SCHEME REPORT
FOR
MARBLE HILL HOUSE – STABLES CAFÉ
LONDON**

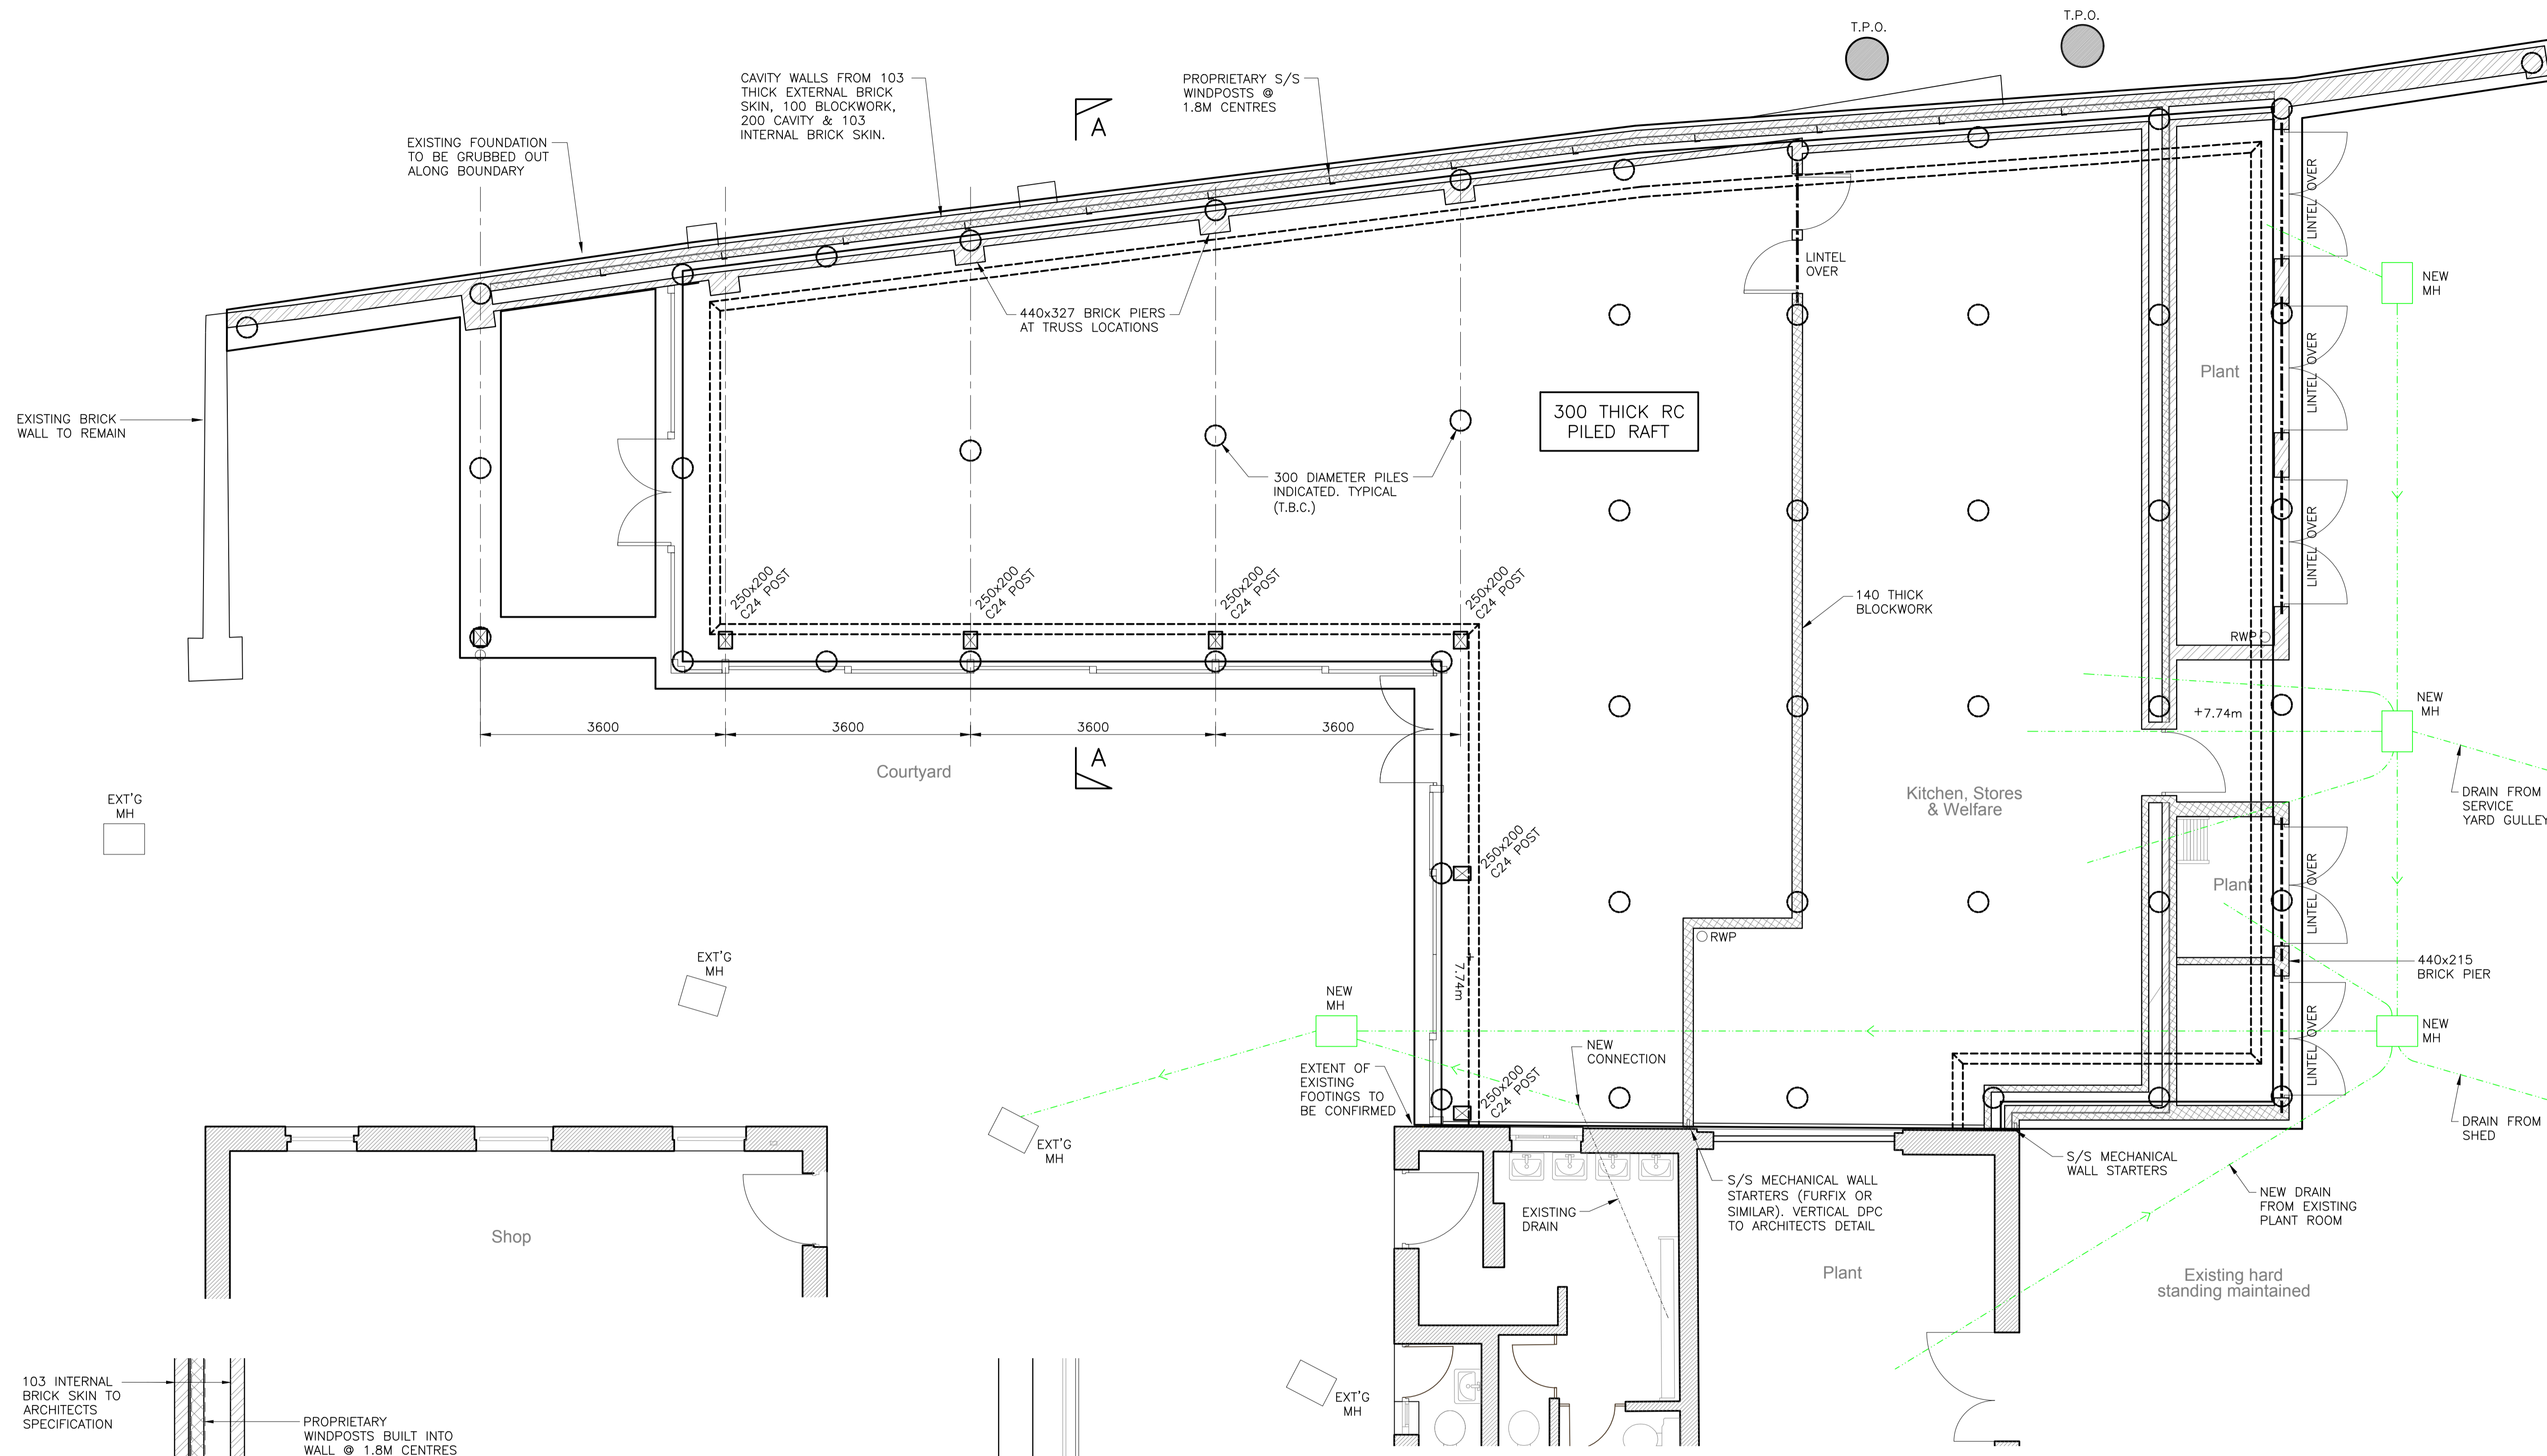
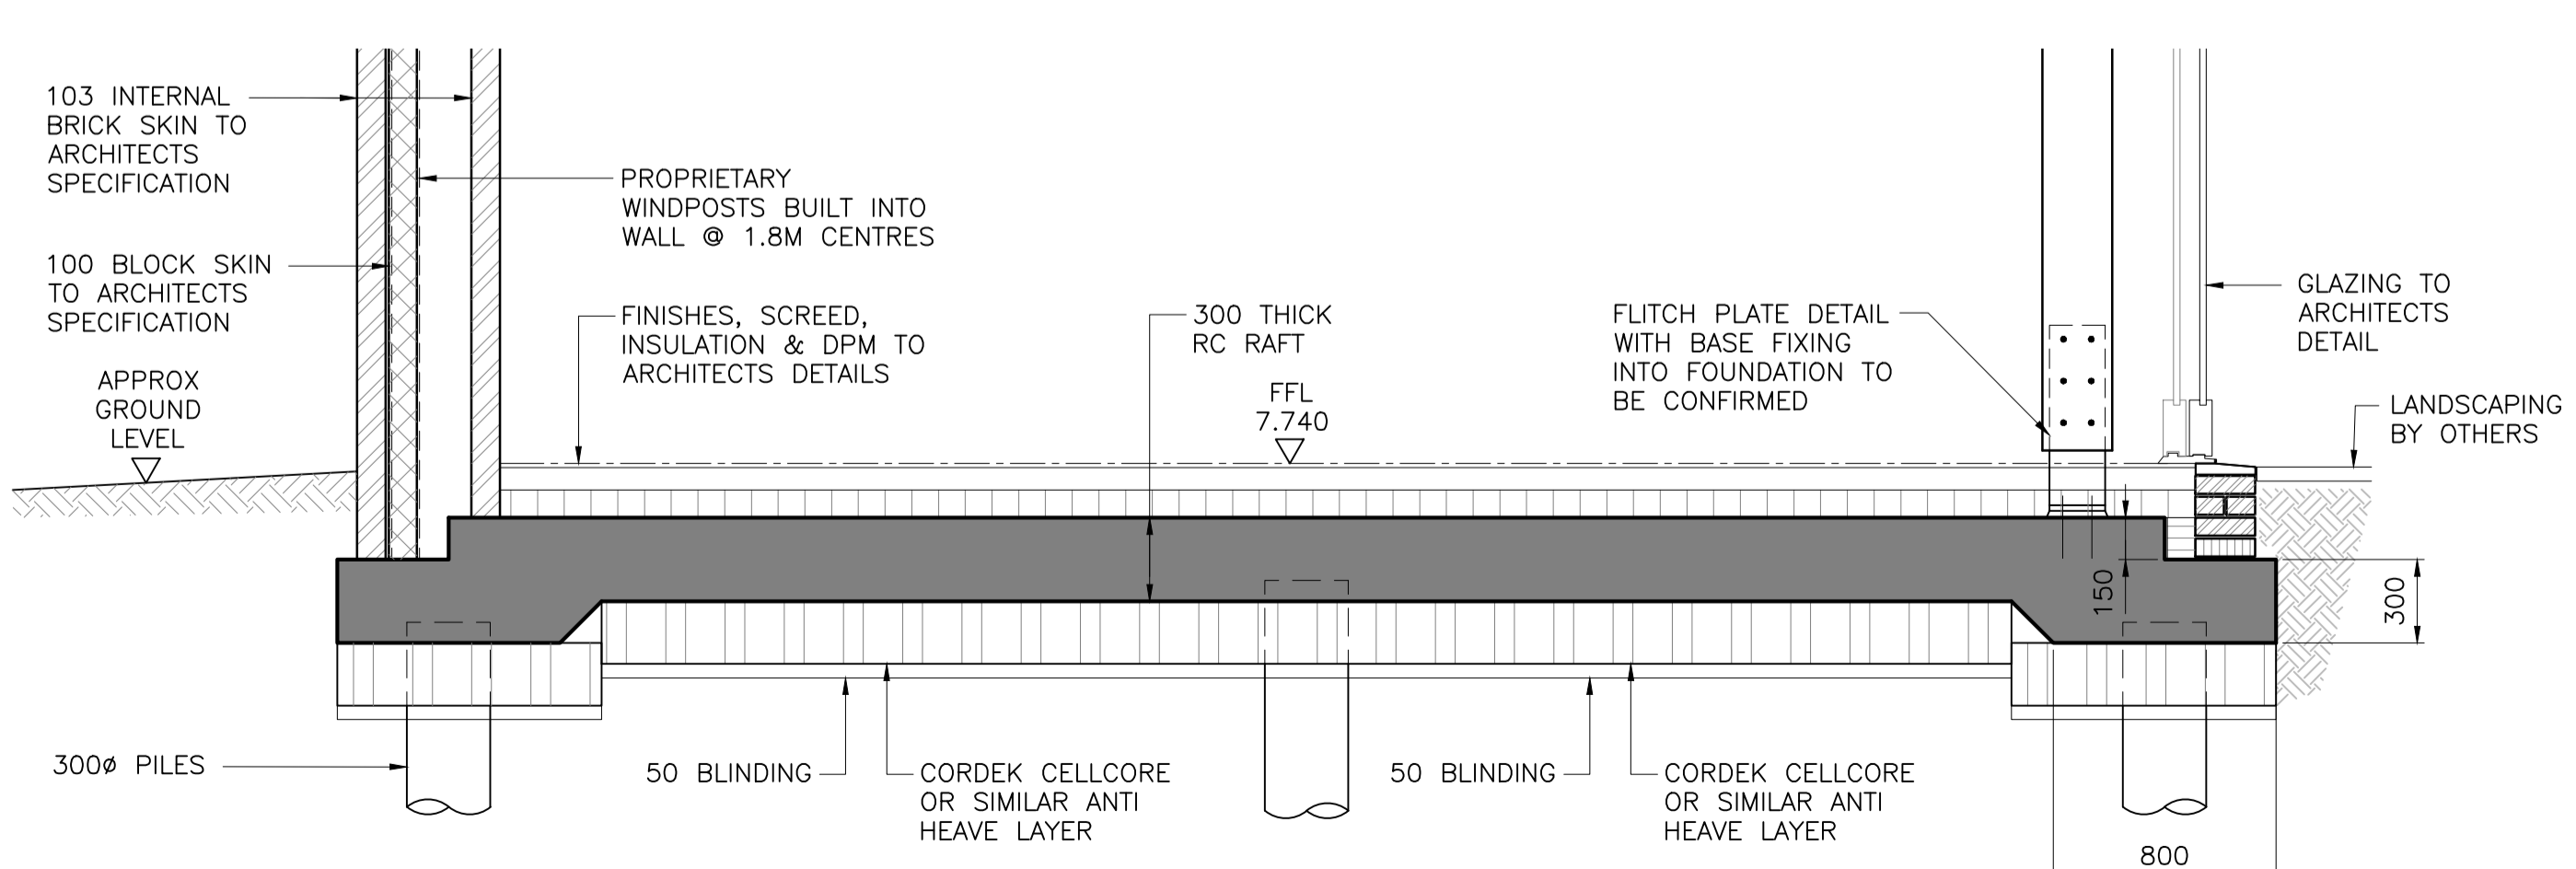
SCALE: 1:50@A1 DRAWN BY: TC
DATE: DEC 16 CHECKED BY: JC
DRG No. 17549-01 C

SECTION A-A

**FOUNDATION & GROUND
FLOOR LEVEL
GENERAL ARRANGEMENT**

- 1.6 We have prepared the following drawings to accompany this stage 3 report:
- 17549-01C Foundation and Ground Floor Level General Arrangement
 - 17549-02A Roof Level Arrangement

- 3.1 In the current scheme presented in the structural markup within Appendix A, the brick boundary wall will be rebuilt using salvaged bricks from the original wall for the outer skin. The piled raft will form the foundation of the rebuilt brick wall.

- 5.4 The replacement of 2No. manholes will be required as they fall within the footprint of the proposed café and internal chambers should be avoided.

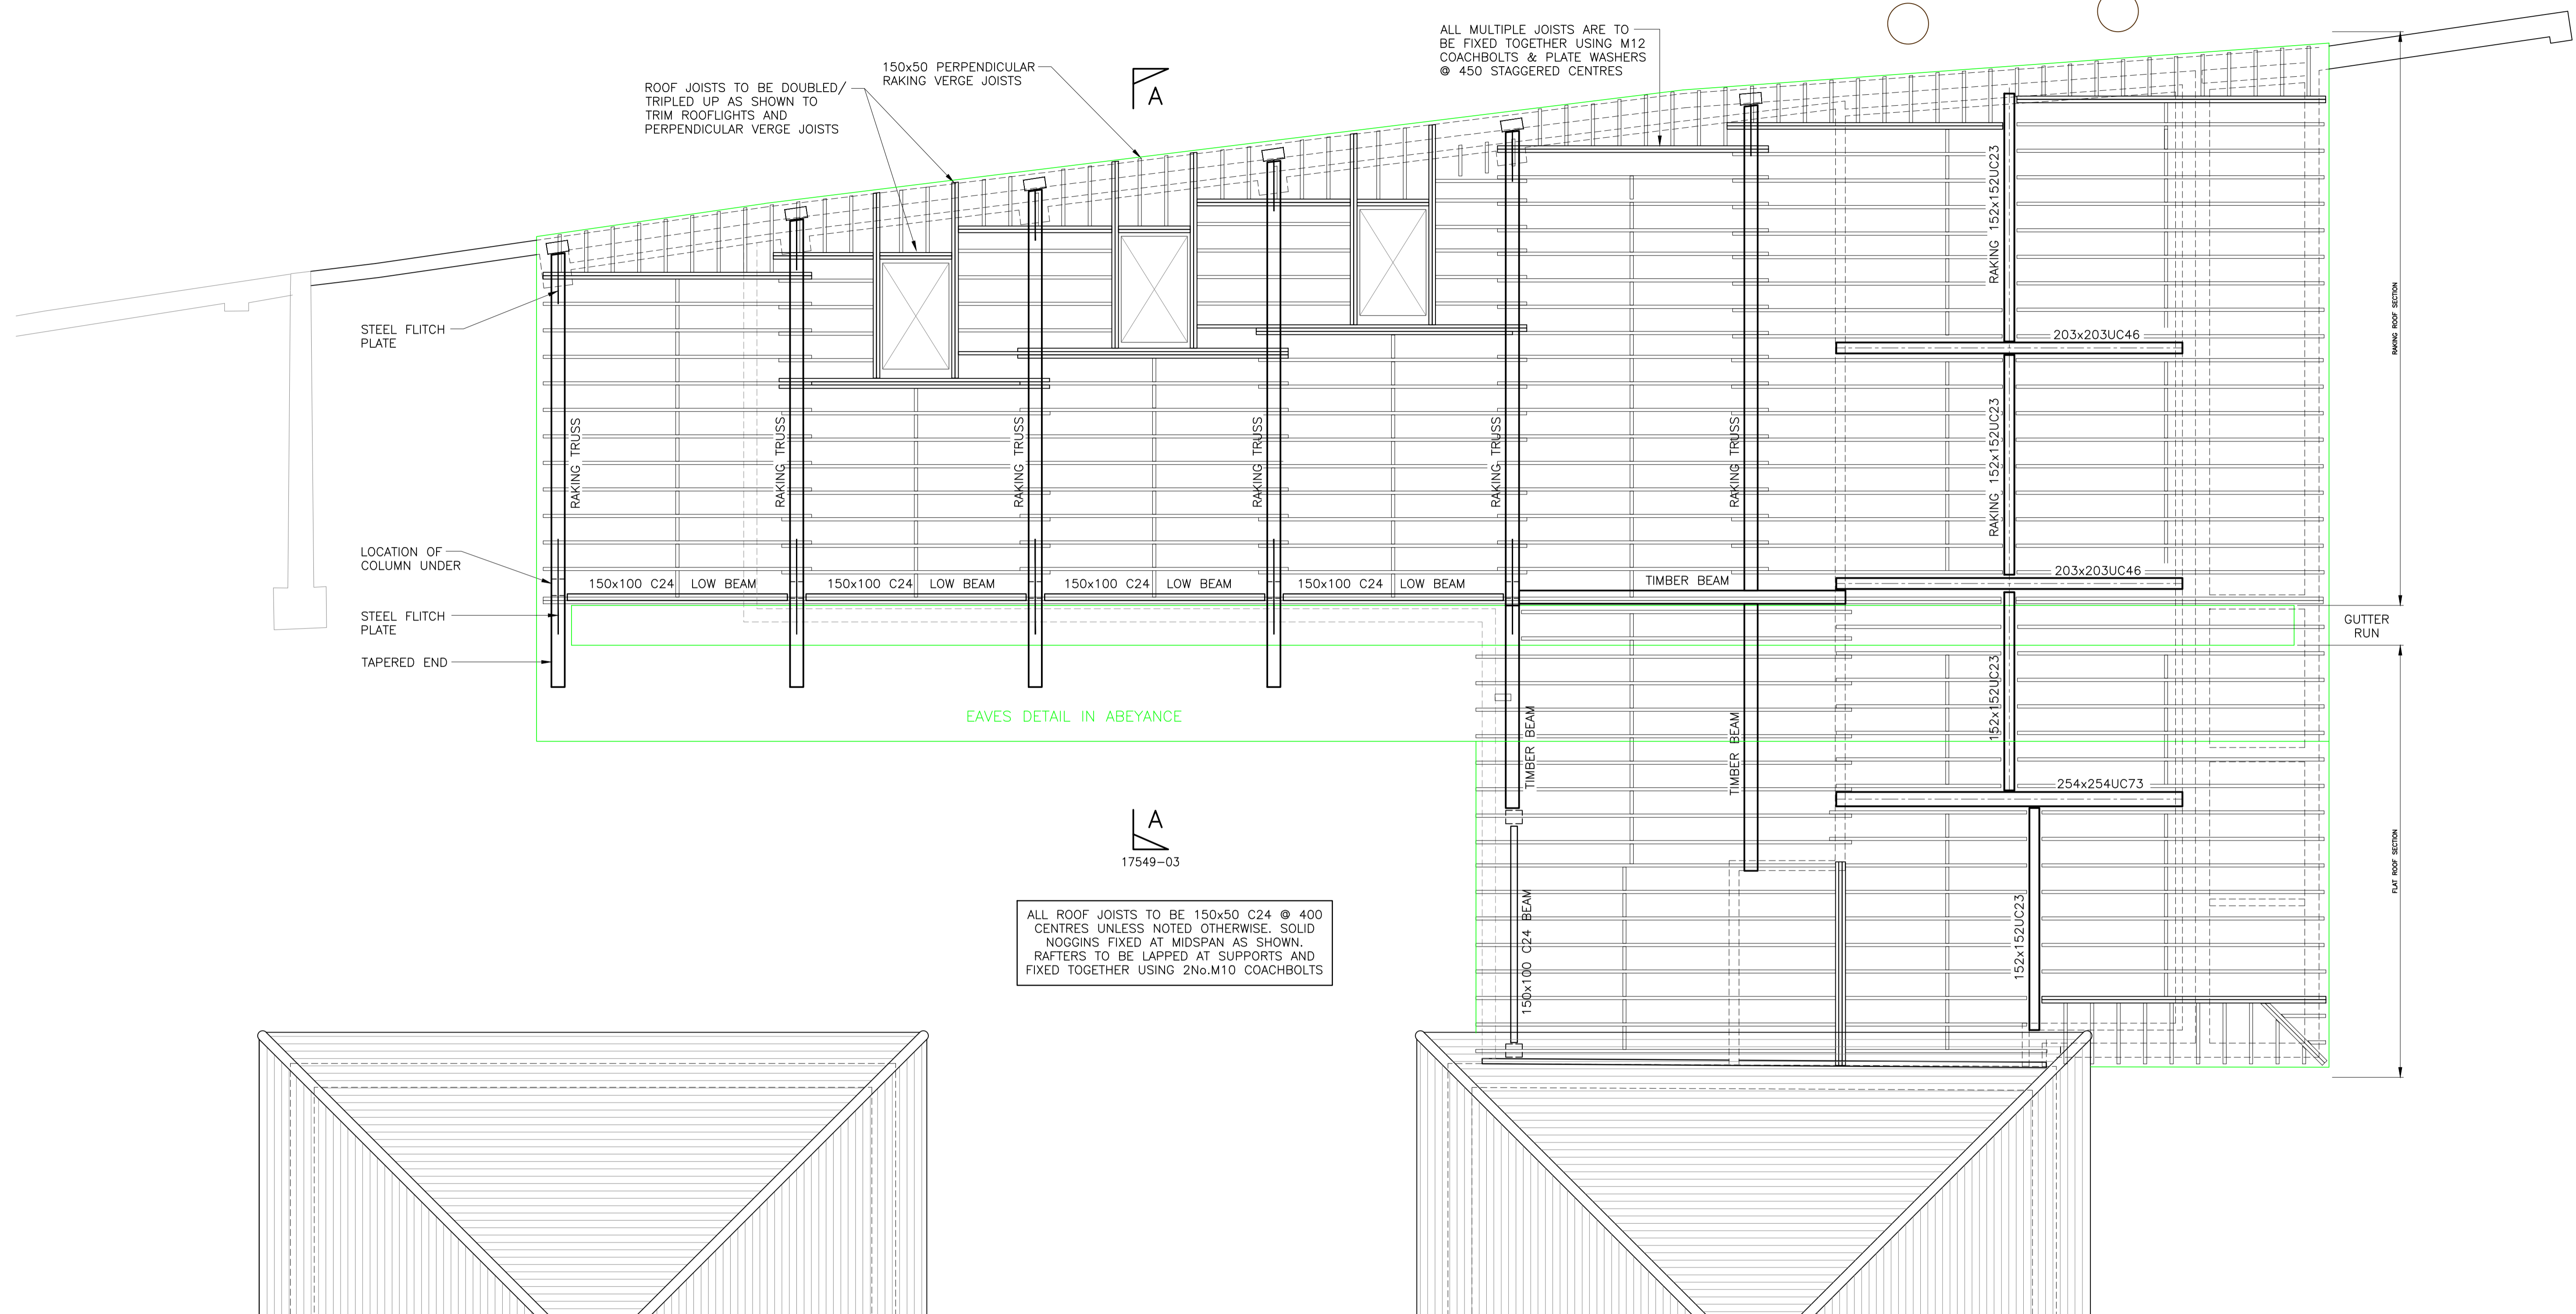
17549-02 A

ALL ROOF JOISTS TO BE 150x50 C24 @ 400 CENTRES UNLESS NOTED OTHERWISE. SOLID NOGGINS FIXED AT MIDSPAN AS SHOWN. RAFTERS TO BE LAPPED AT SUPPORTS AND FIXED TOGETHER USING 2No.M10 COACHBOLTS

- 2.2 The top chord of the truss will extend past the post support and form a canopy over the external eating area. A surface applied preservative is suggested for the timber as it will be exposed externally. The softwood must be kiln dried to a moisture content of 12-16%.
