# PRELIMINARY RISK ASSESSMENT

**PA Housing Limited**

The Strathmore Centre, Strathmore Road, Teddington, TW11 8UH

K360.1~11~001

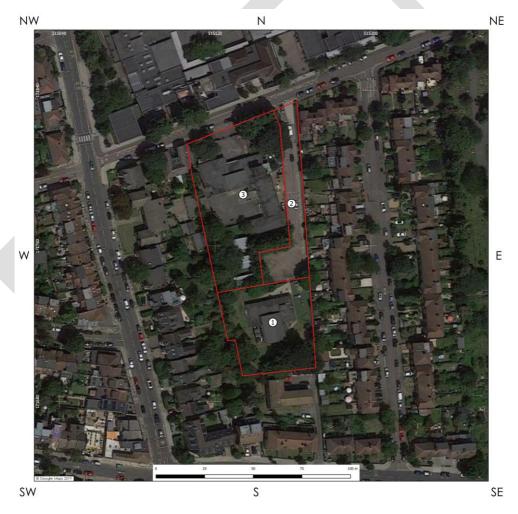
Specifically, the site is centred on Ordnance Survey National Grid Reference 515130,171783 (TQ 15130 71783). An aerial view of the 0.65 ha site is provided in Figure 1 below.

FIGURE 1 Aerial View of Site (boundary shown in red)
