- 1.1 Sheengate is a detached Arts & Crafts Grade II-listed house built c.1925 to designs by Sydney Ernest Castle for H.S. Pyne. The house sits in a generous garden within the Christchurch Road Conservation Area at the Sheen Gate entrance to Richmond Park.

- 1.3 This report is to accompany a Householder Planning and Listed Building Consent application for revisions to the consented scheme for the house.
- 1.4 A Pre-Planning Application for these revisions was submitted on 20 January 2021 (20/P0377/PREAPP), and following positive discussion and feedback in virtual meetings with the Planner and Conservation Officer, written comments were received on 19 March 2021. The response called for further investigative works, which have now been undertaken and concluded.

ı. Summary

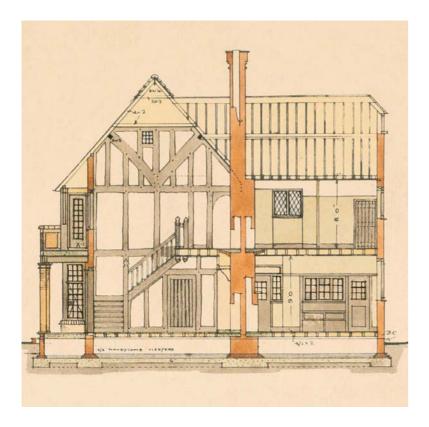
4. 1924 drawing of Sheengate showing suspended timber floor RIBA Collections

- The ground floor has a suspended timber floor structure, and the upper floors sufficient depth between floor joists to allow for installation of plates and insulation between joists.

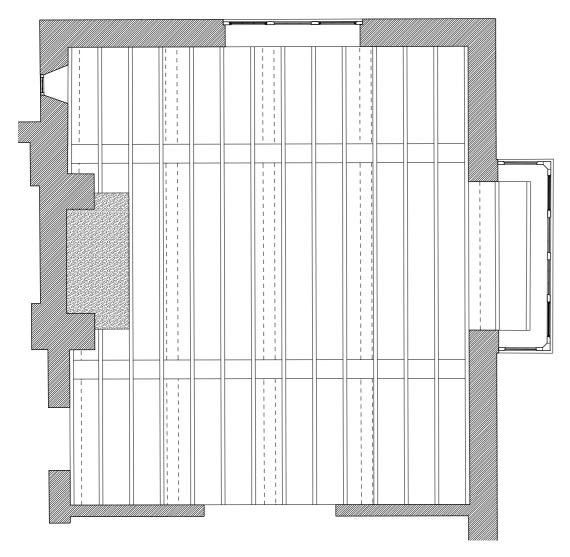
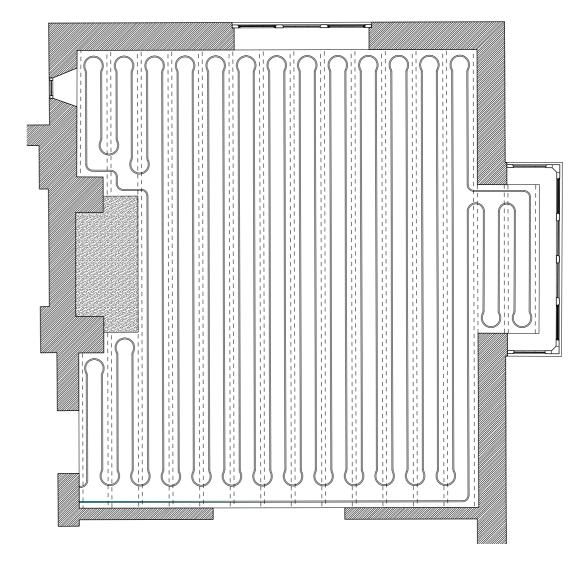
PROPOSED SETTING OUT OF UNDERFLOOR HEATING

SECTIONAL DETAIL OF BETWEEN JOIST UNDERFLOOR HEATING

5. Proposed between joist underfloor heating in the Study

- 3.1 Sustainable heating sources work best at the lower temperatures on underfloor heating, and the previous consent established the principle of underfloor heating installation, allowing the removal of radiators.

- The Donald Insall Associates report provides a method statement for the numbering, temporary removal of floorboards, installation of heating between joists and reinstatement of the boards. They note "The proposed underfloor heating would be installed sensitively, located in a deep void beneath the original floorboards. It is the intention that the boards would be lifted, pipes, insulation and other necessary elements installed primarily between floor joists, and in such a way that the existing floor level would be retained, and visible manifestations of the underfloor heating avoided. As such, there would be no harm to the special interest of the listed building".

A typical detail has been prepared.

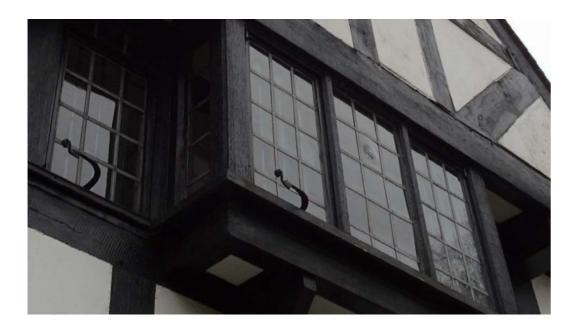
6. Original metal casement timber-framed leaded lights

- 3.4 The intention is to improve the thermal performance of the building with minimal harm to the heritage asset.
- 3.5 The existing windows throughout the house, except for a few modern replacements, are the original single glazed leaded light windows, the opening casements in metal within timber frames. The lead between the thin glazing makes the windows some of the lowest thermally performant windows, and the experience of the house is cold throughout the year.

- 3.6 To address the poor thermal performance, it is proposed to install discreet bronze-framed secondary glazing internally to all windows.
 The proposed metal windows have a frame which is slimmer than the existing timber window frames, maintaining existing sight lines.
 A typical detail has been prepared.

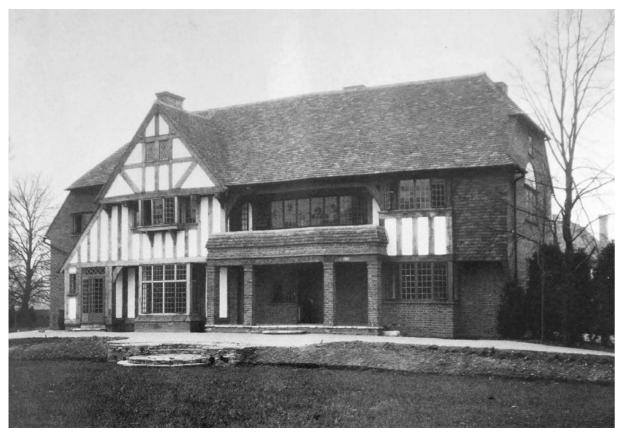
Original photograph of Sheengate c.1925 showing natural finish to all external timber

- 3.12 The only extant early photo of the original house dates from its completion (the house is complete, with the scaffolding struck, with just the garden landscaping remaining to finish) and shows unfinished timbers without stain or paint to the external timber-framing and window frames, with the timber already ageing naturally. Internally, the timber framing is left exposed and unpainted.
- 3.13 It is proposed to strip the external timber framing and window frames back to the original oak.
- At the request of the Conservation Officer in the Pre-Application written response, paint analysis has been undertaken by historic paint specialist Patrick Baty, which indicates that the timbers were not originally stained and that the black paint on the timbers dates from the 1960s. The removal of the paint from the timbers will allow the unfinished timbers to age over time.

Patrick Baty concludes "On balance, I would say that it was originally untreated. What is clear, however, is that it was first painted (black) much later possibly after ca.1960."

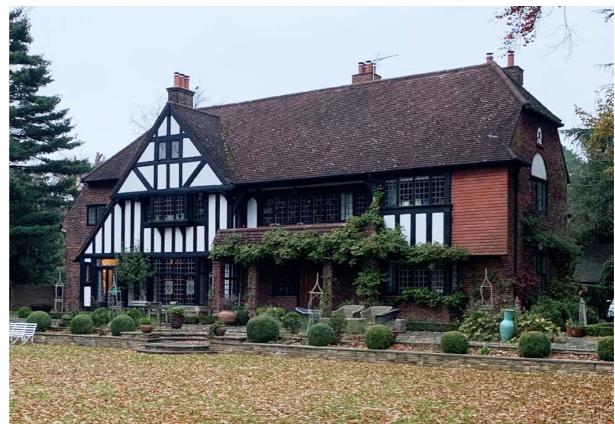
Photograph of Sheengate in 2021 showing black stained timber frame and windows

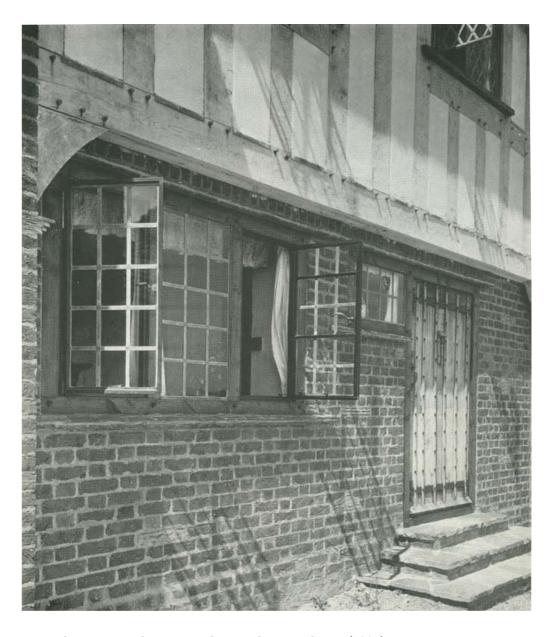
9. Sydney Ernest Castle's Vine Cottage Coulsdon, Surrey (1924)

3.15 Vine Cottage is typical of Castle's work of the 1920s, and features unfinished external timber framing. It was completed six months before Sheengate in September 1924.

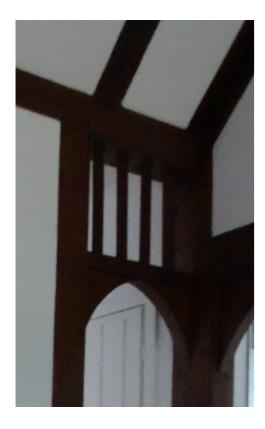
10. Internal window over arched original opening

- 3.23 An internal window, modelled on the panel over the doorway between the main and secondary landings on the first floor is proposed between the new attic stair and shower room, borrowing light from the proposed rooflight to provide daylight to the proposed attic shower room.

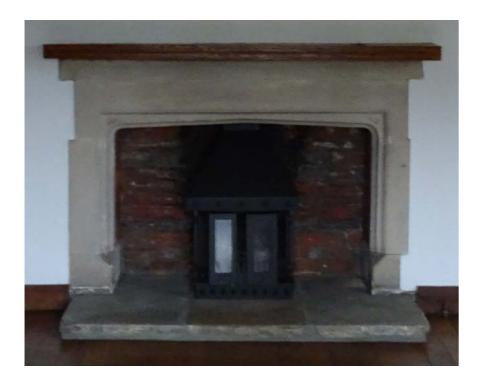
11. Existing fireplace in the Study, showing modern raised concrete hearth

- Fireplaces in the Garden Hall, Study, Book Room, Music Room, first floor Gallery, Bedroom 2 and Master Bedroom all have modern hearths, tiled or stone, and it is proposed to replace them with lower York stone hearths (consent exists under application 18/3099/LBC to replace the fire surround and mantlepiece to the Master Bedroom).
 - Donald Insall Associates note "historically the hearths would most likely have been flush with the floor, and there is clear evidence of this to the Study hearth, which sits on a layer of modern concrete".

- 3.25 It is proposed to install new solid fuel burning stoves to the fireplaces in the Study, Garden Hall and Map Room.
- 3.26 The exposed brick fireplaces in the Garden Hall, Music Room and first floor Gallery have hard cement pointing, and it is proposed to carefully rake this out and repoint with lime mortar.

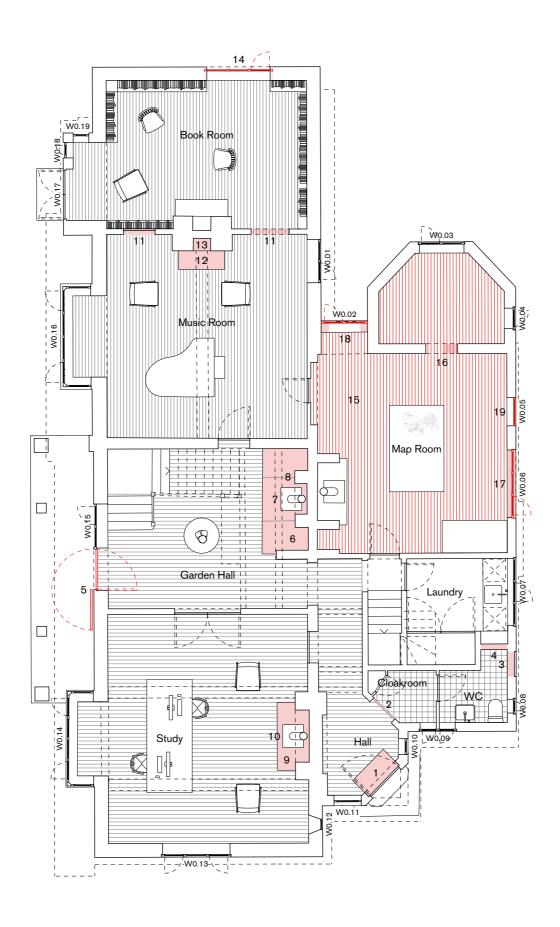
ground floor

- 1 Flush matwell
- 2 Remove and retain Cloakroom door
- 3 Infill behind door internally
- 4 Move wall between WC and Laundry
- 5 Glazed shutter
- 6 Remove hearth, replace with large stone slabs

- 7 Install solid fuel stove to existing fireplace
- Repoint fireplace brickwork in lime mortar
- 9 Remove tiled hearth, replace with large stone slabs
- 10 Install solid fuel stove to fireplace

- 11 Use retained panelling to conceal door and match surrounding panelling
- 12 Remove tiled hearth, replace with large stone slabs
- 13 Repoint fireplace brickwork in lime mortar

- 14 Remove and retain window for reuse
- 15 Floorboards to match original
- 16 Move structural opening to align with window
- 17 Replace modern doors with existing west Book Room window, infill above and below

- 18 Reinstate window as per original drawings, infill above and below
- 19 Replacement glazing for applied leaded light

3.27 [1] It is proposed to remove a section of floorboards immediately inside the front door to install a flush matwell within a brass edge.

- 3.28 [2] Remove and retain door to Cloakroom from Hall.
- 3.29 [3] It is proposed to block up the redundant external door from the inside, retaining it externally unchanged.
- 3.30 [4] Move wall between WC and Laundry.

- 3.31 [5] It is proposed to convert the existing solid timber garden door to open outwards, and to install an inner metal-framed glazed door to allow a clear view into the garden, while retaining the original fabric.
- 3.32 [6] Remove hearth, replace with large stone slabs.
- 3.33 [7] Install solid fuel stove to existing fireplace.
- 3.34 [8] Repoint fireplace brickwork in lime mortar.

- 3.35 [9] Remove tiled hearth, replace with large stone slabs.
- 3.36 [10] Install solid fuel stove to fireplace.

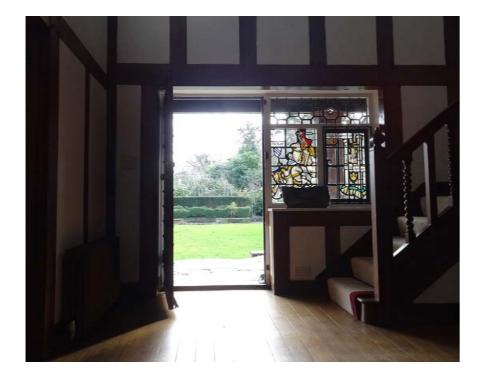
13. Existing door, open to show view to garden

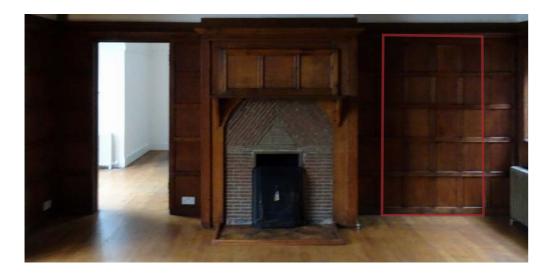
14. Existing panelling to Music Room (rectangle indicates new opening)

3.37 [11] As discussed in the Pre-Application submission, to improve the flow through the house to the new extension, it is proposed to form a new opening between the Music Room and Book Room to the north of the central fireplace. This wall is panelled to the Music Room side, and it is proposed to carefully remove the panelling and use it to infill the existing door. The doorway behind would remain extant so that this is a reversible change. To the Book Room, the current doorway will be concealed by bookcases. An elevation drawing has been prepared.

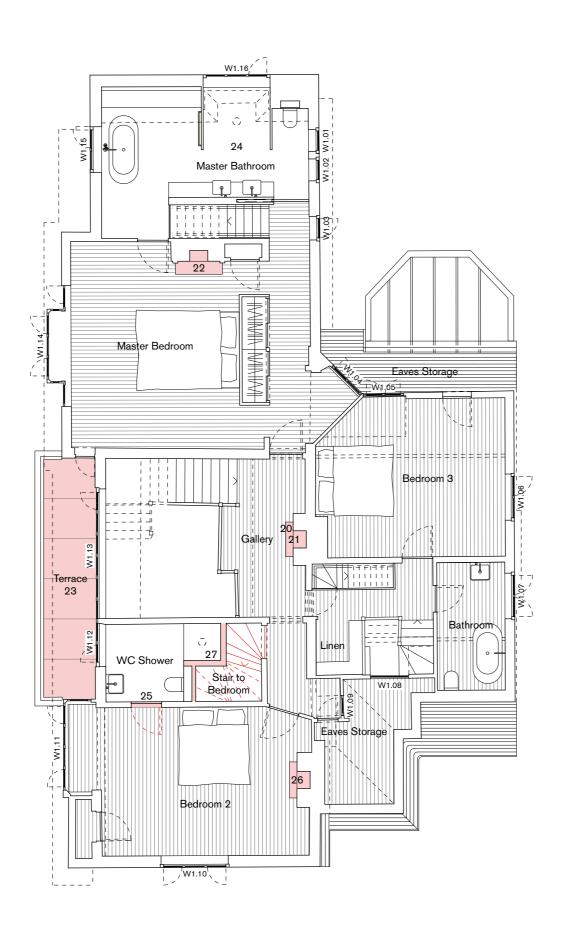
- 20 Repoint fireplace brickwork with lime mortar
- 21 Remove tiled hearth, replace with large stone slabs
- 22 Remove tiled hearth, replace with large stone slabs
- 23 York stone pavers to Terrace
- 24 Revised Master Bathroom layout
- 25 New door
- 26 Remove tiled hearth, replace with large stone slabs
- 27 Revised staircase

- 3.46 [20] Repoint fireplace brickwork with lime mortar.
- 3.47 [21] Remove tiled hearth, replace with large stone slabs.

3.48 [22] Remove tiled hearth, replace with large stone slabs.

3.49 [23] The first floor terrace leading off the Master Bedroom is currently floored with a bitumen roof covering, susceptible to damage in use. It is proposed to install York stone pavers over.

3.53 [27] Proposed remodelling of modern staircase from first to second floor and form Shower Room in exisiting stair void to serve Bedroom 2.

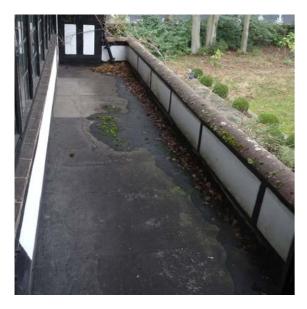
20. Existing first floor terrace

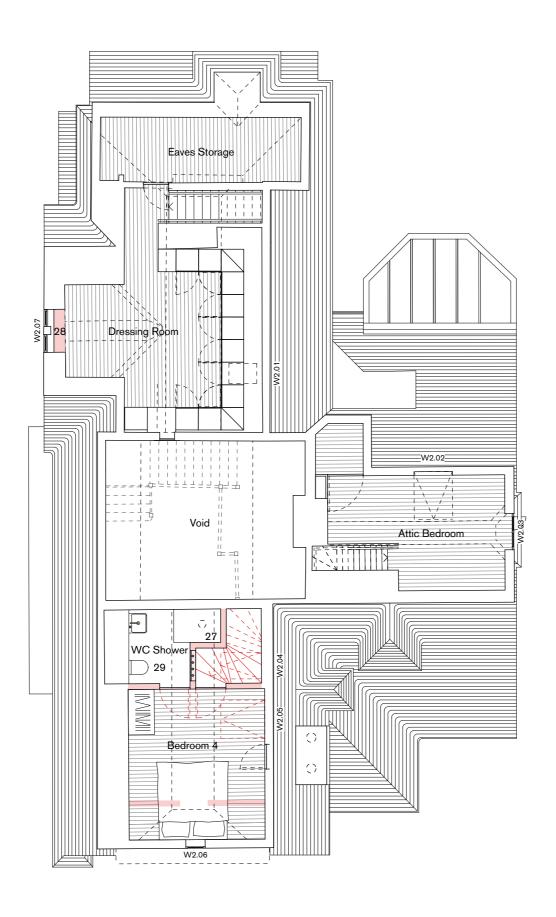
second floor

- 27 Revised staircase
- 28 Remove modern timber window surround
- 29 Shower Room to existing stair void

3.55 [29] As noted under STAIR above, it is proposed to remove the modern shower room and form a new shower room over the existing stair void.

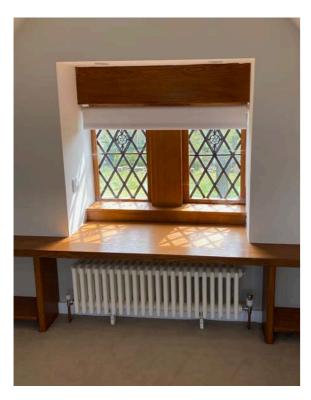
22. Modern timber lining to be removed

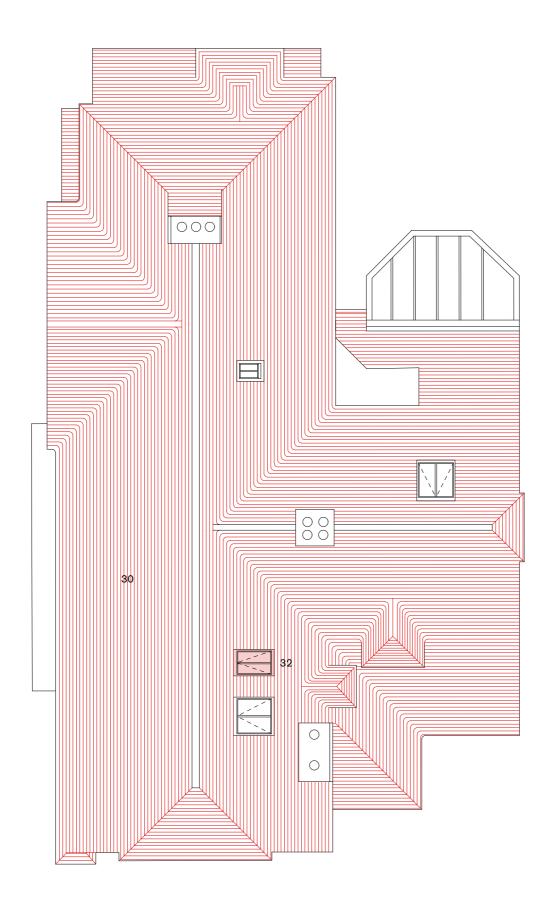
roof / exterior

- 30 Reinstatement of original roof
- 32 Proposed additional conservation rooflight

- 3.58 [31] It is proposed to remove and replace all chimney pots with concealed pots as the original intent.
- 3.59 [32] 1 No. conservation rooflight is proposed in addition to the current consent.

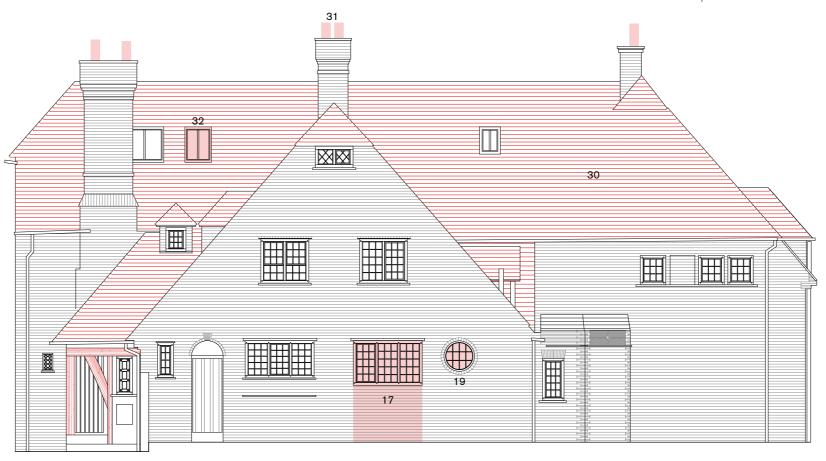
- 30 Reinstatement of original roof
- 31 Remove and replace all chimney pots with concealed pots as the original intent
- 34 Strip the white paint to to reveal the original buff coloured render

- 3.60 The existing rainwater goods are UPVC and are proposed to be replaced in cast iron with half-round gutters on traditional rise and fall brackets.
- 3.61 [33] It is proposed to remove the black paint finish to all external timbers and window frames, to reinstate the natural timber finish.
- 3.62 [34] It is proposed to strip the white paint to rendered panels to reveal the original buff coloured render.

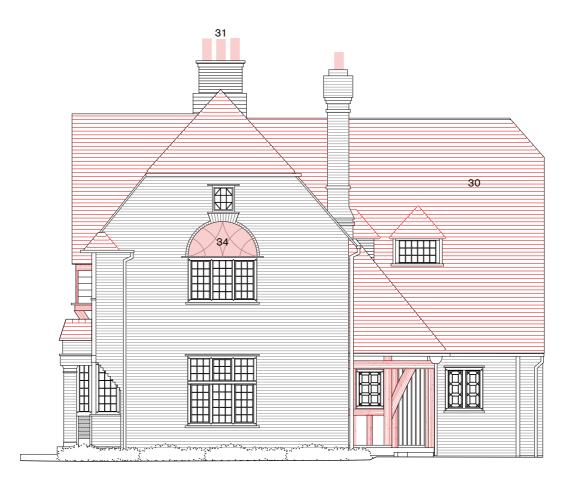
- 5 Glazed shutter to Garden Hall
- 30 Reinstatement of original roof
- 31 Remove and replace all chimney pots with concealed pots as the original intent
- 33 Remove the black paint finish to all external timbers and window frames

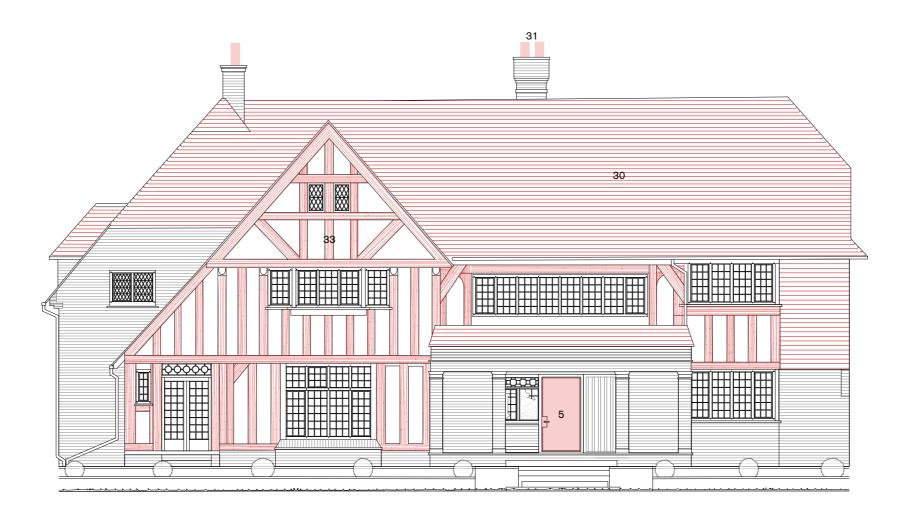
- 14 Remove and retain Book Room window (removal already consented)
- 18 Reinstate window as per original drawings, infill above and below
- 30 Reinstatement of original roof
- 31 Remove and replace all chimney pots with concealed pots as the original intent

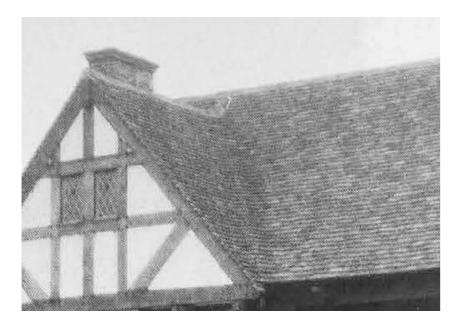
28. Original swept verge and ridge tiles of the roof

Donald Insall Associates note "When comparing the appearance of the existing elevations to the historic 1930s photograph, it is evident that building's elevation and roofscape have undergone alterations... The loss of the variation in colour of the roof tiles suggests that all the roof tiles were replaced at the same time as these alterations, likely in the mid-late 20th century. The proposals seek to reinstate the original appearance of the elevations and the roofscape; the proposed natural clay replacement tiles to both the south elevation and the roof, would reinstate a natural variation in tone as per the historic finish".
