Arboricultural Method Statement

Site: The Rose Of York, Richmond, TW10 6UY

Client: Cunnane Town Planning

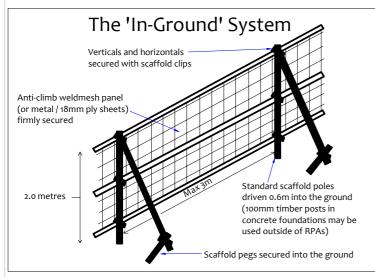
The In-Ground System

Vertical scaffold poles are driven into the ground, onto which are affixed horizontal scaffold poles and diagonal bracing struts. Weldmesh panels (or similar – e.g. Heras type fencing panels, or 18mm+plywood boards) are secured to this scaffold framework using sturdy clips e.g. standard scaffold clips. The system is illustrated in the diagram to the right and is based on BS 5837 guidelines.

This system may be installed where indicated by a solid purple line on the Tree Protection Plan. It should be robust enough to withstand occasional knocks by plant machinery and, once installed, shall remain in place throughout the entire construction phase.

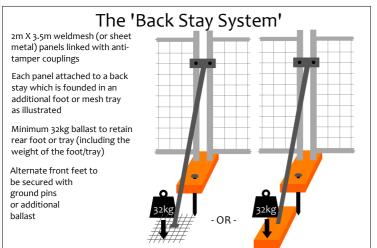
The Back-Stay System

Within this system, weldmesh fencing panels (minimum height 2m) are affixed into rubber or concrete feet and clipped together with anti-tamper couplers. Two couplers should be used, spaced at least 1m apart. Alternate panels should be attached to a diagonal back stay connected to an additional foot or baseplate secured with ground pins or additional ballast. Where ground pins are not used, the total weight of the foot/plate plus ballast should total not less than 32kg.

Where it is not possible to install diagonal struts (such as very close to a hedge) then the front feet shall be secured using ground pins or ballast.

This system may be installed where indicated by a solid or dashed purple line on the Tree Protection Plan. It is more practical over existing hard surfaces or where the fencing needs to be moved to enable permitted activities within a Restricted Activity Zone. This system should be able to withstand occasional knocks by machinery and should not be relocated except with the consent of the site manager and the approval of the local authority.
