## Richmond Hill Campus

Stage 3 Report for LBC Submission

Project no. 1399

Document no. 1399-INT-ZZ-ZZ-RP-S-0003

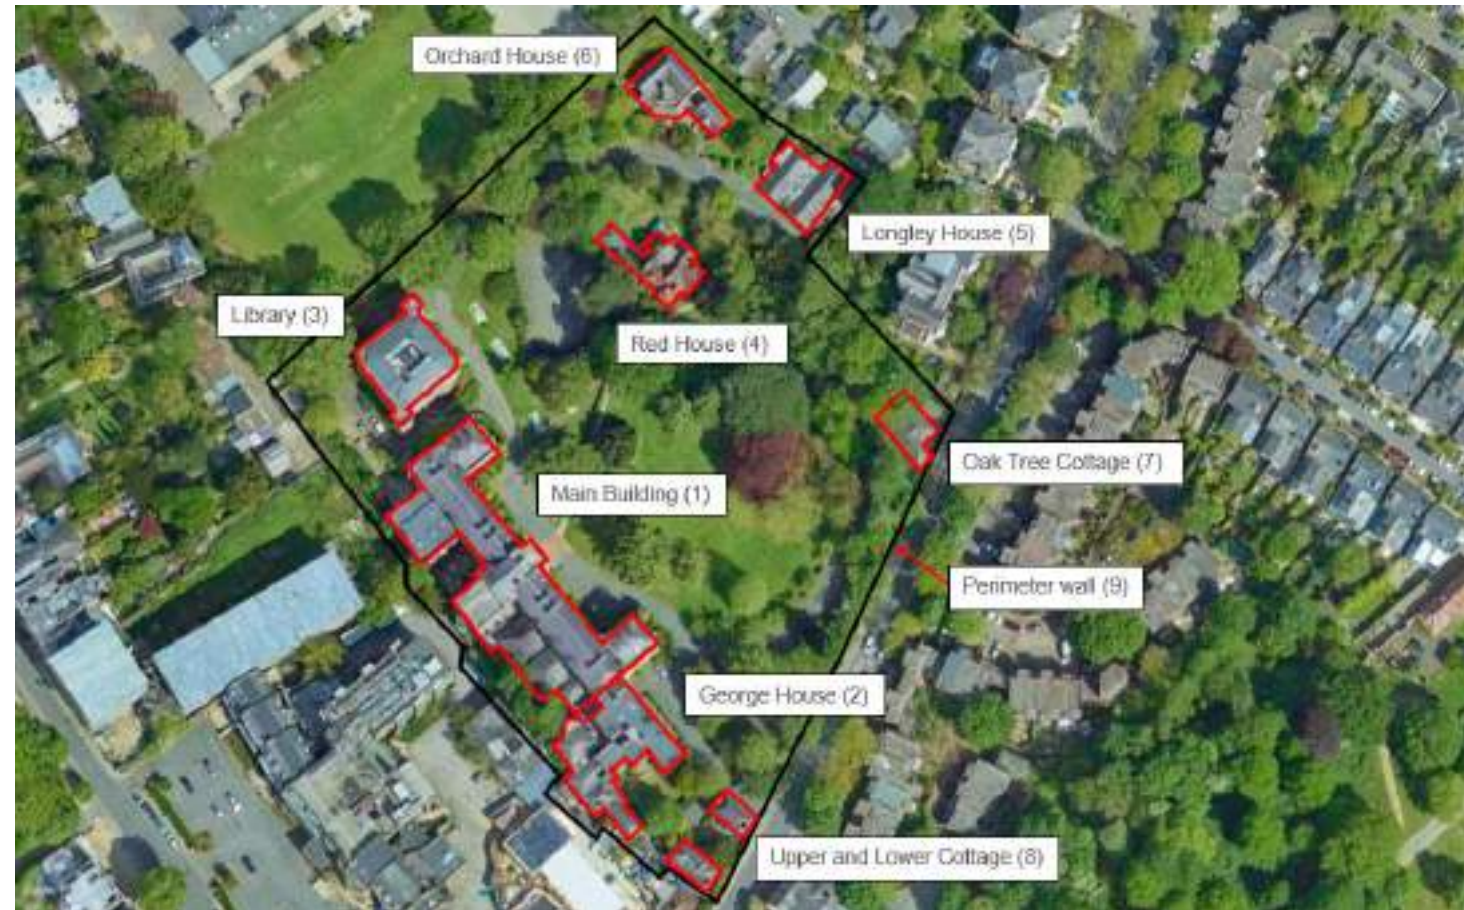
Site overview of existing buildings

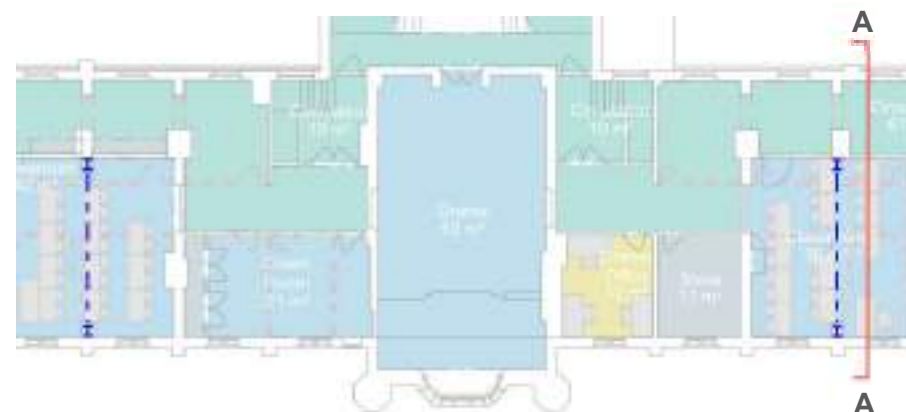
Extract from SK73 showing locations of proposed steel frames at 2<sup>nd</sup> floor

Where the wall needs to be completely removed as it interferes with a classroom space, the wall will be replaced with a full moment frame at second floor level. The design criteria and necessary considerations for moment frame are similar to those discussed in section 10.2.1 regarding the steel frames proposed in the wings of the Main Building.

The bottom beam of the moment frame is to sit within the depth of the existing second floor structure, while the top beam will sit below the existing third floor structure. The size and span direction of the existing timber joists at these levels are to be confirmed but they are anticipated to span perpendicular to the proposed steel frame. The existing timber joists are to be reinstated following the installation of the steel frame.

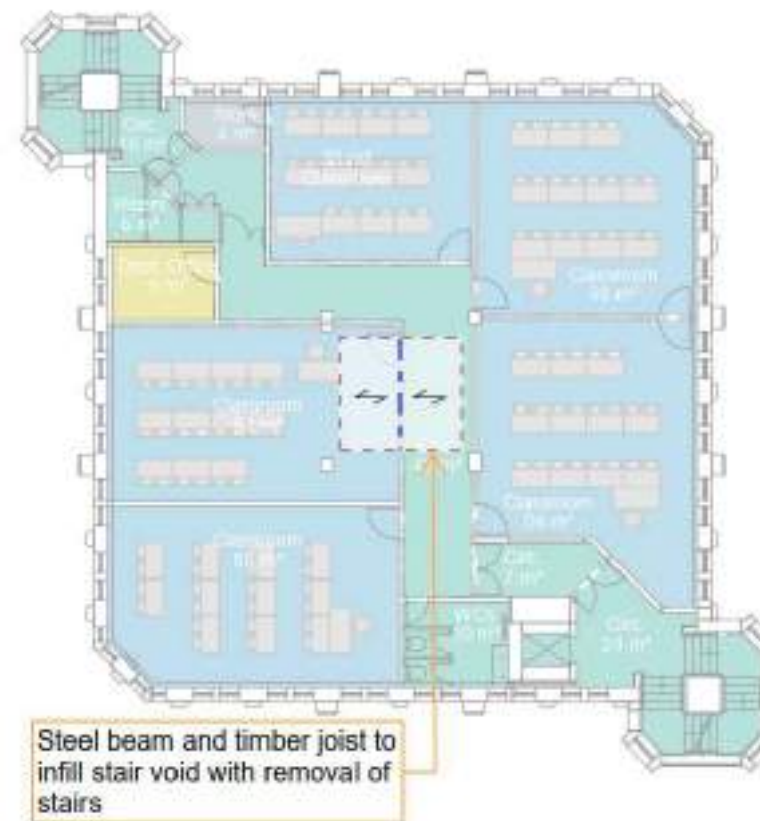
Extract from SK75 showing stair infill structure in Library building

The removal of the central staircore from ground to second floor will require infill structure. At first floor a steel beam is proposed to divide the void span in two as well as being positioned below the new partition line. Timber joists will be used to infill the void.
