Basement Screening Assessment

Job number: JH1751

Project: 73 Castelnau - Pool House

BASEMENT SCREENING ASSESSMENT - NEW POOL HOUSE AT 73 CASTELNAU SW13 9RT

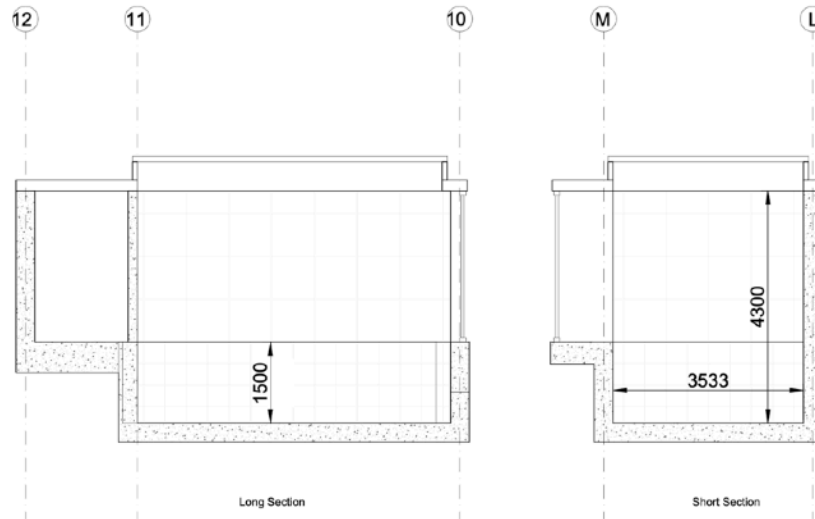
Proposed short (left) and long (right) sections of pool house. Source: Locksley Architects

In addition to the proposed works to the main house, a new-build pool house is to be constructed in the back garden of the existing detached property. The pool itself is 1.5m deep, requiring approximately 2.0m excavation below ground level. The pool house is 8.0 x 4.6m on plan and 3.0m in height.

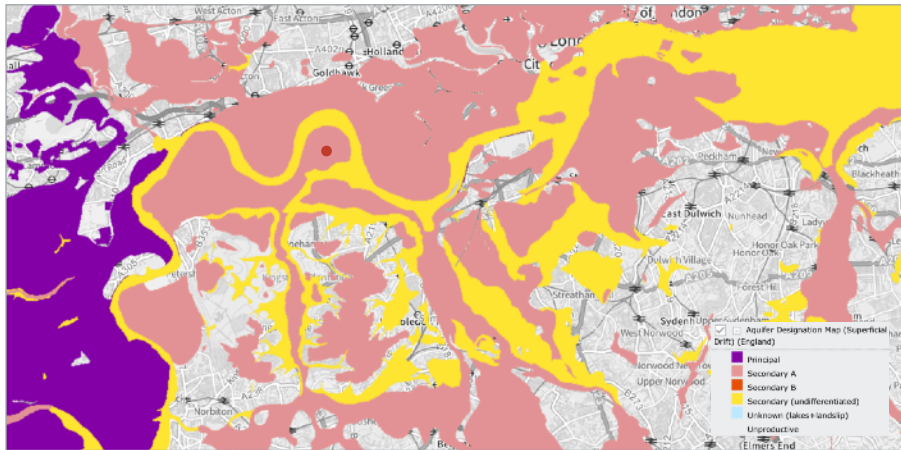
Aquifer Designation Map (Superficial) within the area of 73 Castelnau. Source: DEFRA

Yes. Maps from the Department for Environment Food and Rural Affairs (DEFRA) revealed that the site was underlain by a Secondary A aquifer comprising the superficial Kempton Park Gravel stratum and an unproductive stratum comprising of the London Clay bedrock. Secondary A aquifers are made up of

permeable layers capable of holding small-scale water supplies. Meanwhile, unproductive aquifers are characterised by low-permeability rock strata that contribute negligibly to water supply.

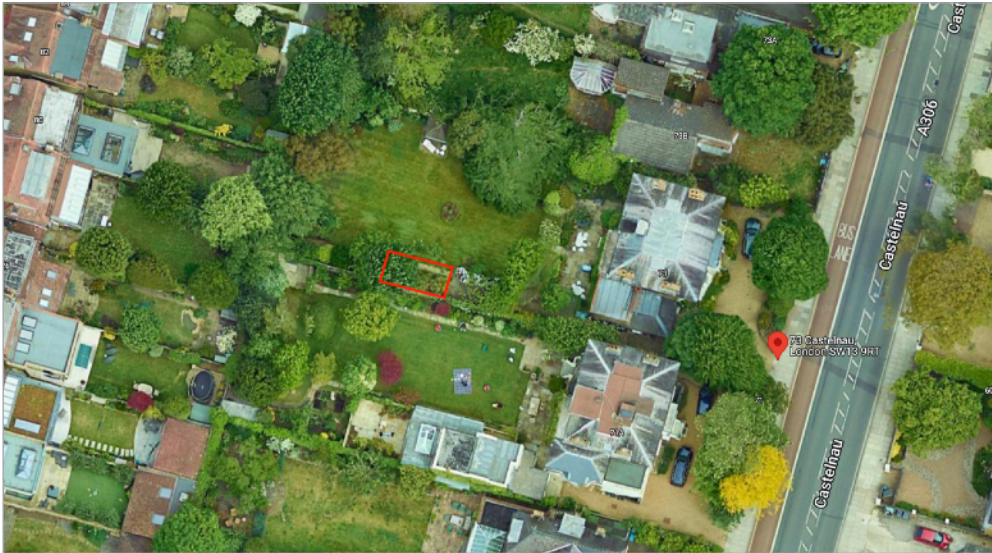
Aerial view of the site showing the approximate location of the proposed pool house. Source: Google Maps

Yes, likely. The pool house is positioned in close proximity (approx. 0.5m) to the boundary of the neighbouring property (No. 73B Castelnau). This boundary is likely to be marked by either a wooden fence or a solid masonry wall. The proposed substructure of the pool house is very likely to extend below the footings of the wall. Depending on the wall construction, a party wall agreement and underpinning works may be required.

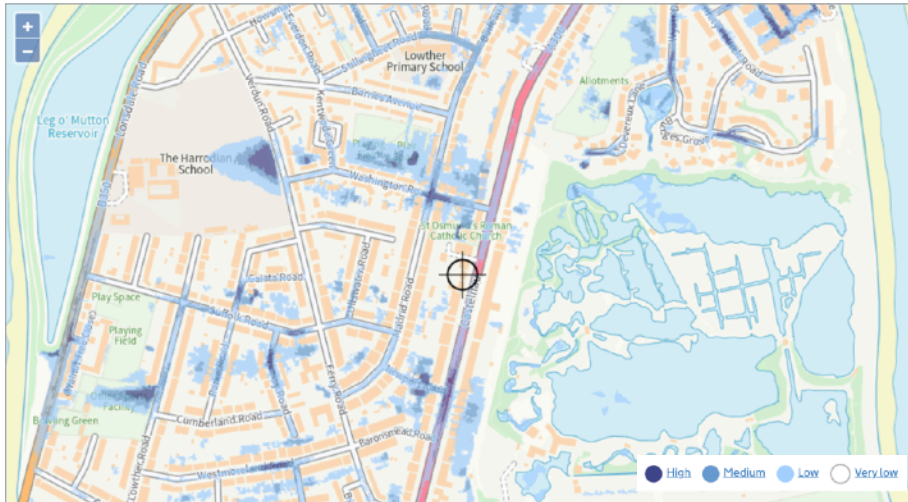
Map showing surface water flooding risk for 73 Castelnau. Source: gov.uk

Not to a significant degree. The flow profile of surface water will be affected by the new presence of the pool house. However, this is only a minimal effect due to the small plan area of the pool house and the fact that the the risk of surface water flooding of the site is very low.
