**LISTED BUILDING APPLICATION**

JOB TITLE:  
**KNELLER HALL**

DRAWING TITLE:  
**EAST ELEVATION PROPOSED EXTERNAL REPAIRS**

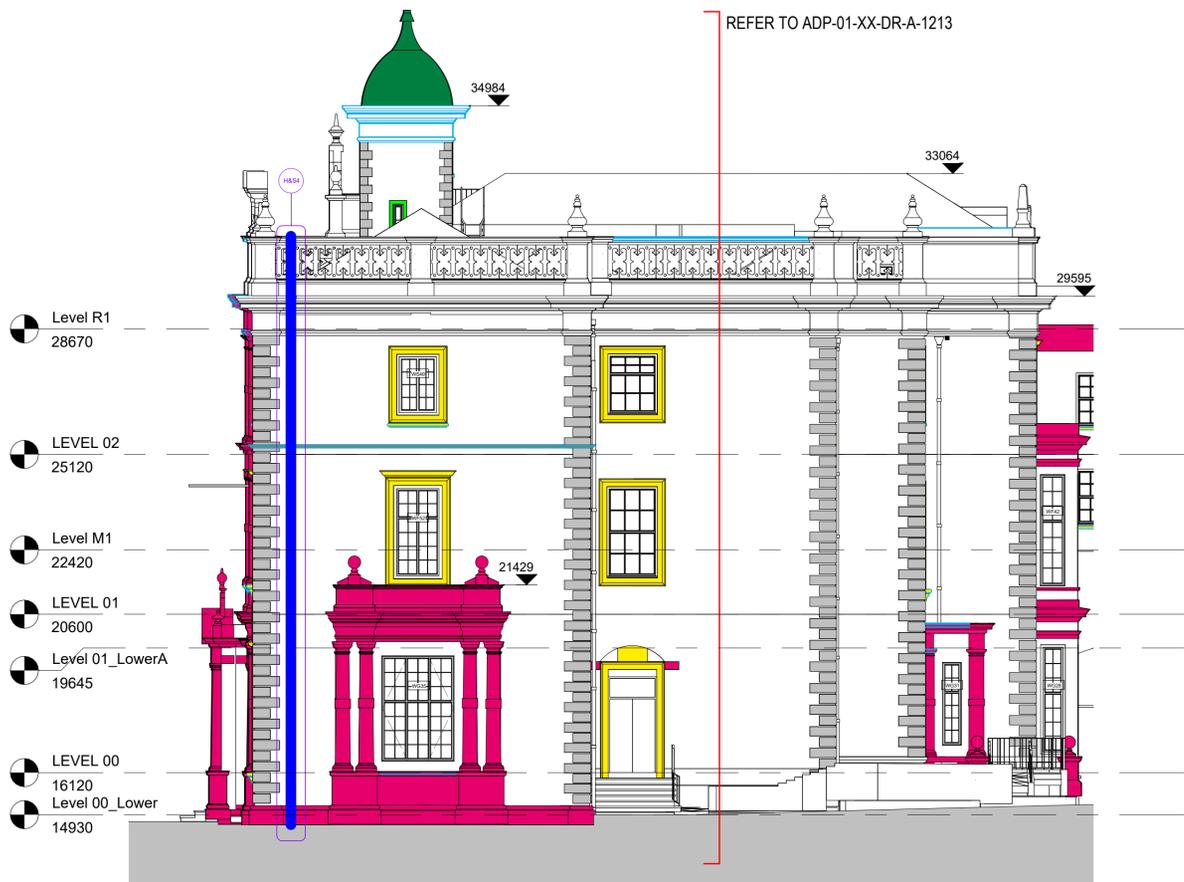
**1 EAST ELEVATION PROPOSED EXTERNAL REPAIRS**  
1 : 100

External Repairs Schedule - East (Application_Rev 01)			
Reference	Purpose	Notes	Decoration
H&S4	Health & safety	Proposed location for lightening protection. Refer to suppliers drawing for further information.

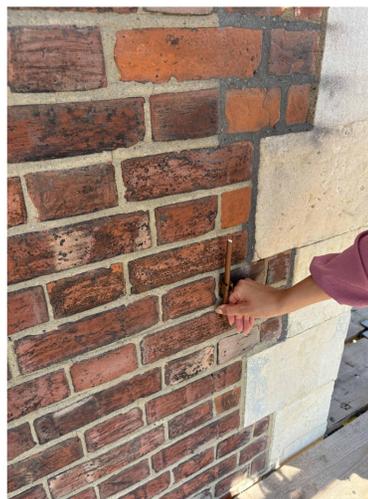
**Image 1**  
Thin copper Lightening Protection tubes dropped down on elevations as per locations on drawing above

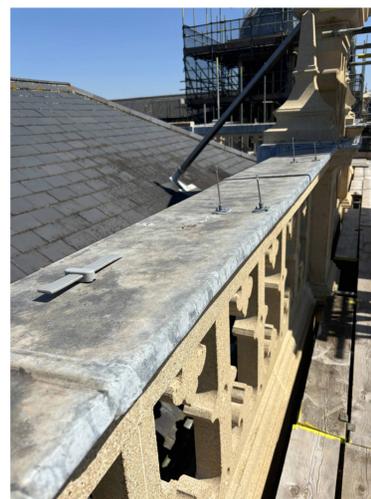
**Image 2**  
Lightening Protection tape at roof level - refer to A-1005 & suppliers drawings for locations
