LISTED BUILDING APPLICATION

JOB TITLE:
KNELLER HALL

DRAWING TITLE:
SOUTH ELEVATION - PROPOSED EXTERNAL REPAIRS

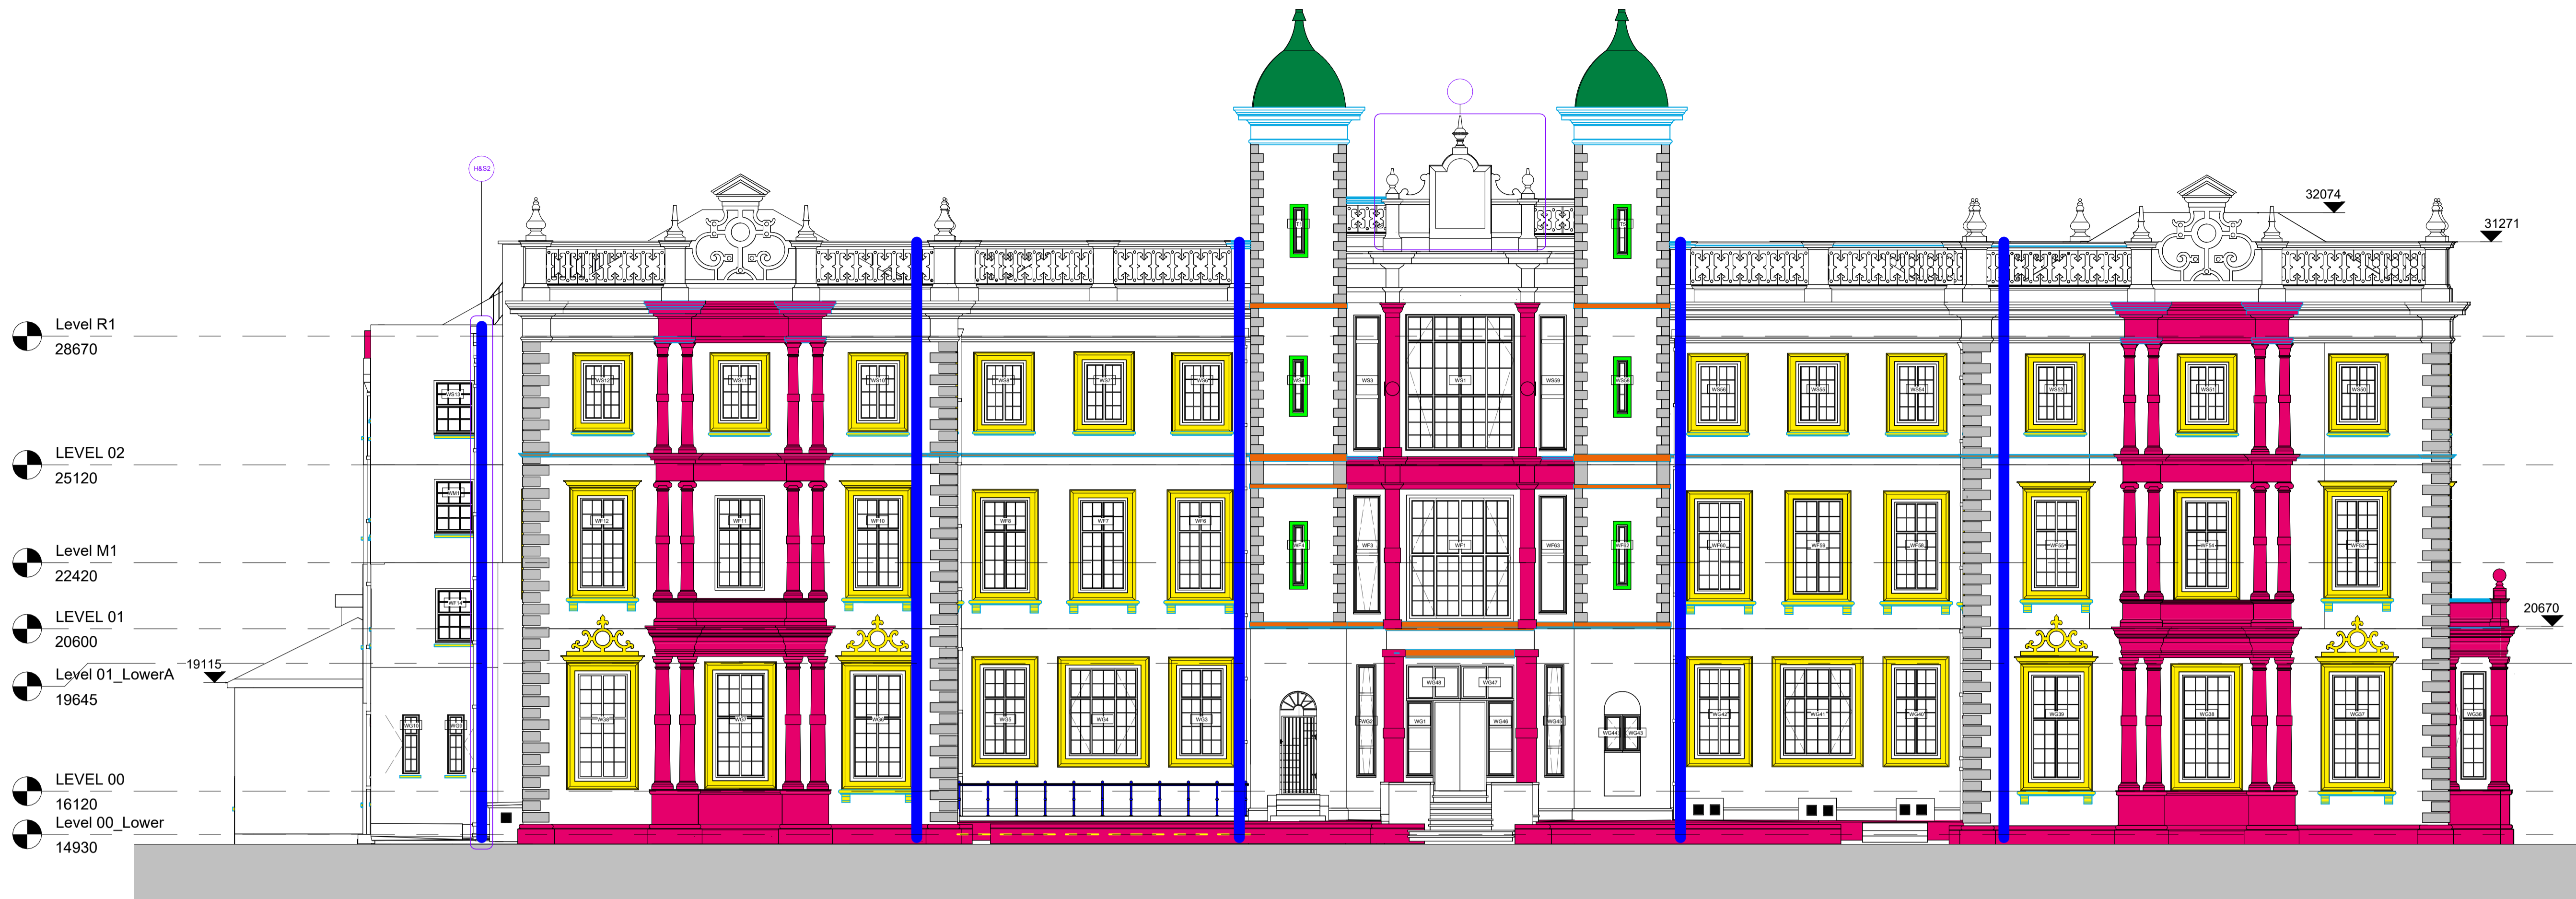
1
1 : 100

**SOUTH ELEVATION - (COLONNADE NOT SHOWN)
PROPOSED EXTERNAL REPAIRS**

FOR THE PURPOSE OF THIS DRAWING THE COLONNADE HAS NOT BEEN SHOWN IN ORDER TO REVEAL THE PROPOSED REPAIRS ON THE GROUND FLOOR OF THE ELEVATIONS
THERE ARE NO EXTENSIONS/DEMOLITION OR ALTERATIONS
PLEASE REFER TO ADP-01-XX-DR-A-1211 FOR REPAIRS TO THE COLONNADE

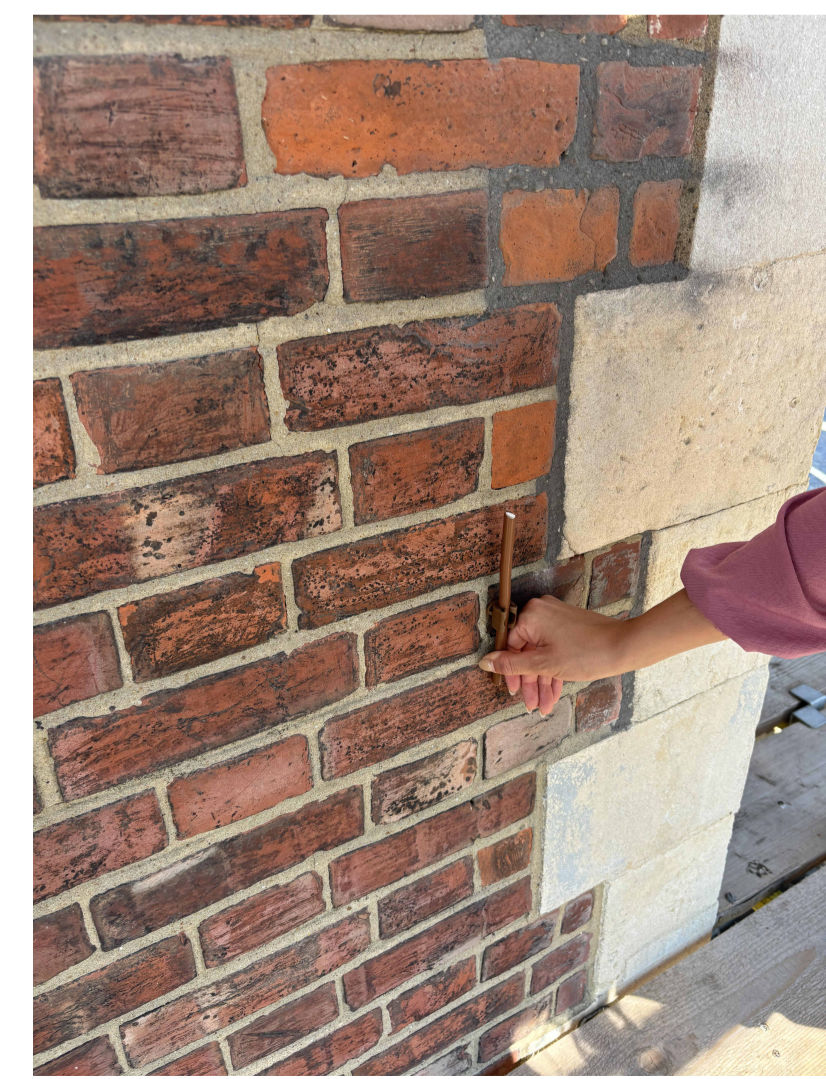
Image 1
Thin copper Lightening Protection tubes dropped down on elevations as per locations on drawing above

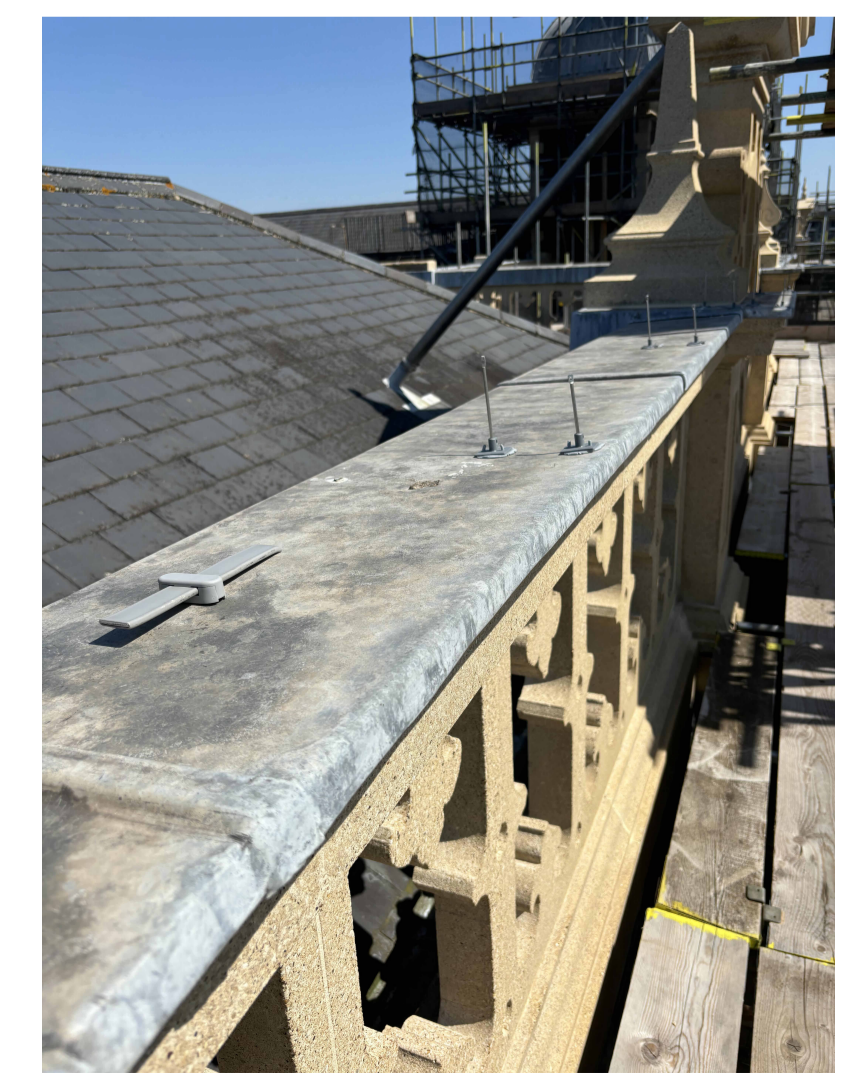
Image 2
Lightening Protection tape at roof level - refer to A-1005 & suppliers drawings for locations
