0360 Hampton Pools
High Street
Hampton
TW12 2ST

**Planning Condition NS09
Arboricultural MS**

NS09 ARBORICULTURAL METHOD STATEMENT & TREE PROTECTION PLAN**Submission in response to
Condition U0120581 Arboricultural Method Statement and
Tree Protection Plan**

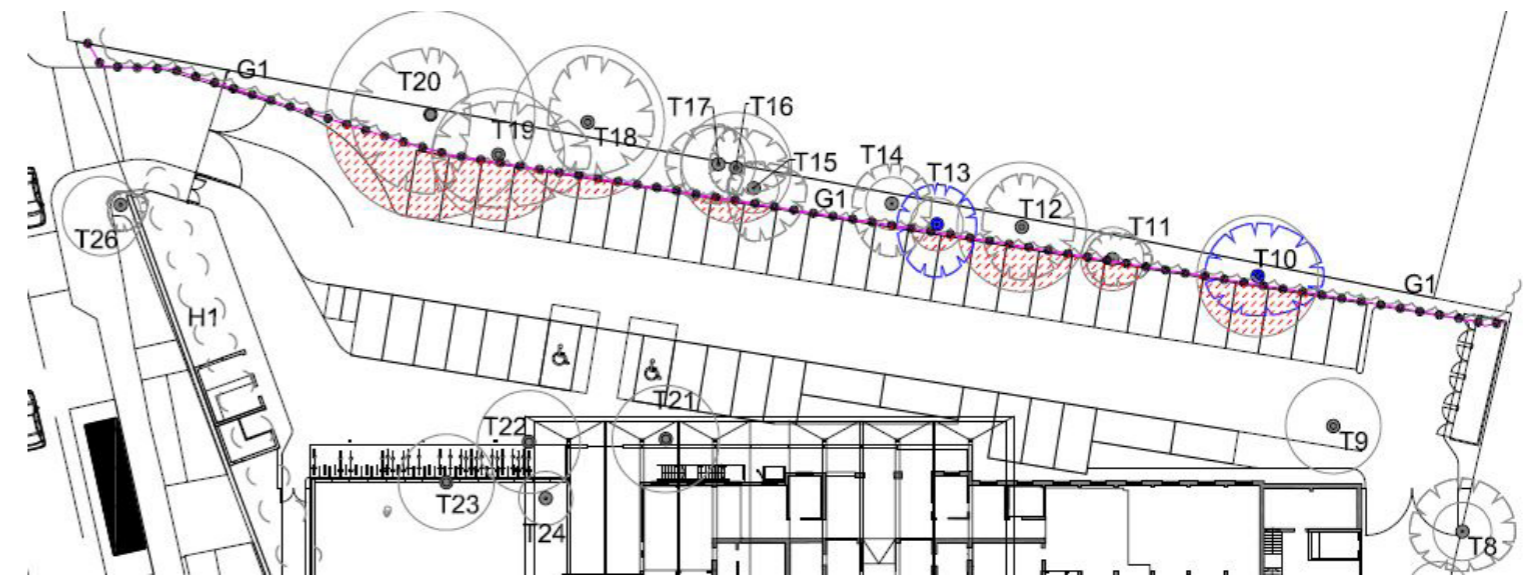
Extract from Tree Protection Plan showing Trees along the car park boundary

- The following trees will be affected by resurfacing the existing car park. Where the resurfacing within the RPA of a retained tree is proposed, the existing sub base is to be retained and reused. The existing wearing course is to be removed in accordance with the methodology described in Section 5.2 below:

Where the existing wearing surface is proposed to be removed from within the RPA of T10, works will be carried out under the supervision of a suitably qualified arboriculturist. The existing wearing course will be broken up using hand operated tools and removed by excavator with a toothless bucket. The excavator will remain on the hard surface at all times and retreat away from the trees as the wearing course is removed. When the area is to be resurfaced, the existing sub-base is to remain in place and be re-used. The new wearing course will be laid immediately after the existing is removed.

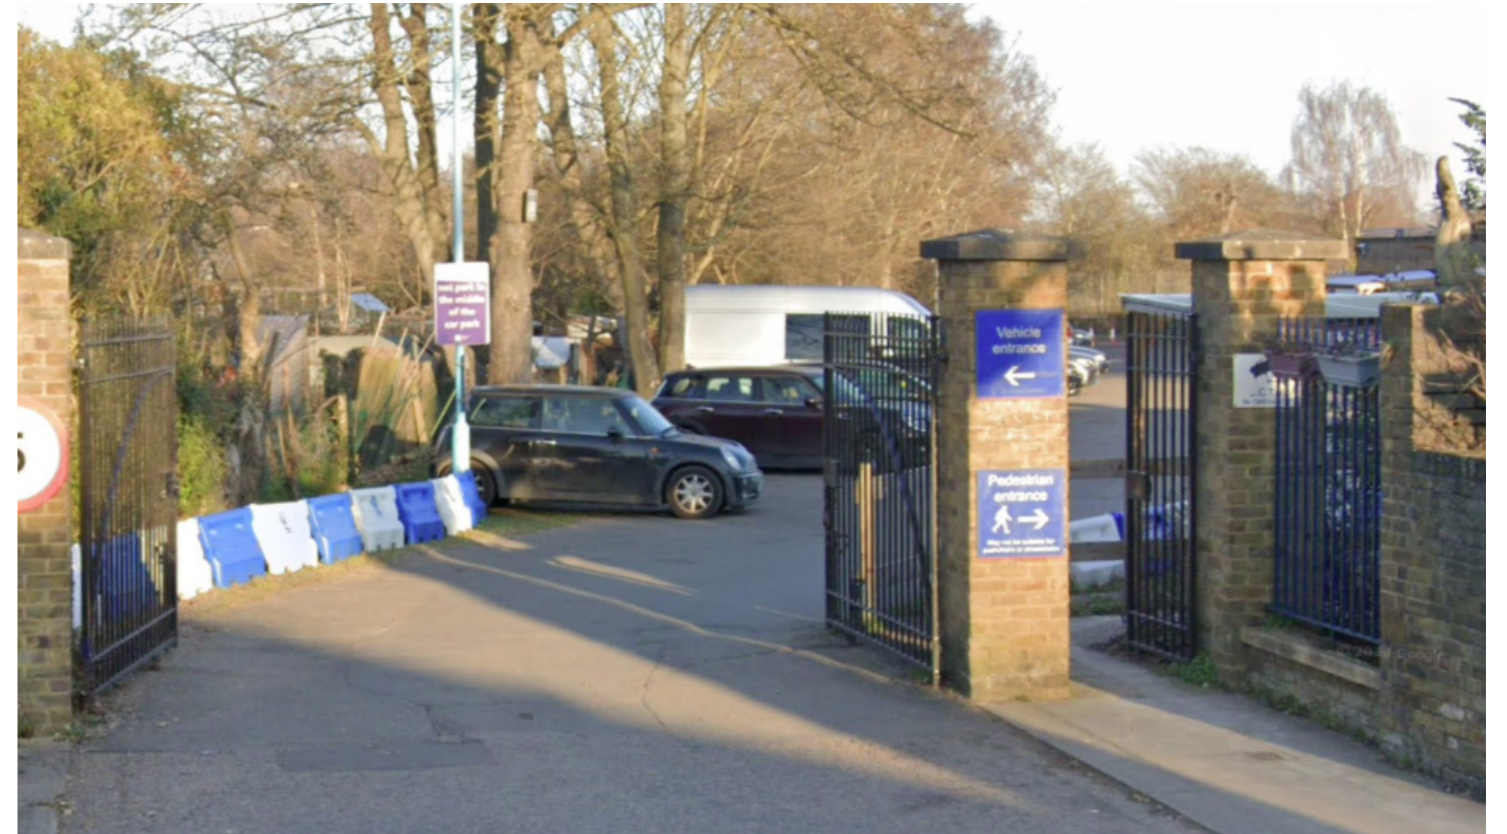
The area in question is all currently parking on with a tarmac non porous surface and has been for a very long time.

The picture below is clearly shows this - which is not something that the application is not changing with regards to this edge. There will be no new service runs in this area.

Please also see below details of the new existing levels – (in brackets) and proposed levels below in this area. This confirms that we are only building up from the existing levels in the area of concern and that part of this area is being returned to soft landscaping.

Plan of Car Park at Entrance Area
