## Richmond Hill Campus

Stage 3 Report for LBC Submission

Project no. 1399

Document no. 1399-INT-ZZ-ZZ-RP-S-0003

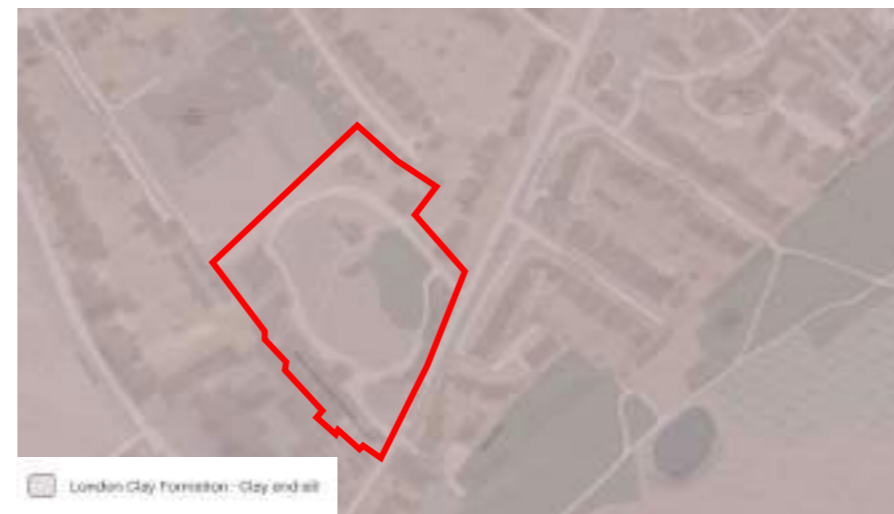
Bedrock geology – London Clay Formation

Information has been gathered from the 1:50,000 British Geological Survey (BGS) maps. The BGS maps show that Richmond Hill Campus is underlain by the London clay formation comprising river deposits in clay and silt, with superficial outcrops of sand and gravel present around the site.

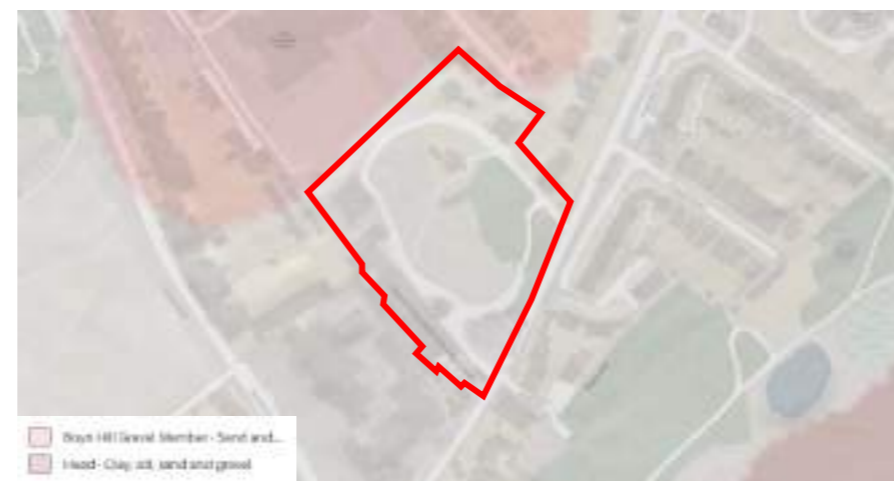
Superficial deposits

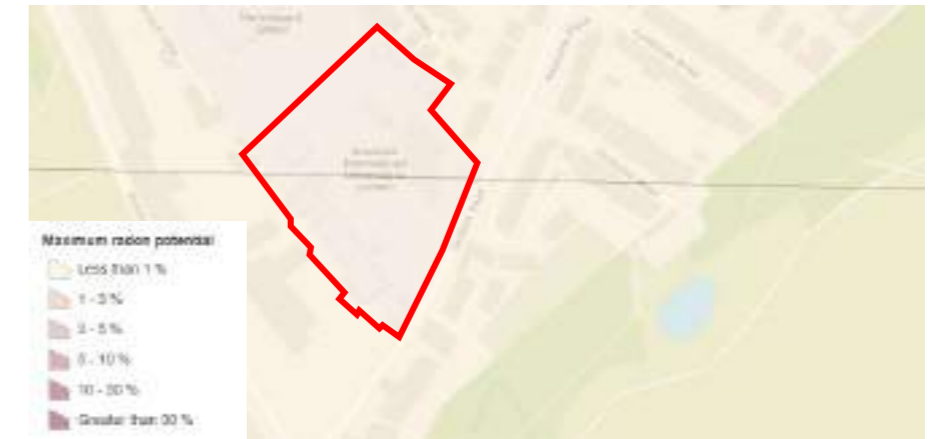
Extract of UK Radon map

Maps from UK Radon show a <1% maximum radon potential within the site and wider Richmond Area. This means that radon protection measures are unlikely to be required.

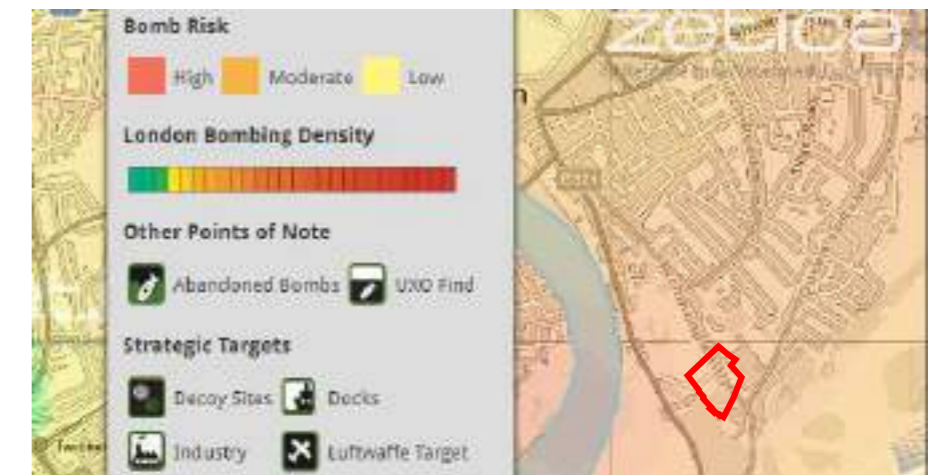
Extract of ZeticaUXO map

The potential for unexploded ordinance (UXO) on site has been preliminarily assessed by looking at WWII bombing density maps provided by ZeticaUXO. These maps show a 'moderate' bomb risk on site based on the bombing density of the surrounding area during WWII. No abandoned bombs or UXOs have been found on site or within the wider Richmond area previously.

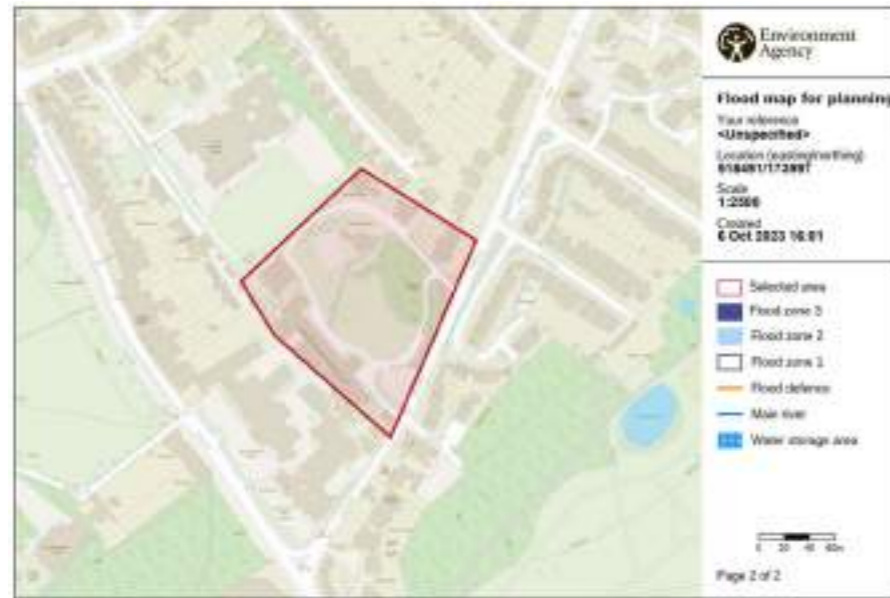
Flood map for planning

The site lies within flood zone 1 which is low risk, however the red line boundary for planning is more than 1 hectare which usually triggers the requirement to submit a flood risk assessment for planning.

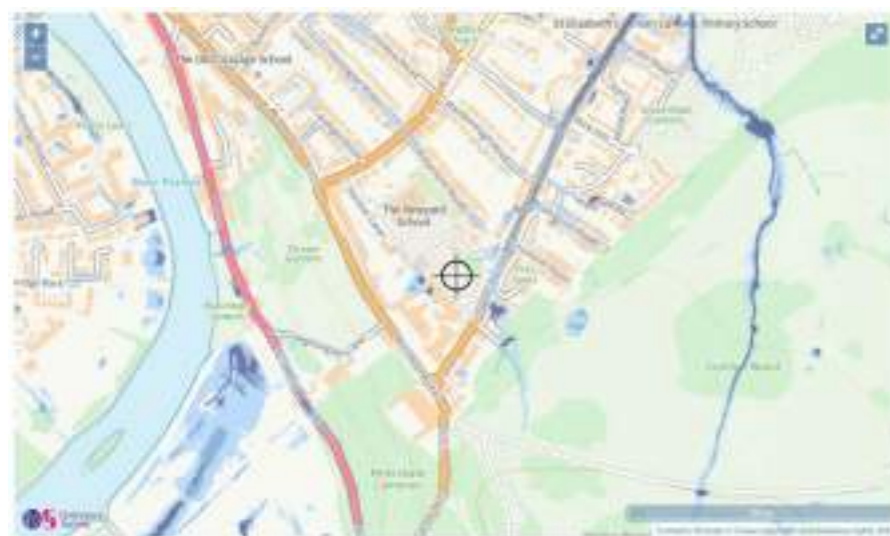
Surface water flood map

The surface water flood map does show some areas to the rear of the main building which are at a high risk of flooding from surface water. This may not be an issue for planning if there are no external works ie the existing situation is being left unchanged, but this is an increasingly prominent requirement with some local authorities. It would also be prudent to discuss this with the school and explore whether they want to make improvements in any case, for example altering ground levels to fall away from the building.

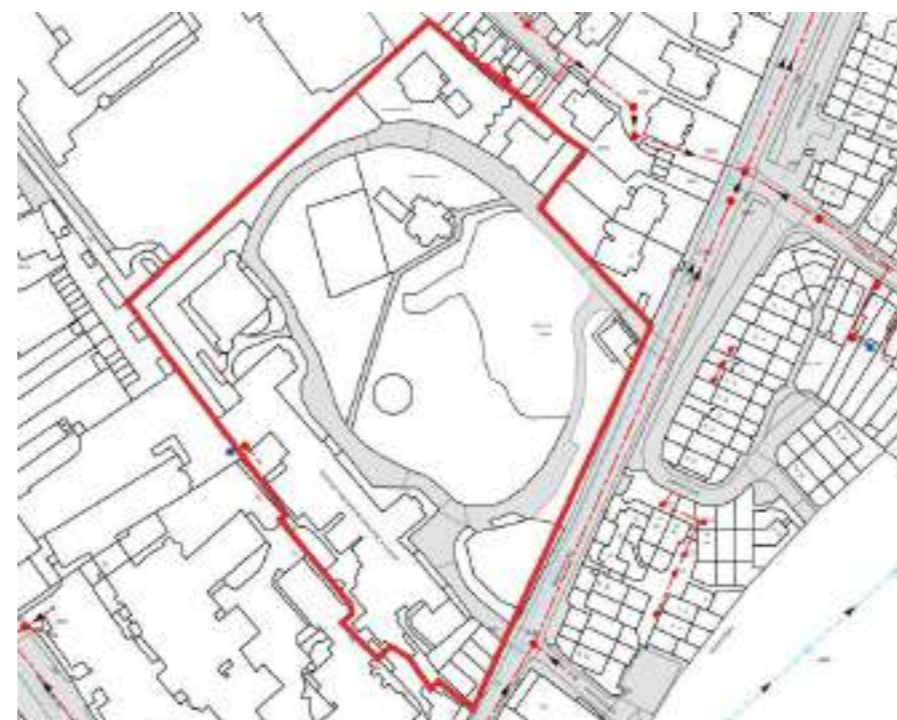
Extract from Thames Water asset map

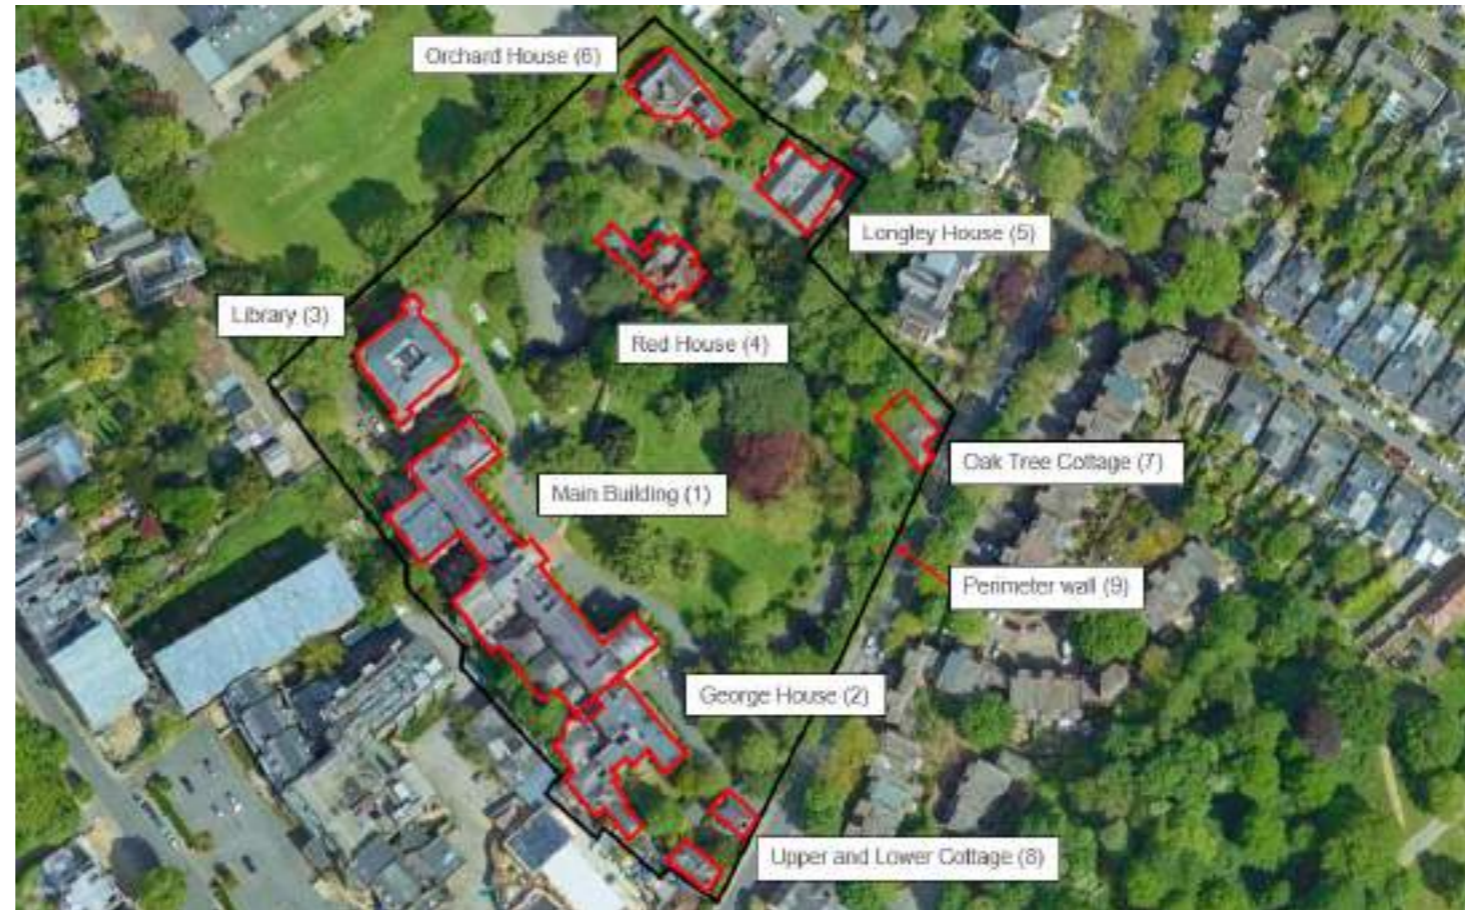
Site overview of existing buildings

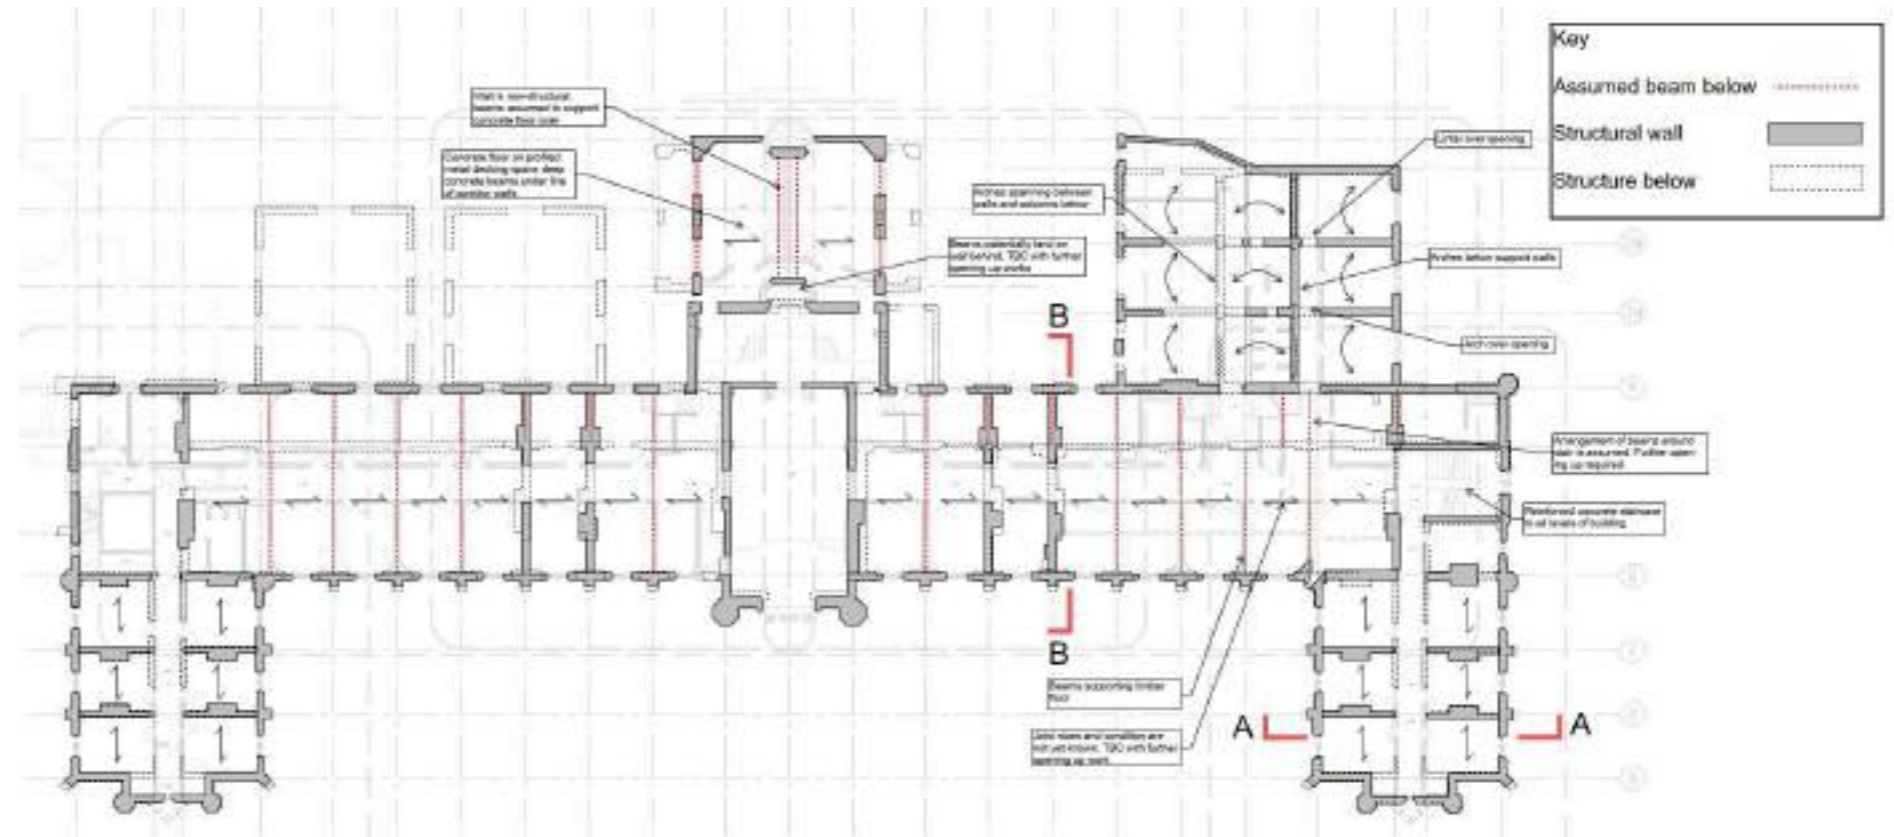
Extract from SK083 showing Main Building general layout with currently assumed beam and timber joist spans

The Main Building primary structure is load bearing masonry with timber floor joists. Internal structural walls have been identified by visiting the site and examining the floor plans. There are some key structural lines across the building which support the chimneys and provide lateral stability. From initial investigations there is no evidence of significant issues with the condition of existing timber within the building as it has generally been well maintained.

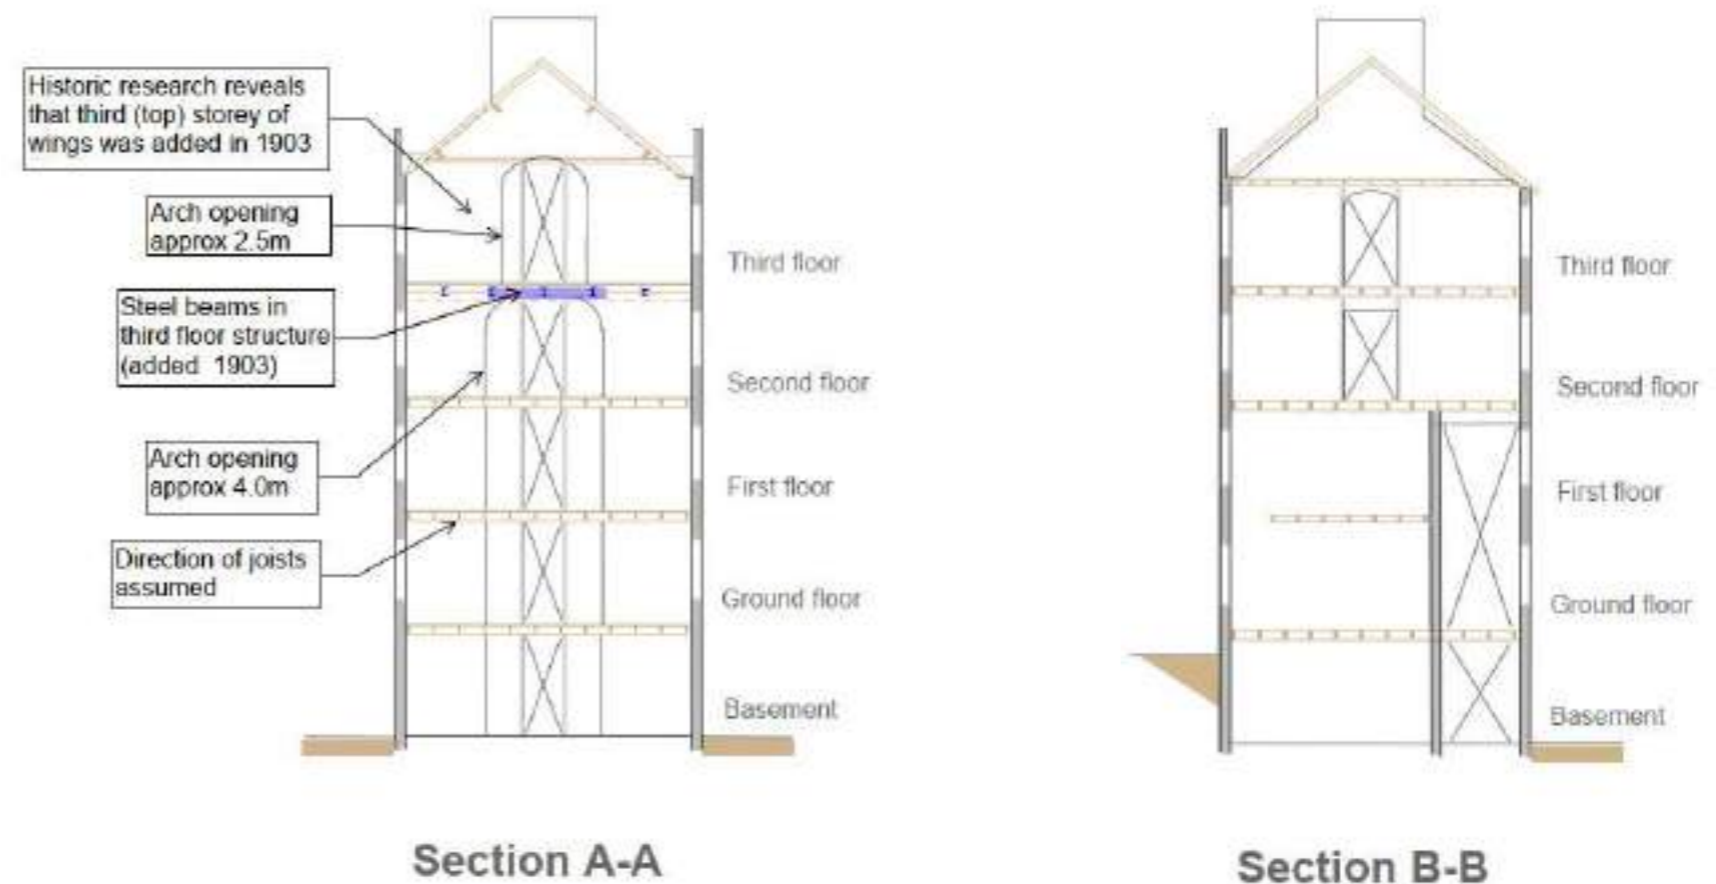
Section A-A

Section B-B

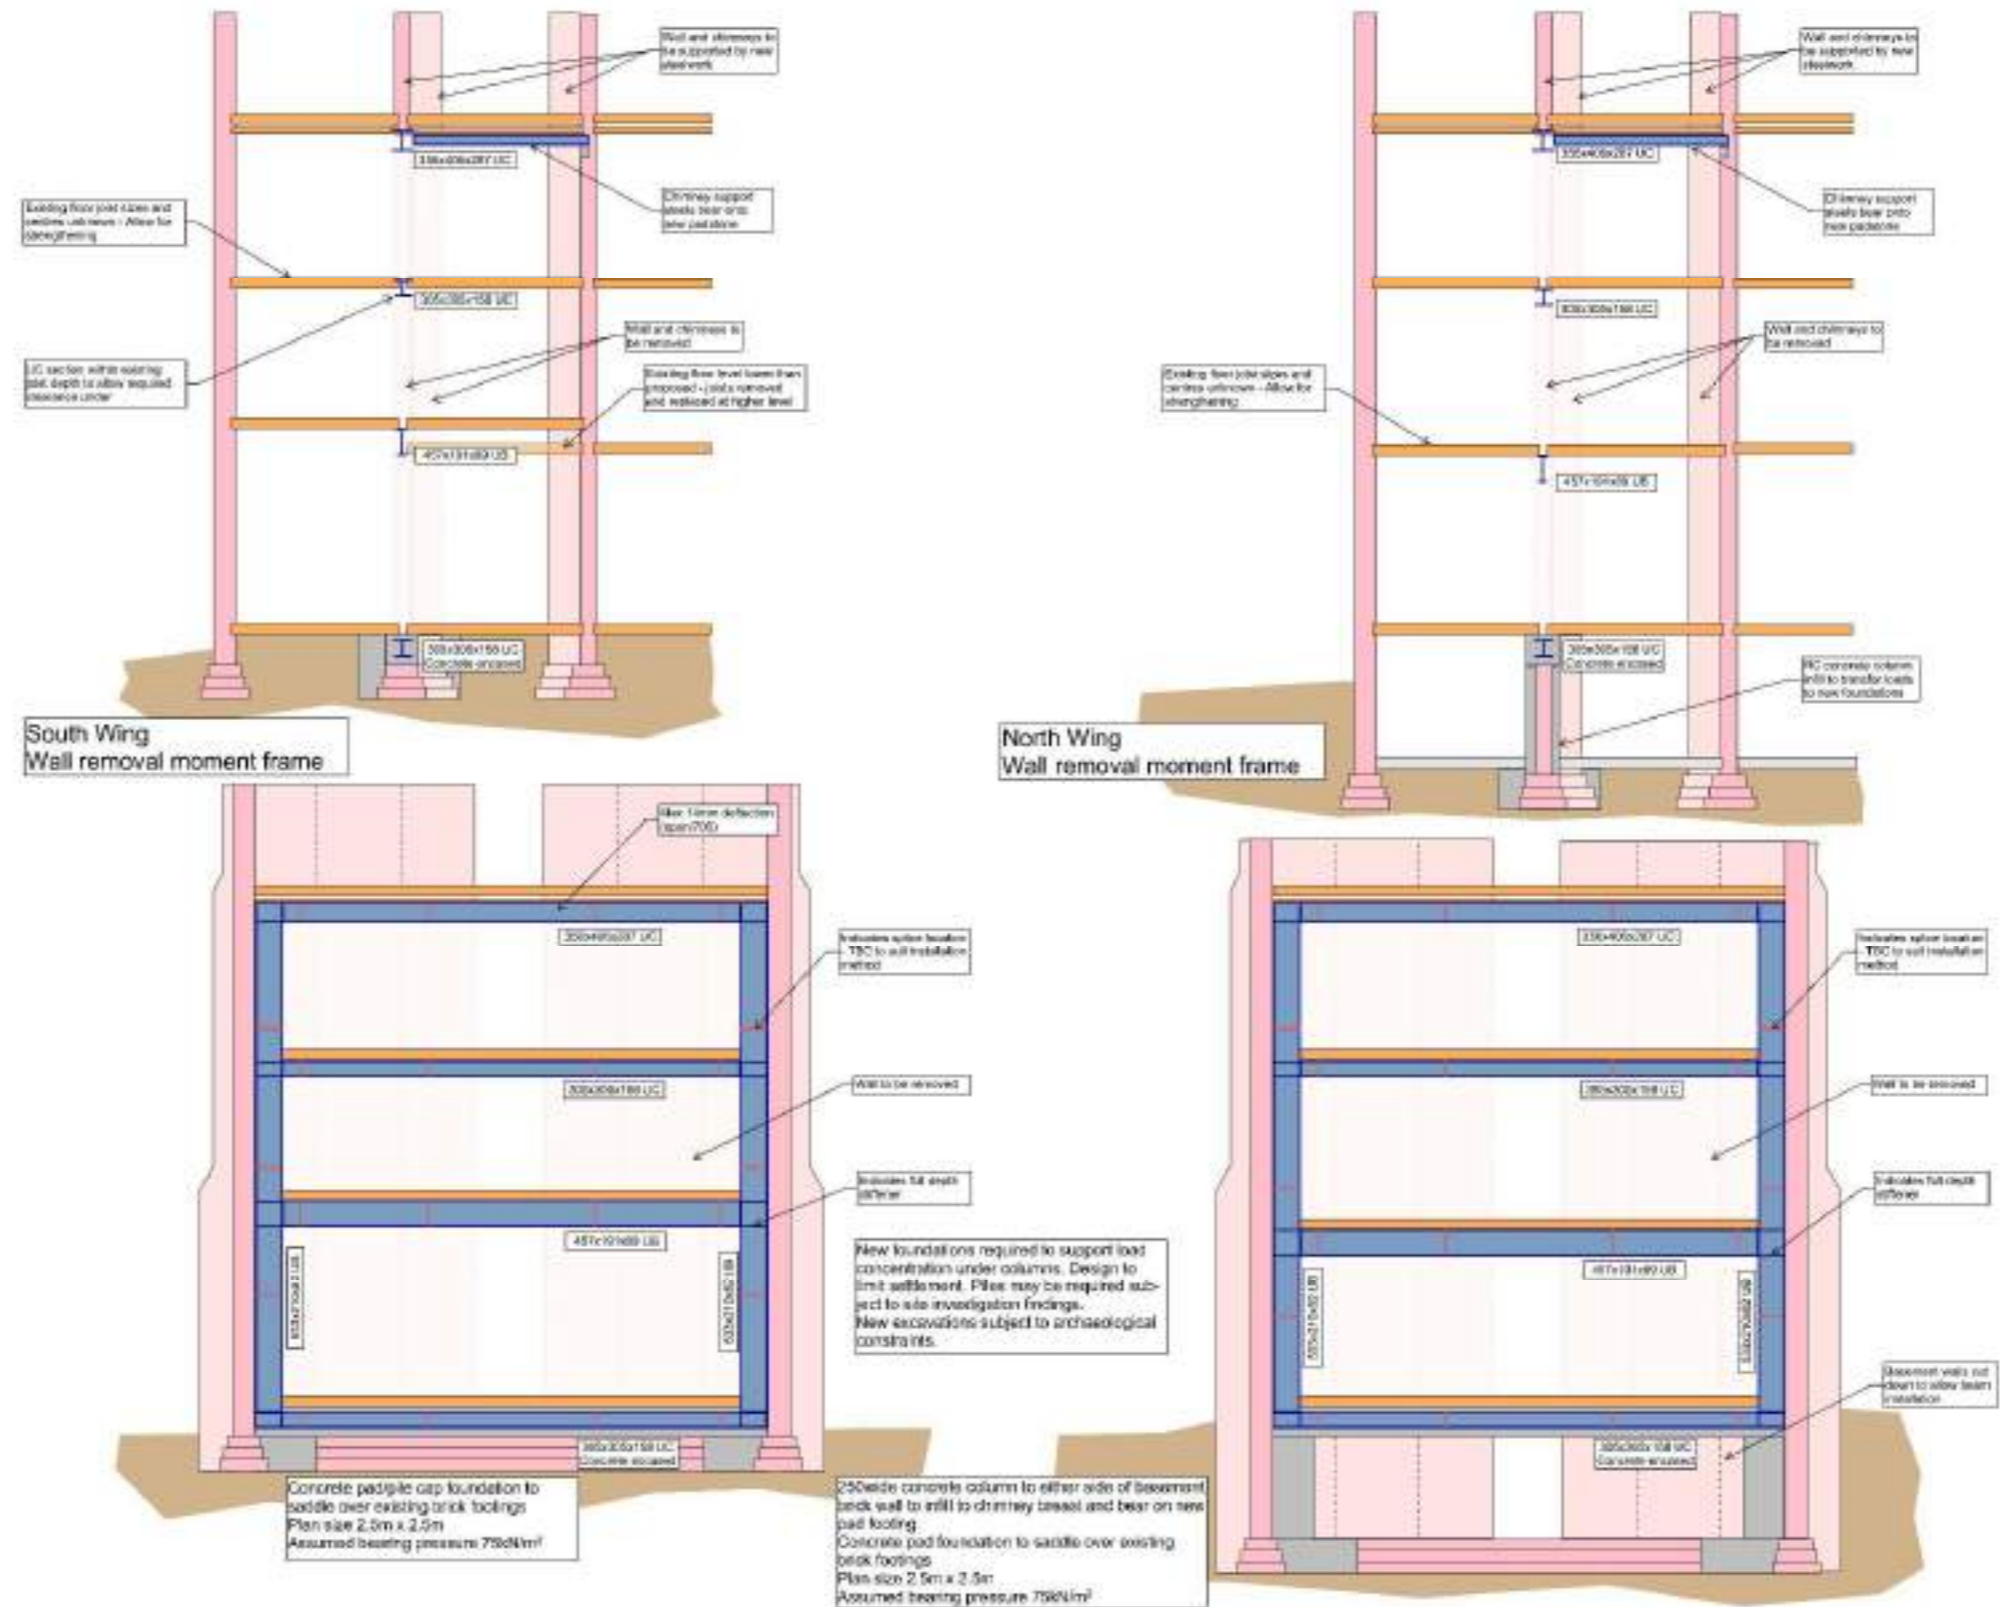
Sections through north and south wing moments frames

To replace the walls in the wings of the building it is proposed that a steel moment frame is placed at each of these locations. As the frame is placed inside an existing masonry structure, restricting lateral movement of the steel columns is significant and largely dictates the sizes of the proposed members. A sway deflection limit of 5mm and a vertical deflection limit of 15mm has been used for the design.

In order to achieve the required headroom in the rooms UC sections have been adopted. To achieve the same stiffness as the UBs in the stage 2 design the weight of these sections has increased as a result of the change to UC sections.

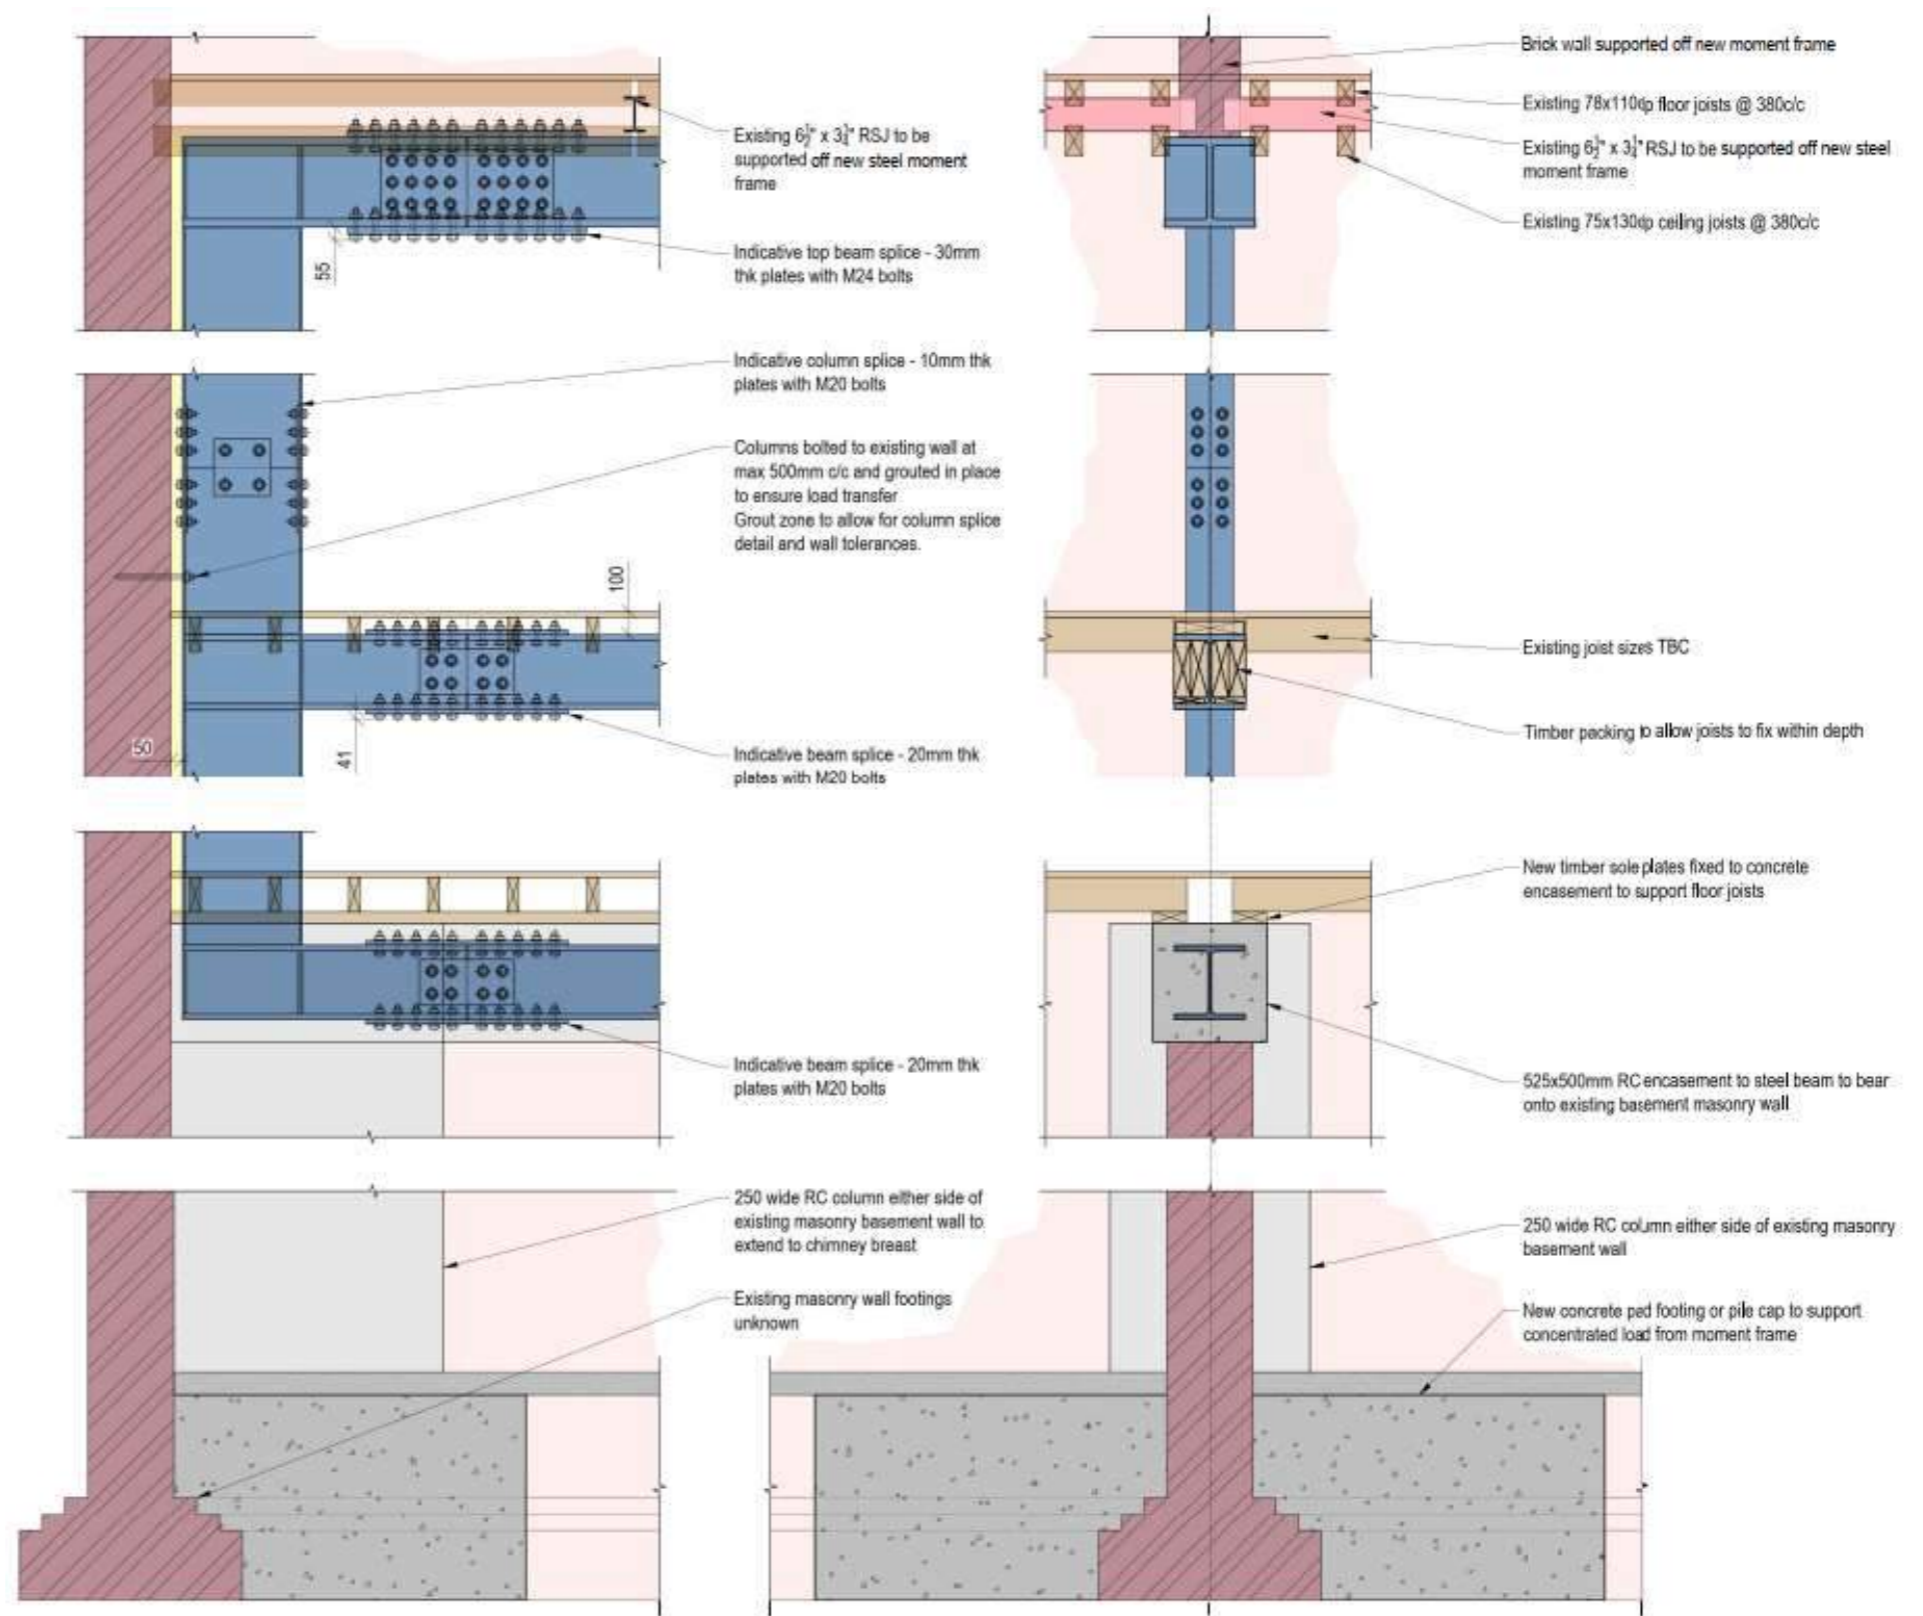
North wing moment frame details, including indicative splice connections, basement works and foundations

The moment frame and the increased variable loading lead to high concentrated loads under the new columns. It is proposed to provide new foundations to account for these loads. No site investigation data is currently available, so an initial pad footing design has been based on an assumed allowable bearing pressure of 75 kN/m<sup>2</sup>.

To maintain the required lateral stiffness a bottom steel member is provided. This also helps to transfer some of the vertical loading back into the existing wall/footing under. It is proposed to concrete encase this beam. It is noted that in the northern wing the bottom spreader beam will significantly impact on head height in the central basement corridor.

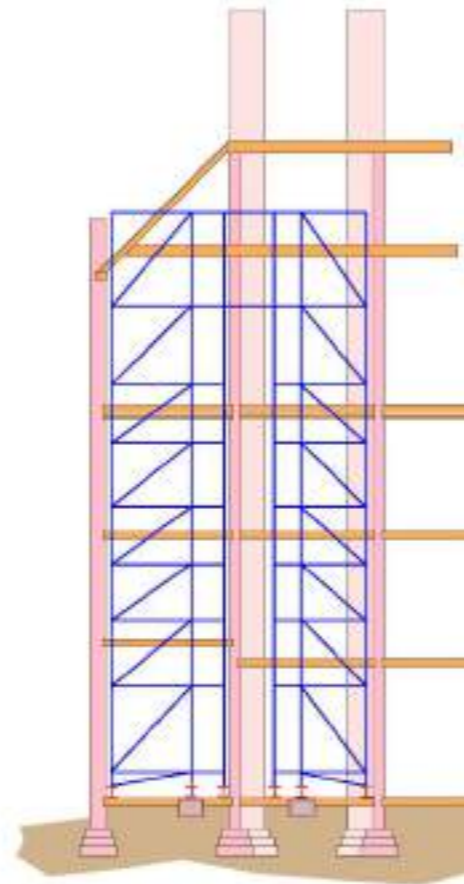
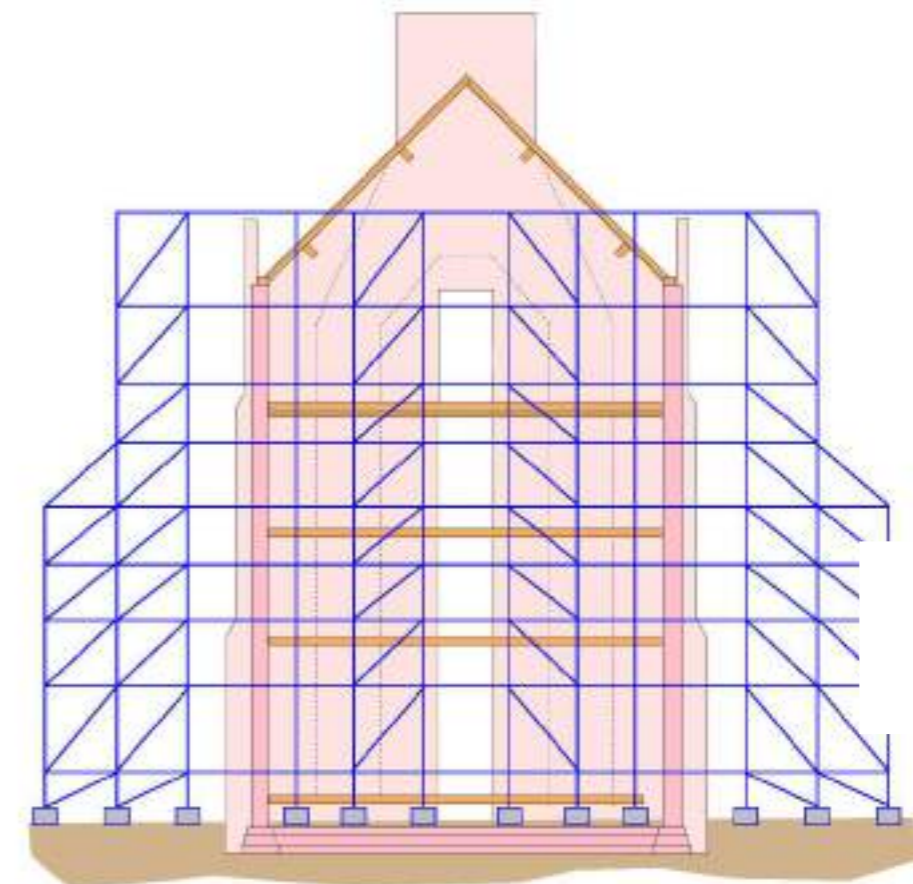
Large lateral loading may require temporary pad foundations or screw piles as the loads on the external scaffold will be considerable.

Full birdcage scaffold within the retained walls to allow access for steel install. Floorboards and joists removed and stored for reinstatement.

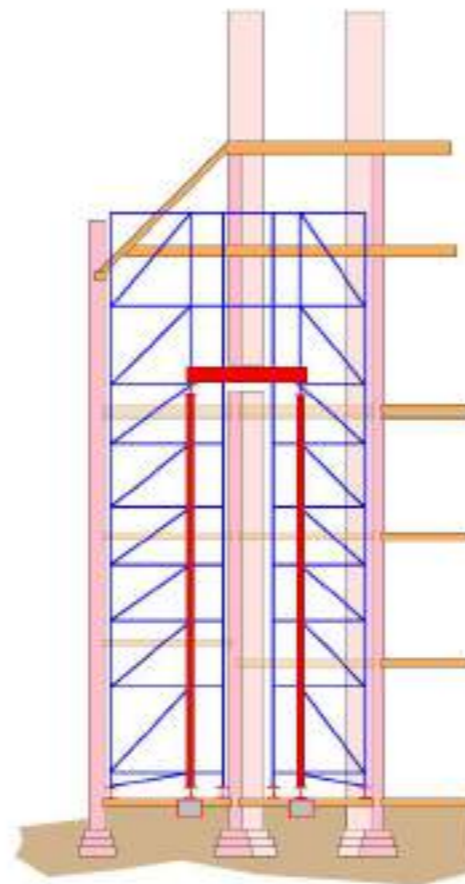
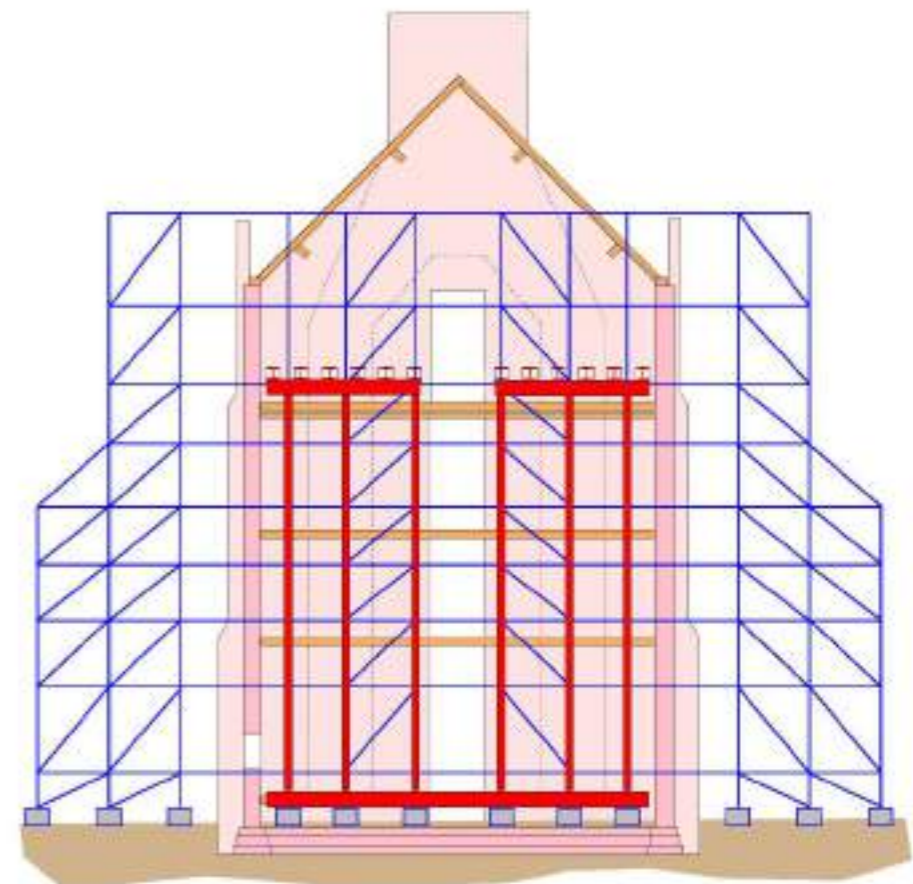
#### 10.2.2.2 Step 2 – Needle prop chimney

Install spreader beam in basement on needle prop lines.

Form openings for needle propping above 3<sup>rd</sup> floor joists.

Insert needle props, assumed 254UCs at 500c/c (larger if needed later in process to lift in steel sections)

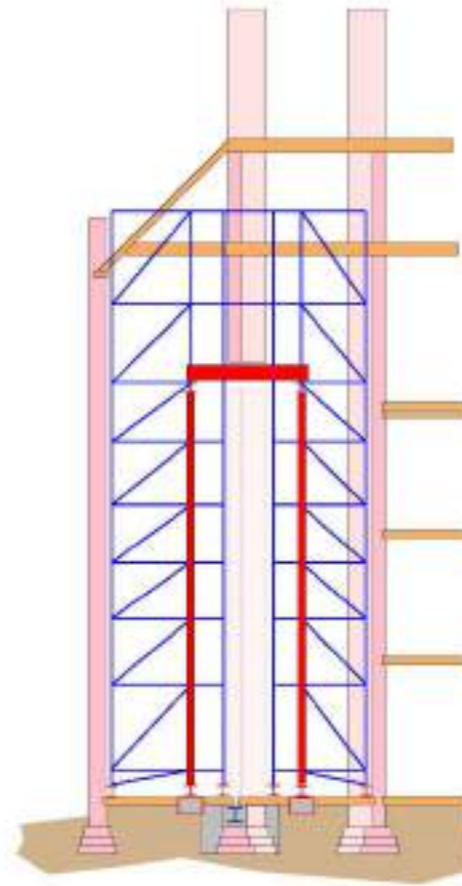
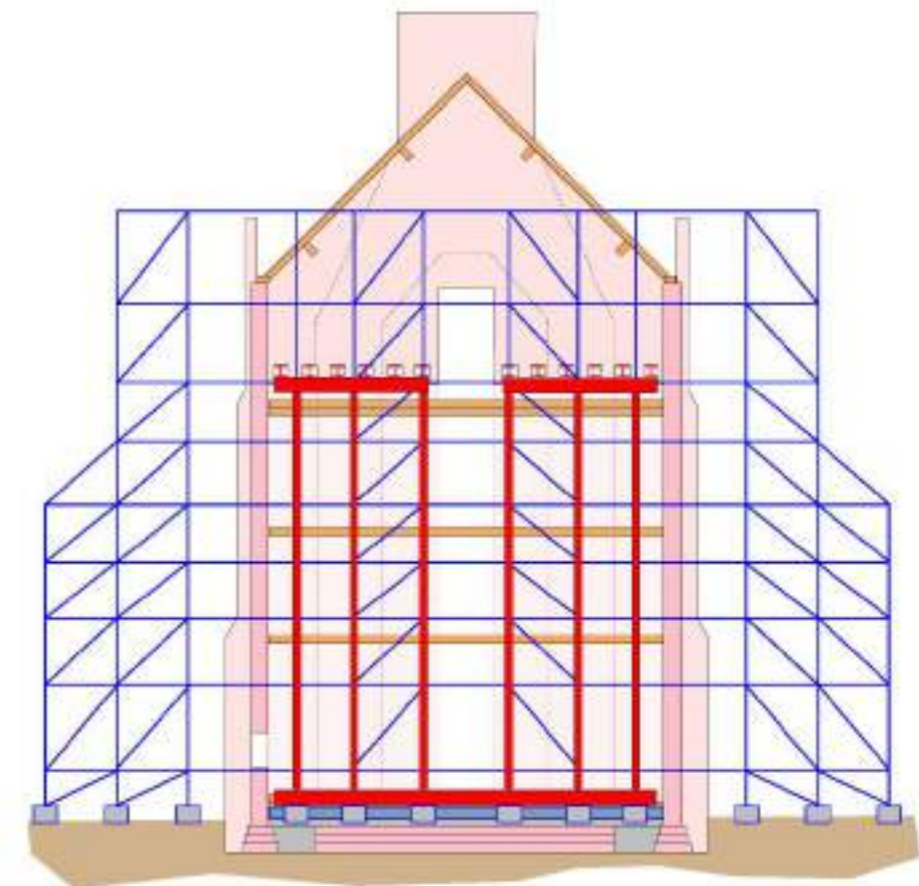
### 10.2.2.3 Step 3 – Demolish walls and remove existing floors

All joists and floorboards to 1<sup>st</sup>, 2<sup>nd</sup> & 3<sup>rd</sup> floors removed carefully and stored for reinstatement including the rolled steel joists at third floor level.

Make good any damage to external/cross wall intersection where toothed in bricks removed.

Form hole in external wall at ground level to allow new steelwork to be passed between lines of needle propping. This needs to be done carefully so stones can be reused when reinstating.

Install ground floor steel beam including concrete encasement.

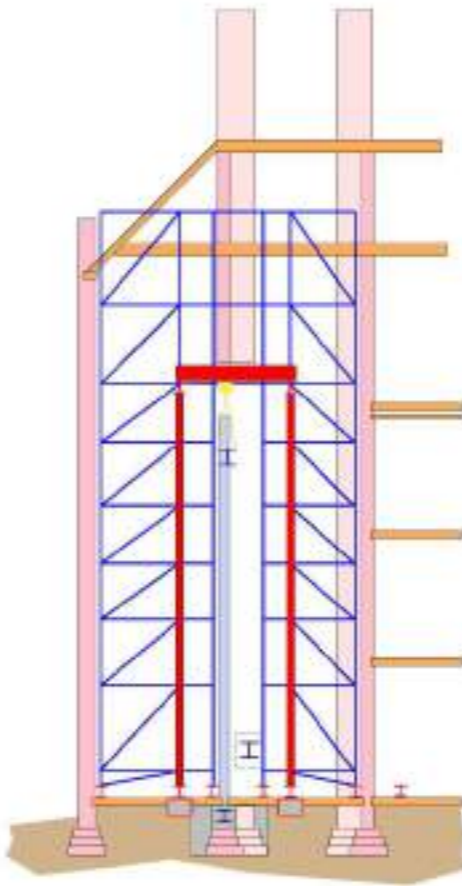
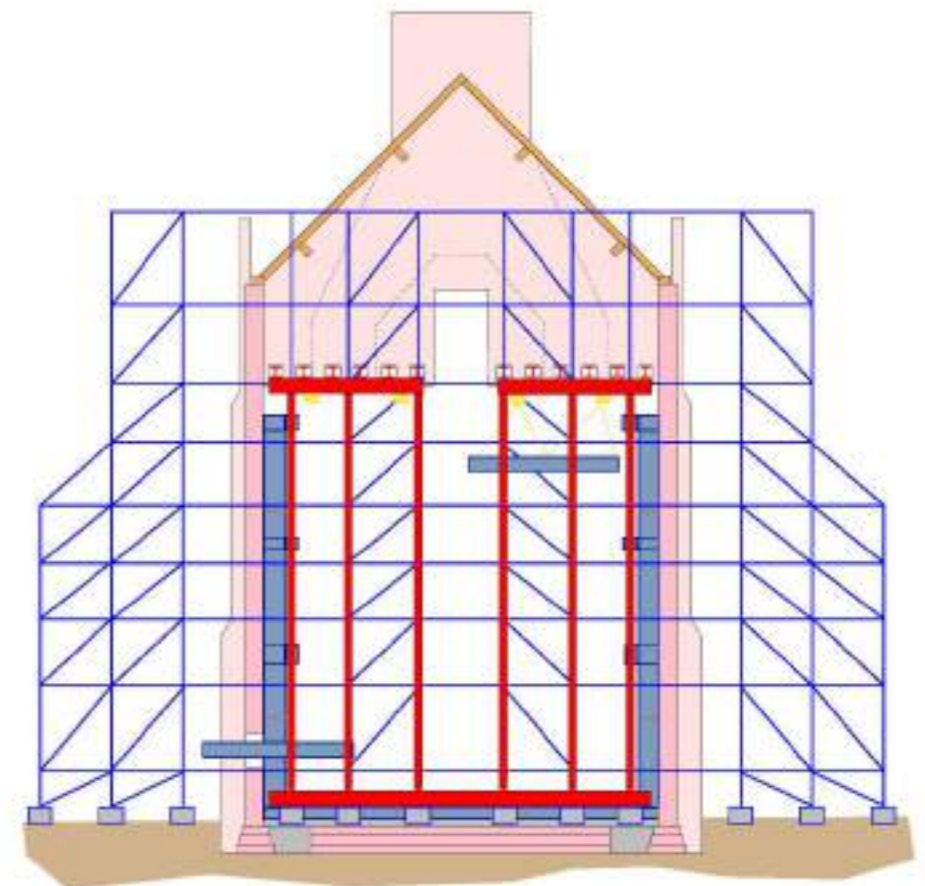
### 10.2.2.4 Step 4 – Install new steelwork

Columns delivered through opening in wall and rotated upright.

Installed single floor at a time and spliced. Noted each section weighs approximately 300kg.

If level of slip and size of bolted splice plates not acceptable then splices to be formed with on site welding.

Columns bolted and grouted to external walls once beams installed and levelled.

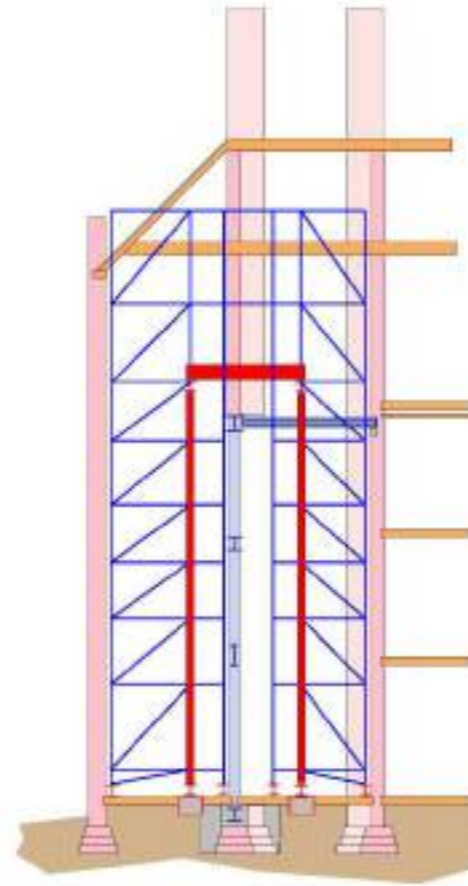
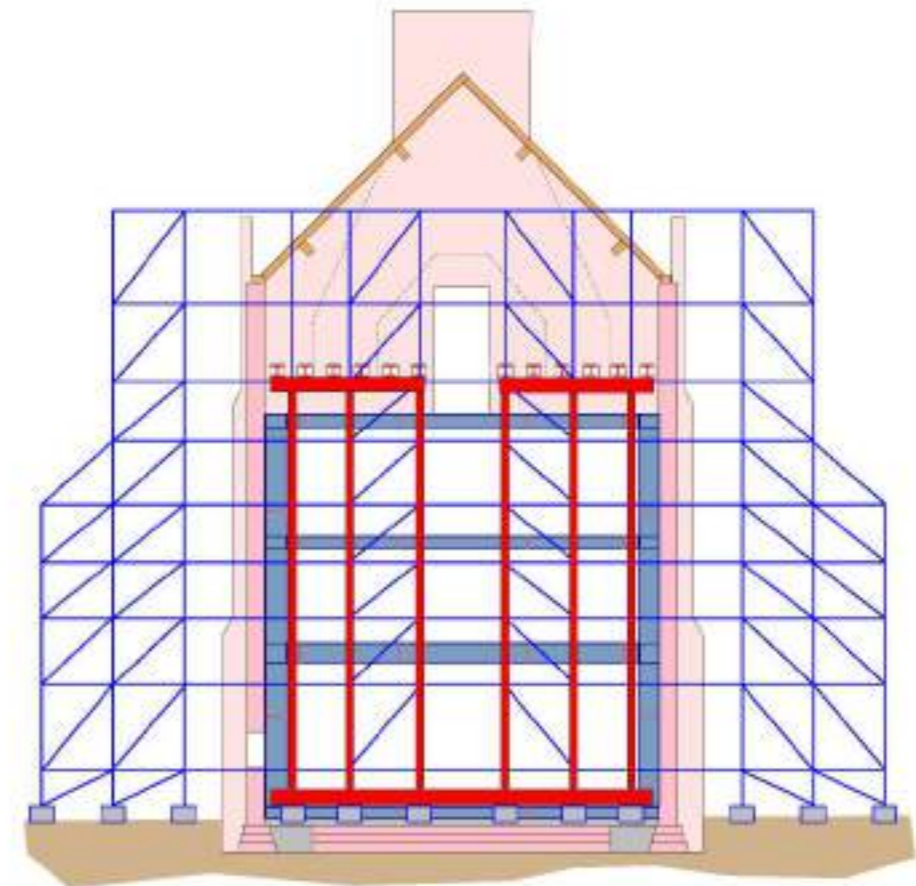
#### 10.2.2.5 Step 5 – Rebuild brick to sit on new steelwork

Steels to support front of chimney installed including padstone to remaining cross wall.

Masonry dry packed and infilled down to top beam to allow load transfer from needle props to new works.

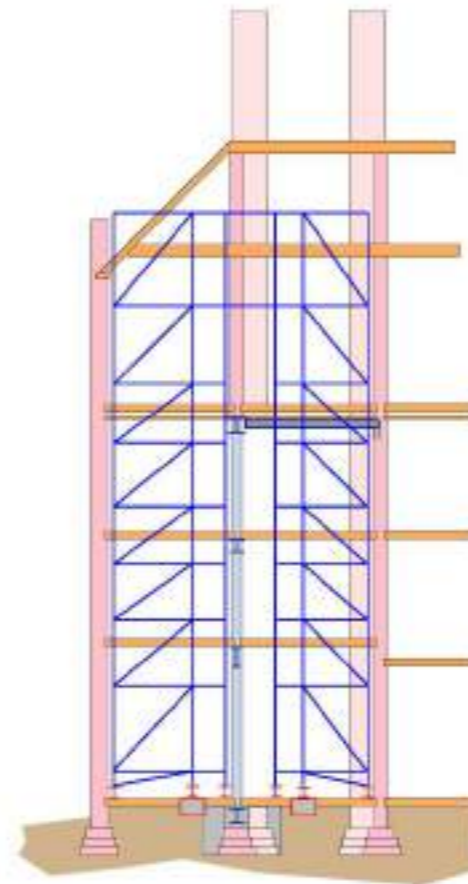
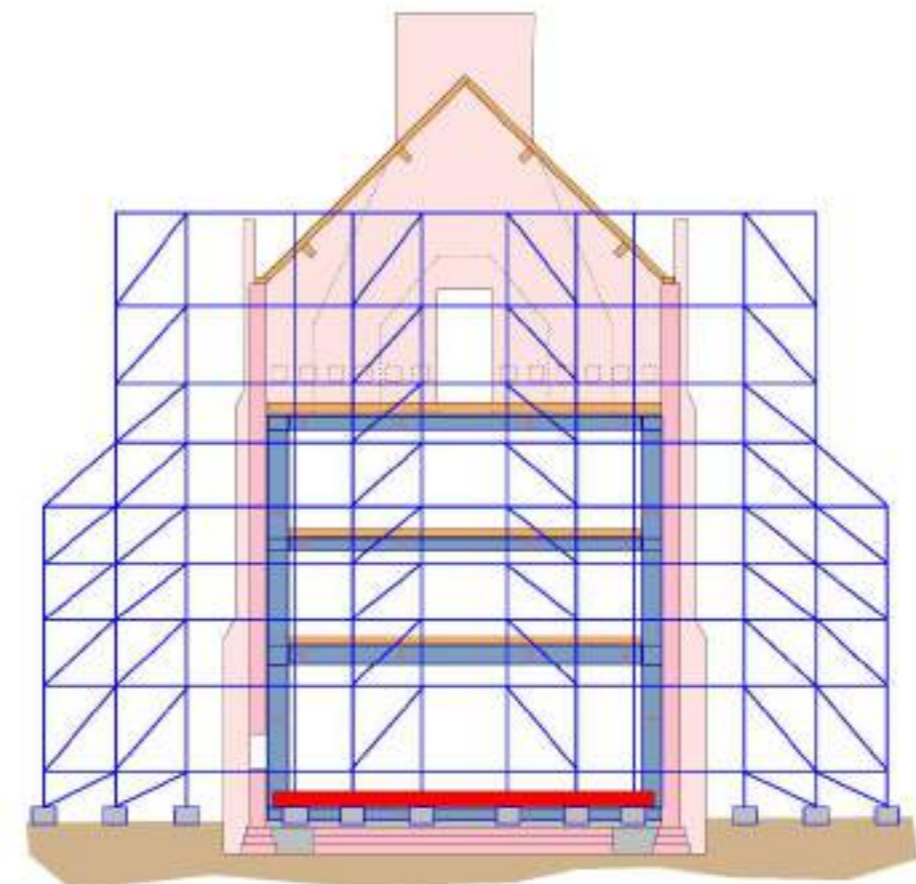
#### 10.2.2.6 Step 6 – Reinstall floors

Needle propping removed.

Any cracks to chimney assessed and repaired.

Original steel beams, timber joists and floor boards reinstalled, with modifications to bearing where required.
