## Richmond Hill Campus

Stage 3 Report for LBC Submission

Project no. 1399

Document no. 1399-INT-ZZ-ZZ-RP-S-0003

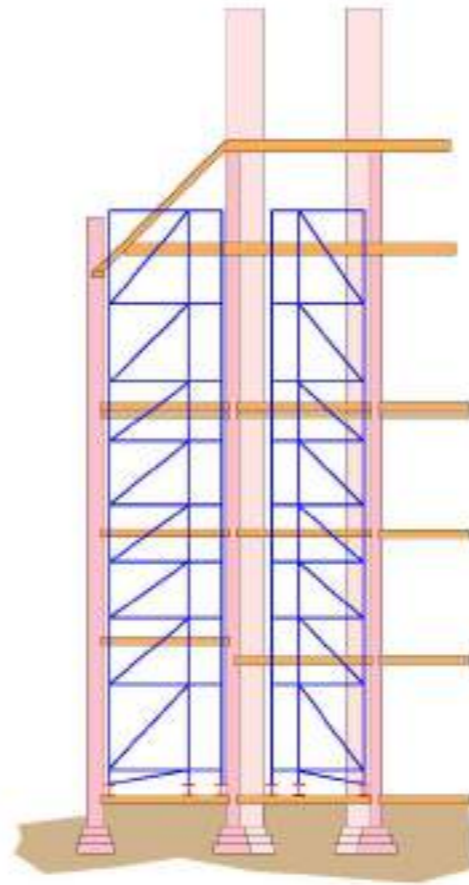
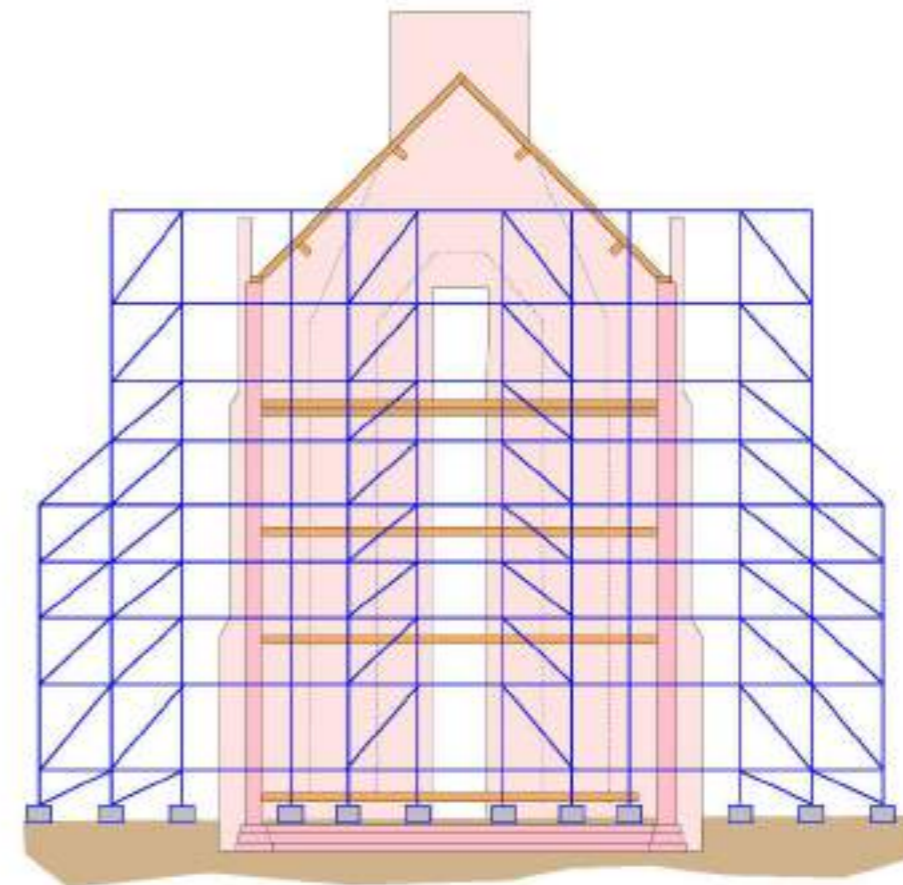
Large lateral loading may require temporary pad foundations or screw piles as the loads on the external scaffold will be considerable.

Full birdcage scaffold within retained walls to allow access for works.

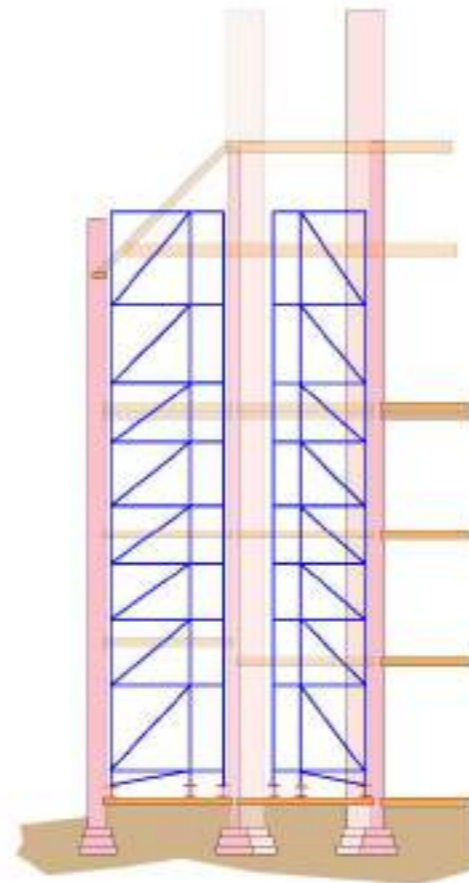
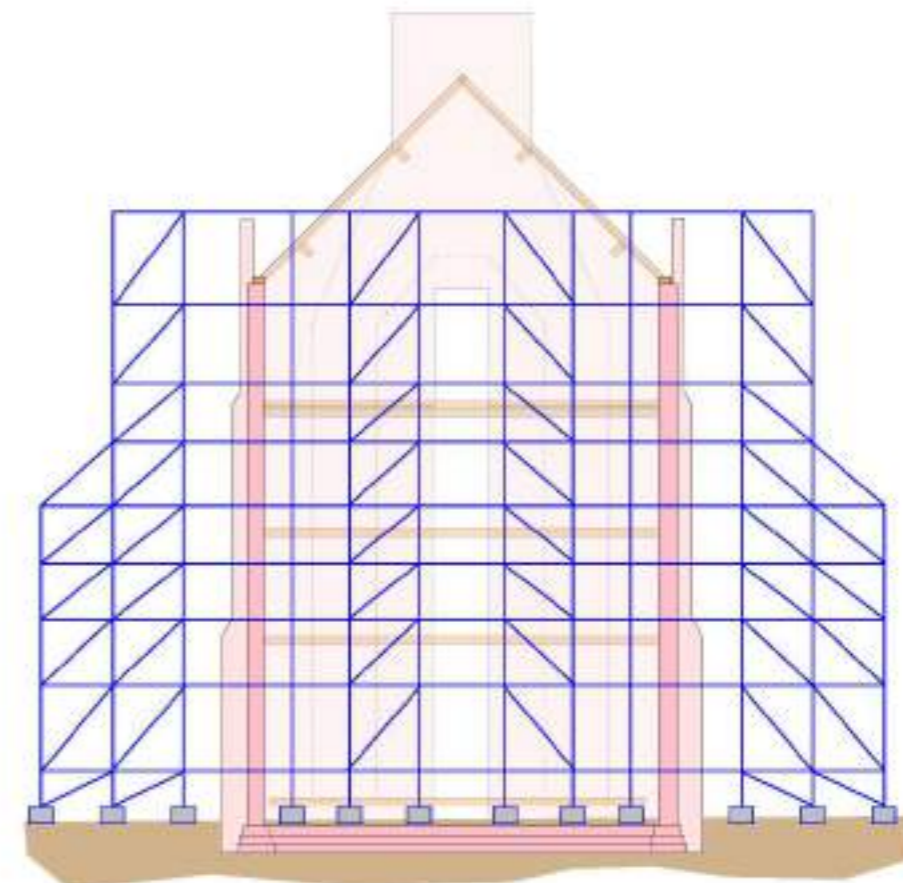
##### 10.2.3.2 Step 2 – Remove roof, floors and dismantle chimneys

Roof and chimneys dismantled carefully, numbering external visible masonry units to allow rebuild at later date.

Existing steel beams at third floor removed and carefully stored for reinstatement.

Masonry cross wall removed. Make good any damage to external/cross wall intersection where toothed in bricks removed.

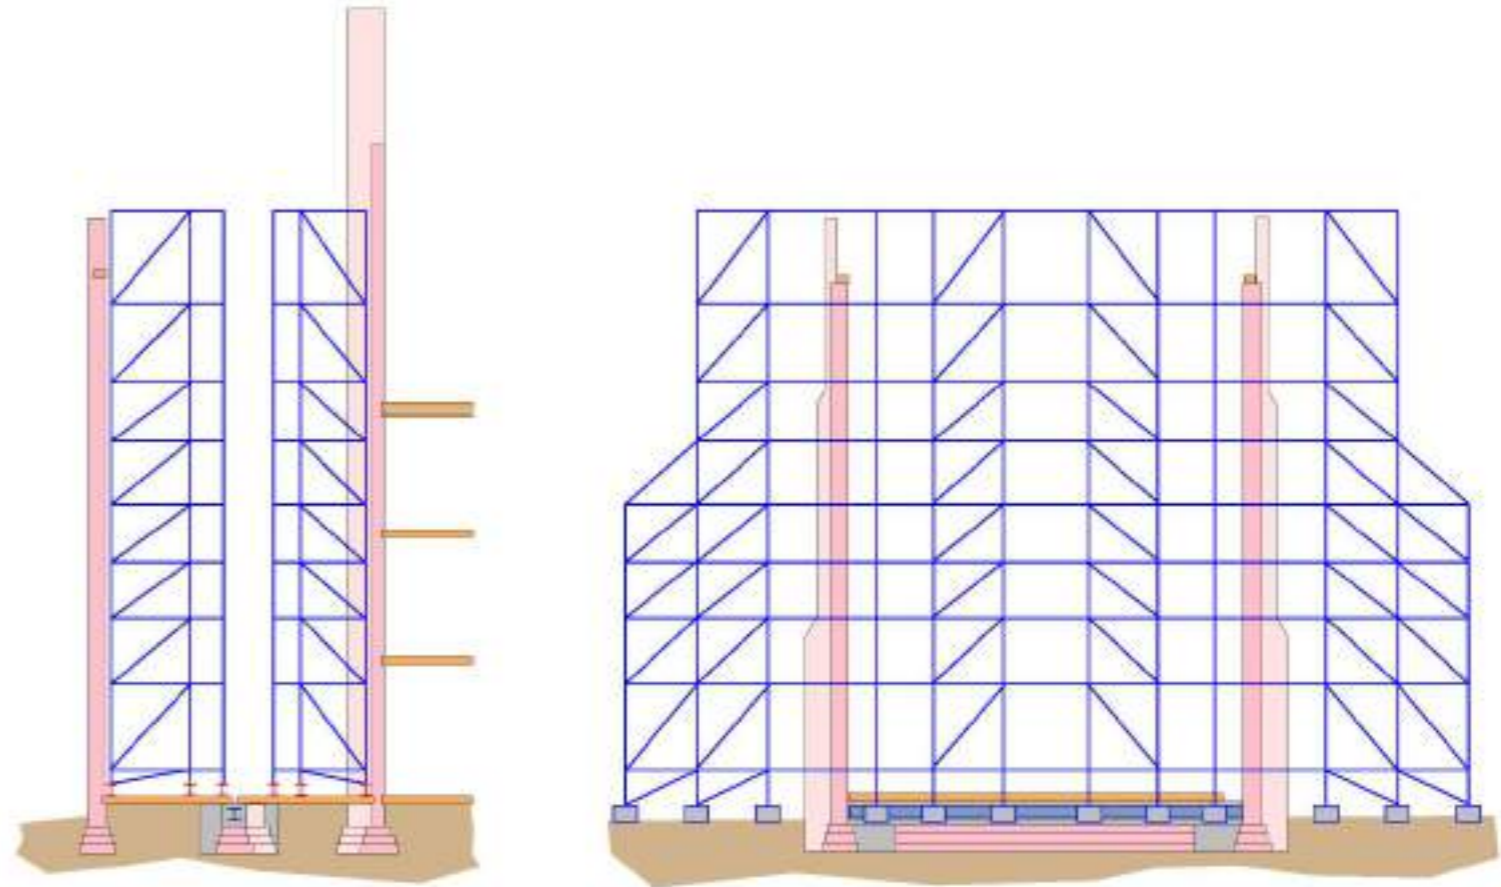
**10.2.3.3 Step 3 – Foundations and ground beam**  
Install the foundations and ground beams.

Concrete encasement to ground beam.

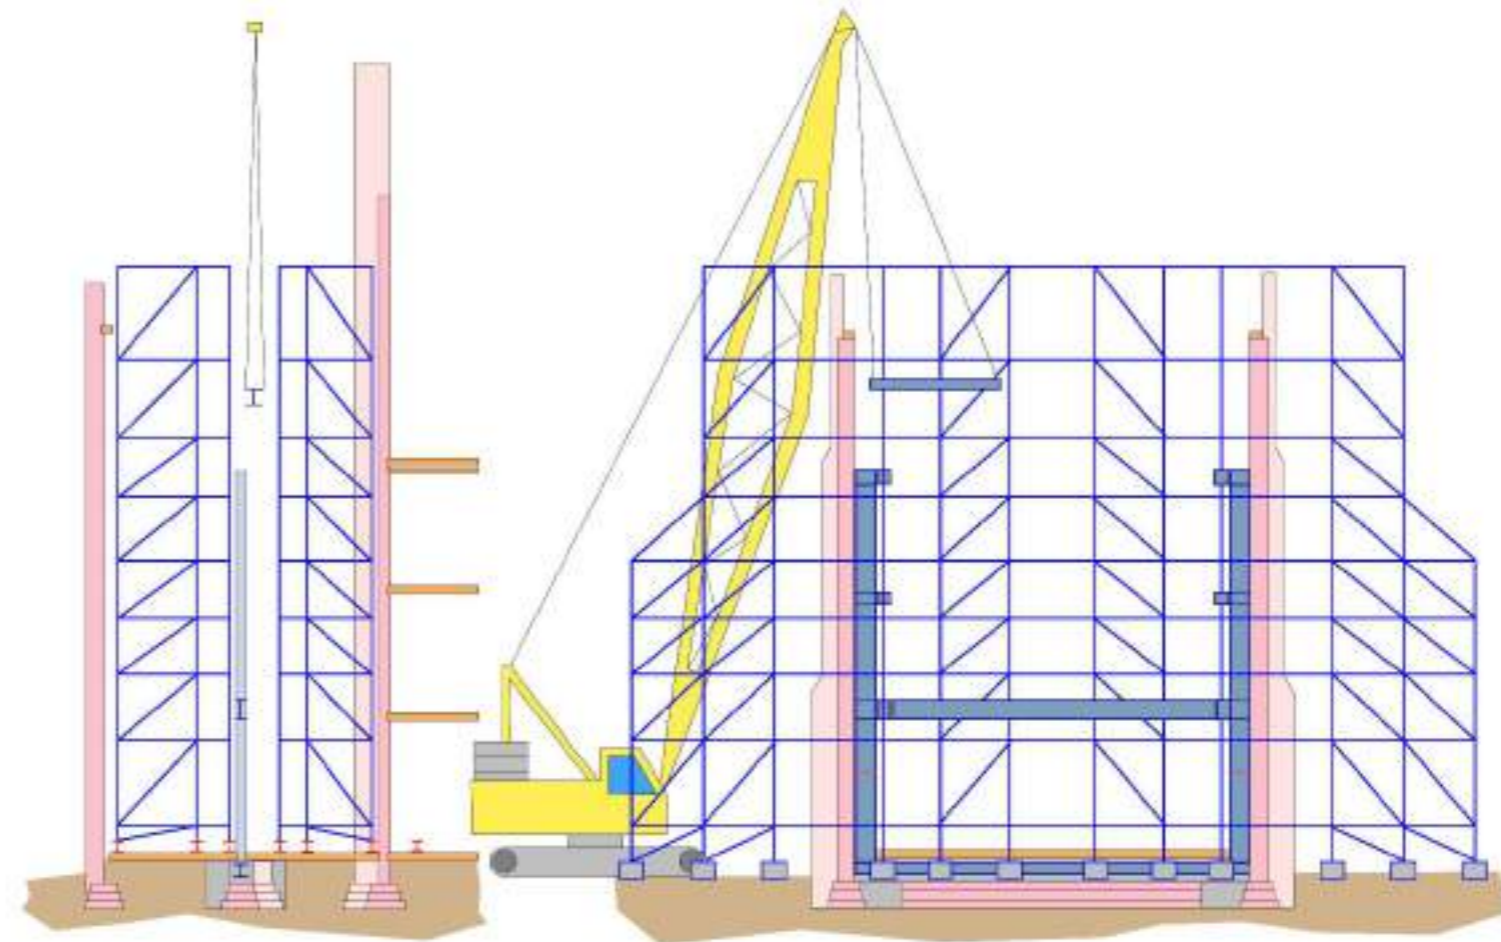
**10.2.3.4 Step 4 – Install steelwork**

New steel craned into place. Larger lengths of steel can be used (relative to “chimney retained” option) and splices minimised according to delivery and crane restraints.

Columns bolted and grouted to external walls once beams installed and levelled.

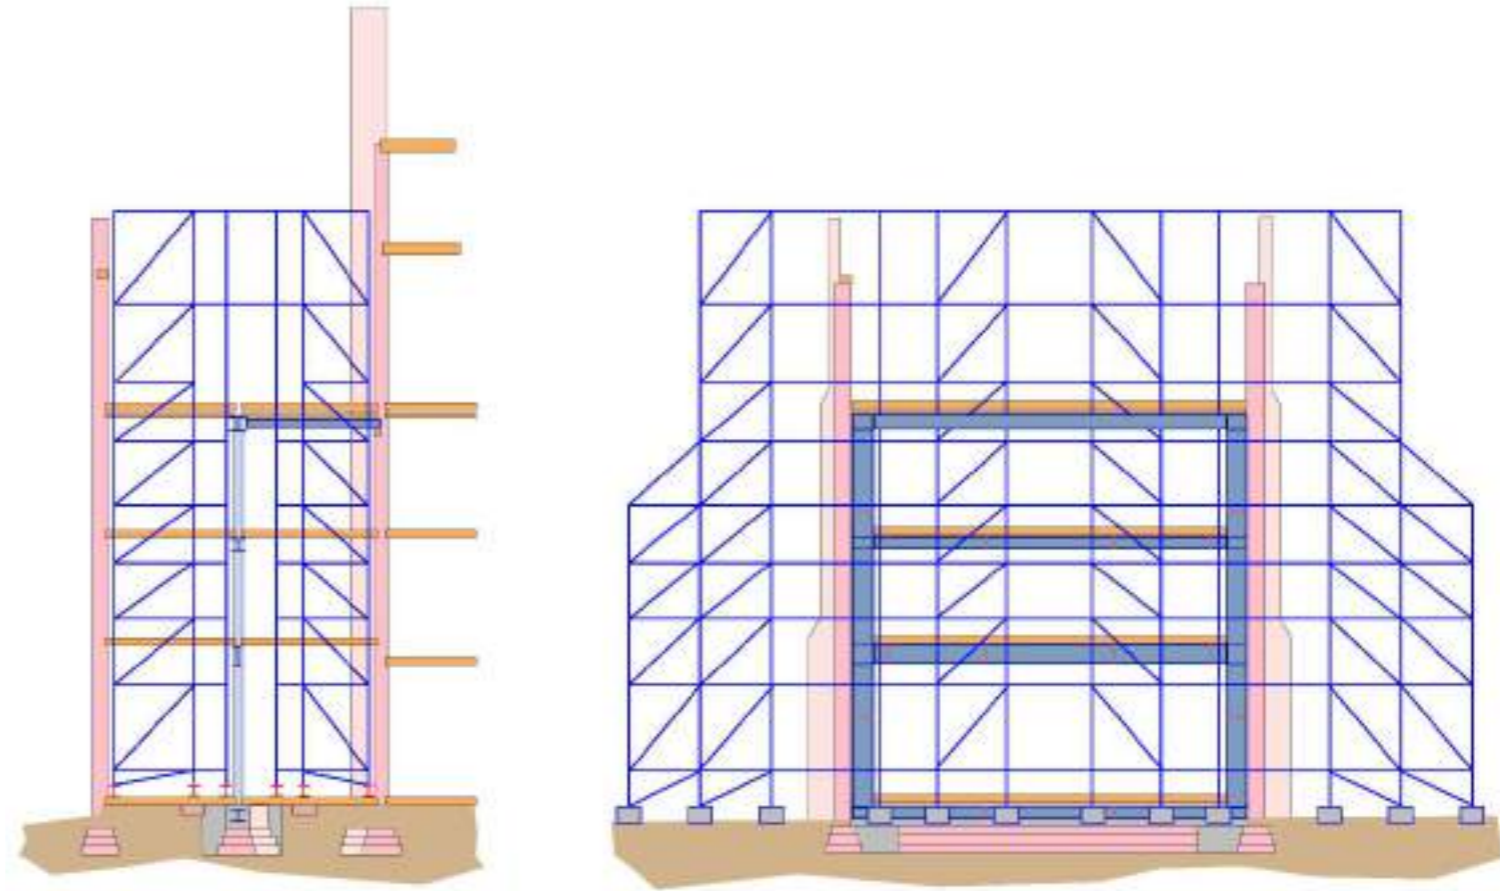
#### 10.2.3.5 Step 5 – Replace existing floorplates

Original timber joists and steel beams reinstated, with modifications to bearing where required.

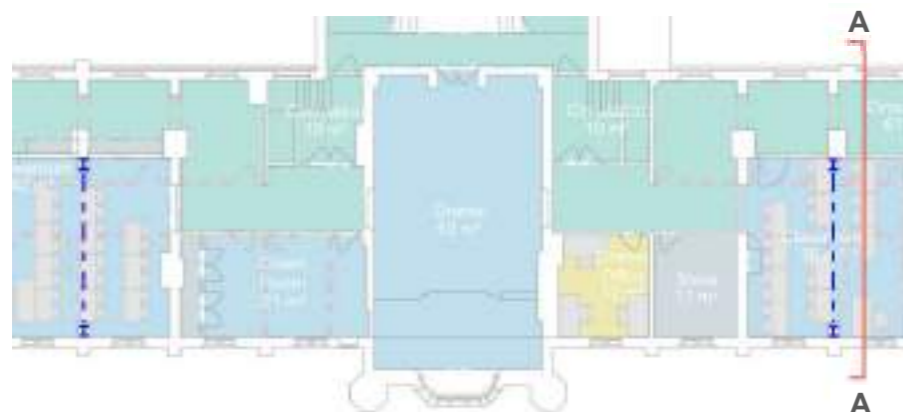
Extract from SK73 showing locations of proposed steel frames at 2<sup>nd</sup> floor

Where the wall needs to be completely removed as it interferes with a classroom space, the wall will be replaced with a full moment frame at second floor level. The design criteria and necessary considerations for moment frame are similar to those discussed in section 10.2.1 regarding the steel frames proposed in the wings of the Main Building.

The bottom beam of the moment frame is to sit within the depth of the existing second floor structure, while the top beam will sit below the existing third floor structure. The size and span direction of the existing timber joists at these levels are to be confirmed but they are anticipated to span perpendicular to the proposed steel frame. The existing timber joists are to be reinstated following the installation of the steel frame.

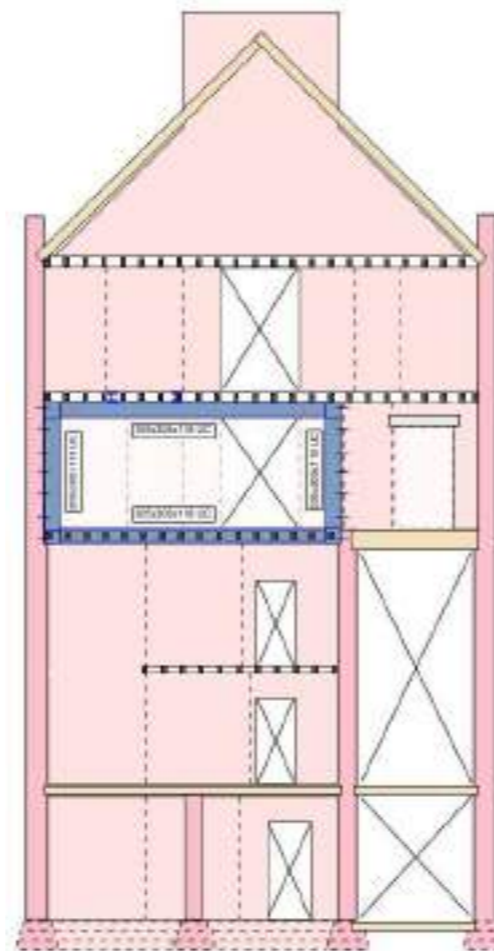
Section A-A: Extract from SK62

In the Maufe extension a series of walls, anticipated to be structural, are to be removed at second floor level. It is assumed that these walls provide support to the flat roof over as well as laterally restraining the external masonry walls.

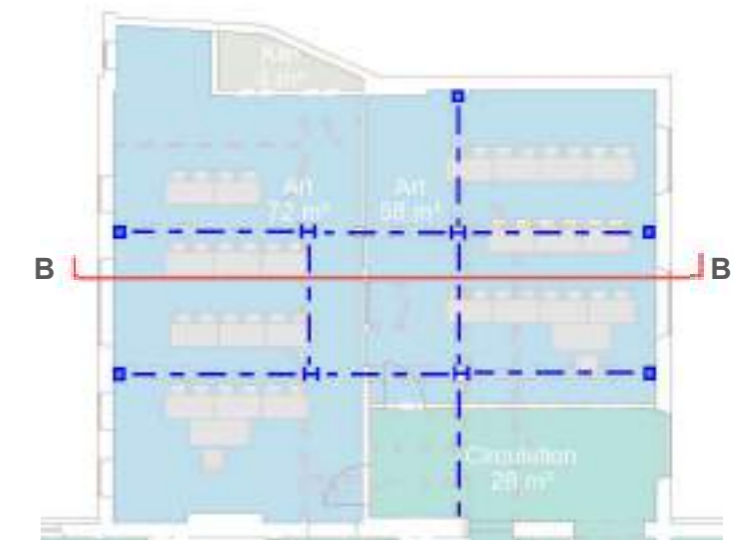
Extract from SK73 showing Maufe extension proposed steel framing at 2<sup>nd</sup> floor

Therefore, at second floor new steel is required at each line where walls are removed. As shown below, the proposed internal columns at second floor have been positioned to align with the sides of the vaults below, in order to avoid transferring load onto the existing arches. A detail will be required to hide the column baseplates within the floor finishes zone.

The external walls between second and third floor are anticipated to provide sufficient lateral stability to the top storey, assuming the roof acts as a diaphragm. Because of this the proposed steel frame is required to support the roof only. SHS windposts are also required to restrain external walls where internal walls are being removed.

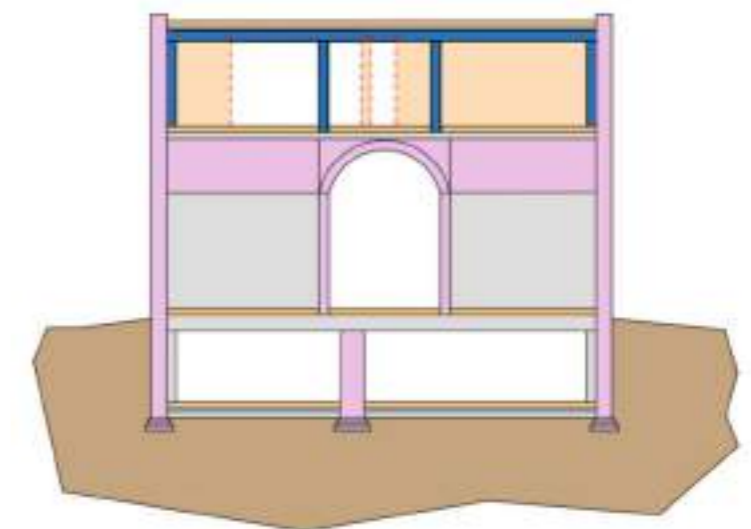
Section B-B: Extract from SK63

The installation method and sequencing is a key consideration for the proposed frame. Similarly to the works occurring in the north and south wings, an external scaffold designed to provide lateral stability in the temporary condition will be required. With appropriate propping of the third floor wall and chimney breast, a portion of roof and floors could be removed to allow steels to be craned into position from above, before the original fabric of the floors and roof are reinstated. Alternatively, windows could be temporarily removed to provide access for steels to be loaded in and lifted into position. As with the wings, the actual sequence and temporary works will be determined by the contractor.

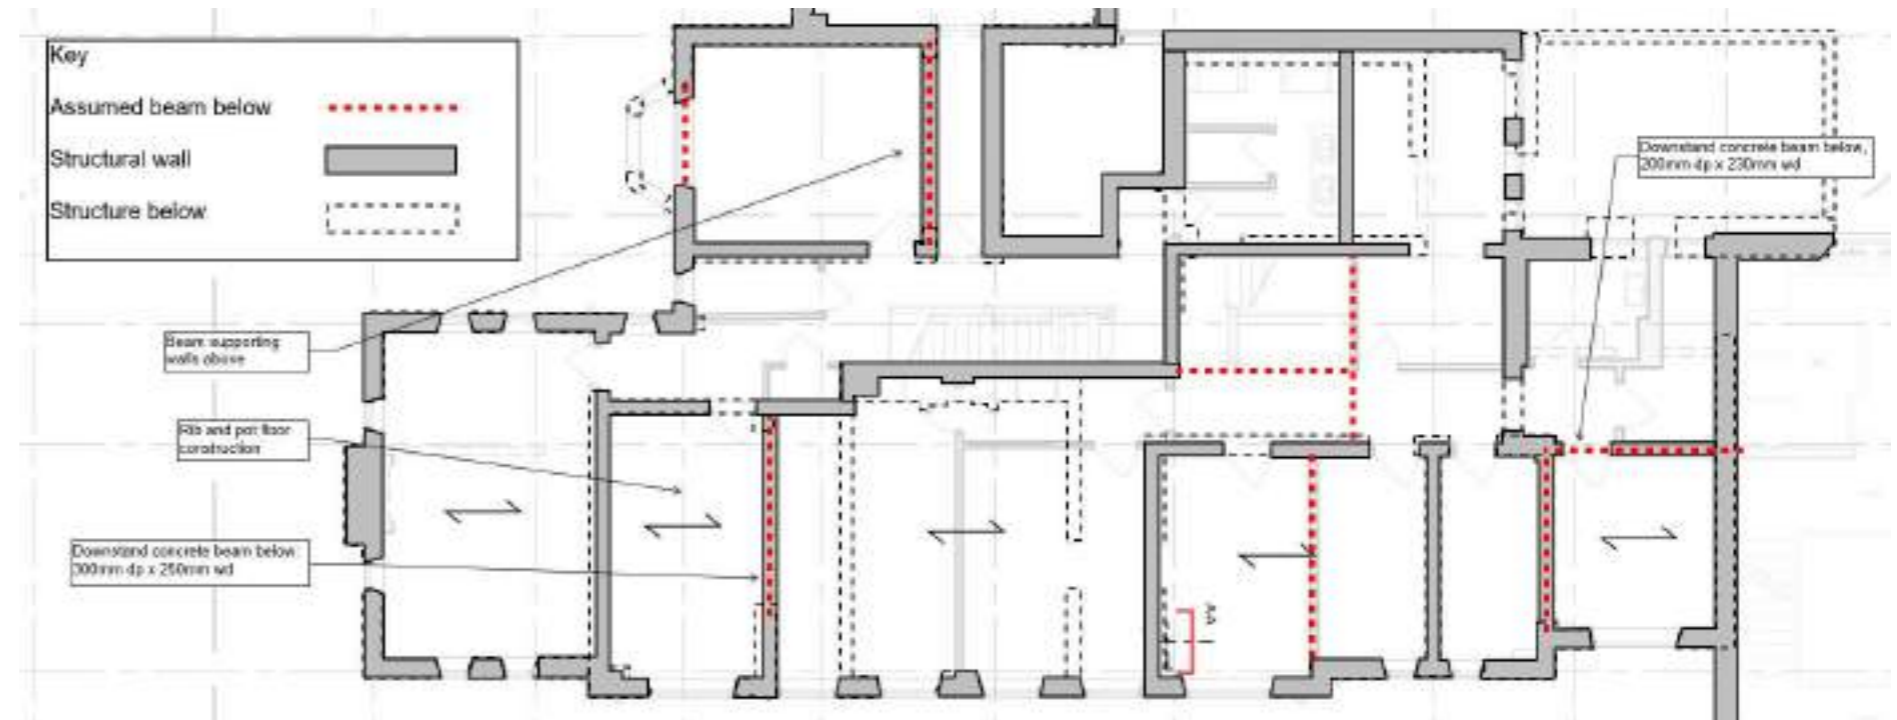
Extract from SK87 showing general layout of existing George House structure. Note: spans of rib and pot floors assumed

In George House many of the non-structural walls will be removed to create open spaces for classrooms. Where a structural vertical loadbearing wall is removed a new steel beam will replace the action of the former masonry wall. Windposts may be required to provide lateral support to external walls where partitions are being removed. A small area of timber joist infill floor is required at first floor level where a staircase is being removed.

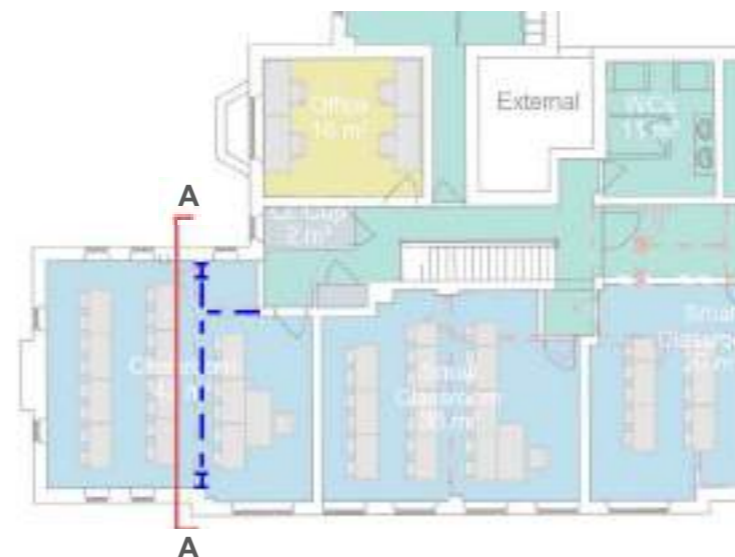
Extract from SK072 showing location of proposed steel frame

The most significant alteration to George House is the removal of a structural stability wall from ground to roof level, located to the south end of the building. It is proposed that this structural wall is replaced with a steel moment frame with design criteria similar to that described in section 10.2.1 regarding the steel frames proposed in the wing of the Main Building.

According to information gathered from the point cloud survey the available headroom in George House is generally greater than in the Main Building, allowing for UB sections to be utilised at ground and first floor. The headroom reduces at second floor level and so a UC section has been used at this level.

The installation method and sequencing is a key consideration for the proposed frame. An external scaffold designed to provide lateral stability in the temporary condition will be required. With appropriate propping, steels to be craned into position from above through openings forming in the floors, ideally through the 'pots'. The steel beams would then be loaded in through window openings at each level and lifted into position. If openings are formed through the roof, consideration would need to be given to reinstatement of roof finishes and waterproofing as disruption may void its warranty.

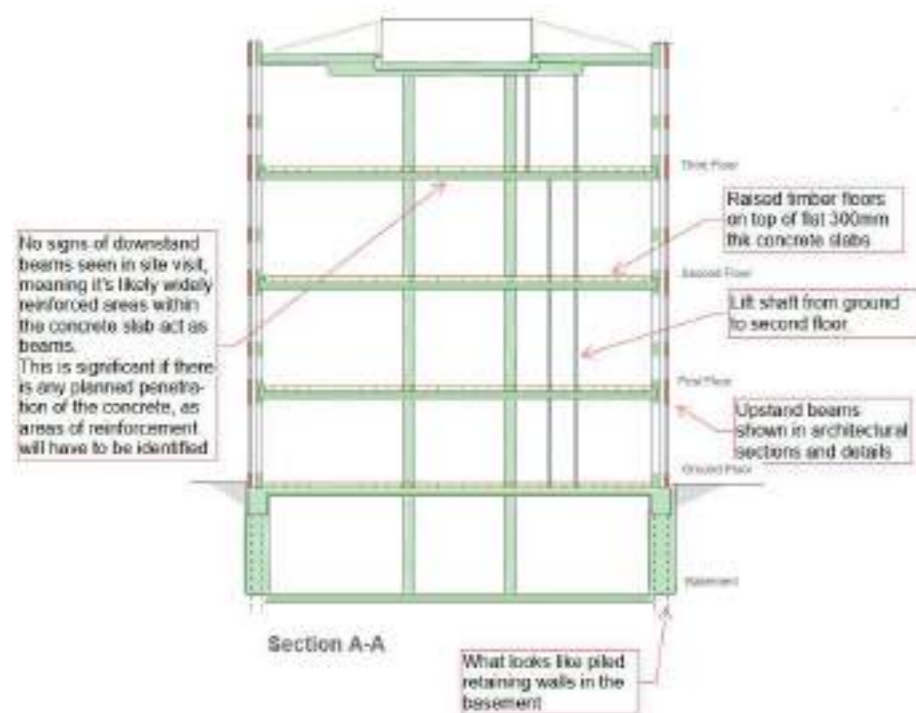
Extract from SK14 of existing section through Library building

No downstands are visible in the slab soffits. It is therefore likely that heavily reinforced beam strips exist within the slab. Records of architectural details show RC upstand beams at each level to the slab perimeter within the slab external wall zone.

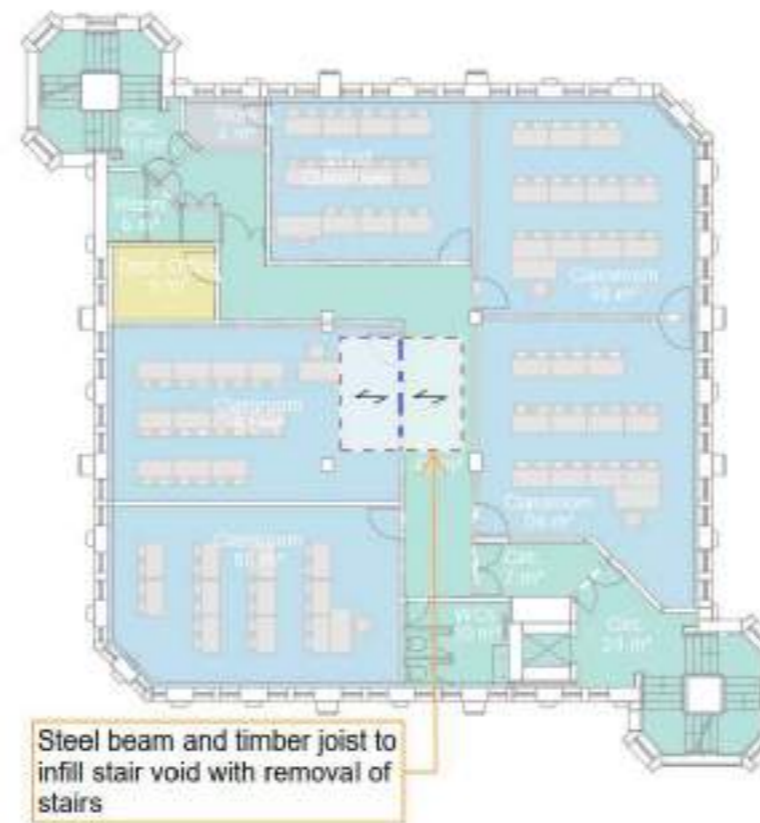
Extract from SK75 showing stair infill structure in Library building

As noted, it is likely that heavily reinforced beam strips exist within the slabs. This will be significant for any new penetrations proposed through the existing concrete floors.

The removal of the central staircore from ground to second floor will require infill structure. At first floor a steel beam is proposed to divide the void span in two as well as being positioned below the new partition line. Timber joists will be used to infill the void.

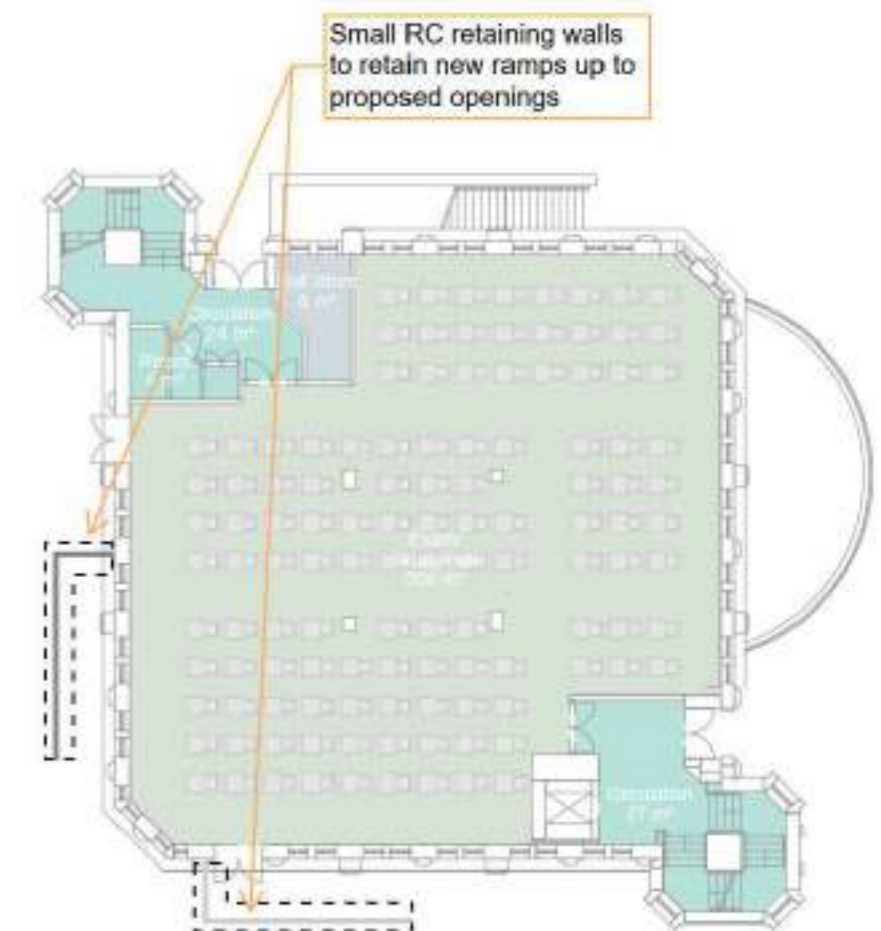
At ground floor two new doorways are proposed which require new ramps externally. Small RC retaining walls will be required to retain these ramps.

Extract from SK75 showing stair infill structure in Library building
