SuDS Management and Maintenance Plan 5802_TW10_London_06.1

Site Address: 28 Friars Stile Road
London
TW10 6NE

Project: SuDS Maintenance Plan

Reference: 5802_SW13_London_06.1

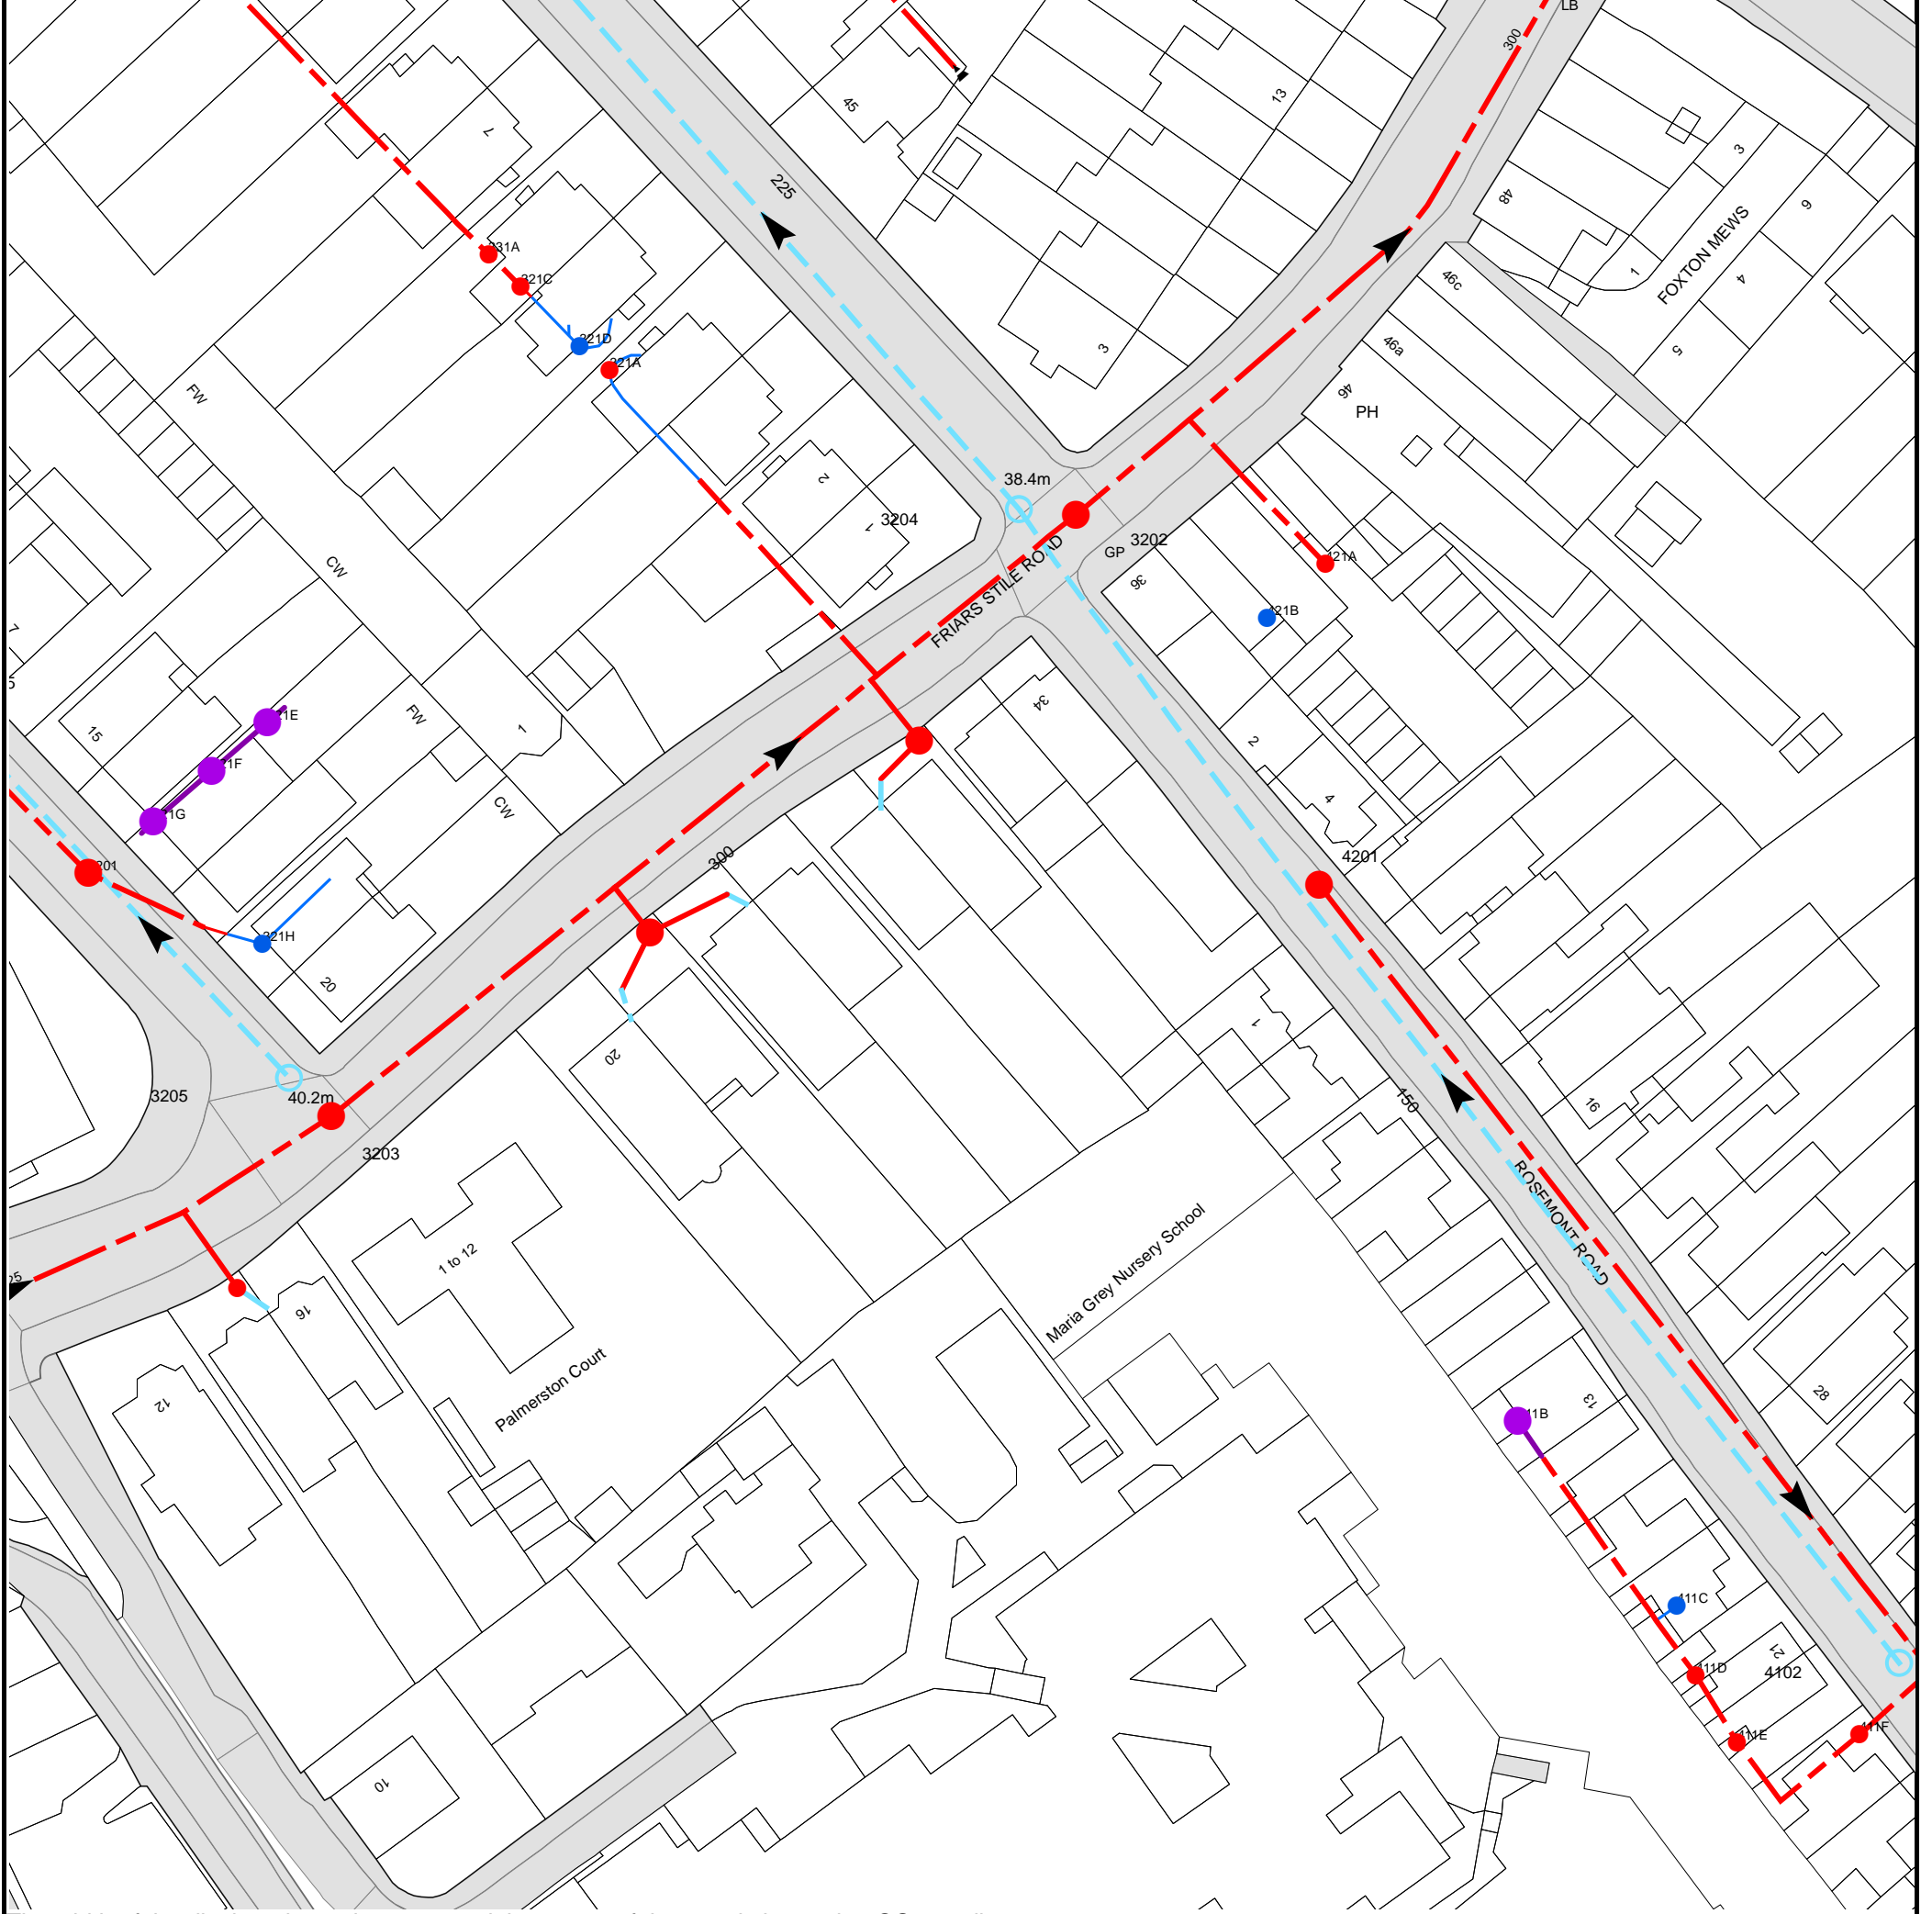
Asset Location Search Sewer Map - ALS/ALS Standard/2023 4921659

The width of the displayed area is 200 m and the centre of the map is located at OS coordinates 518386,174228

6) The text appearing alongside a sewer line indicates the internal diameter of the pipe in millimeters. Text next to a manhole indicates the manhole reference number and should not be taken as a measurement. If you are unsure about any text or symbology, please contact Property Searches on 0800 009 4540.

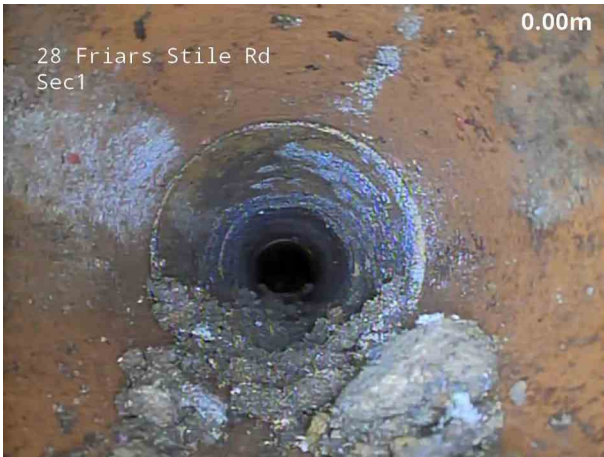
1, 00:01:12, 0.10 m
Settled deposits, coarse, 20% cross-sectional area loss, start

No.	m+	Code	Observation
1	0.00	MH	Start node, manhole, reference: MH3
2	0.00	WL	Water level, 0% of the vertical dimension
3	0.10	DER	Settled deposits, coarse, 20% cross-sectional area loss, start
4	0.70	DER	Settled deposits, coarse, 10% cross-sectional area loss, change
5	1.70	FCJ	Fracture, circumferential at joint from 9 o'clock to 5 o'clock
6	2.40	DER	Settled deposits, coarse, 40% cross-sectional area loss, change
7	3.00	DER	Settled deposits, coarse, 70% cross-sectional area loss, change
8	3.10	DER	Settled deposits, coarse, 70% cross-sectional area loss, finish
9	3.12	SA	Survey abandoned

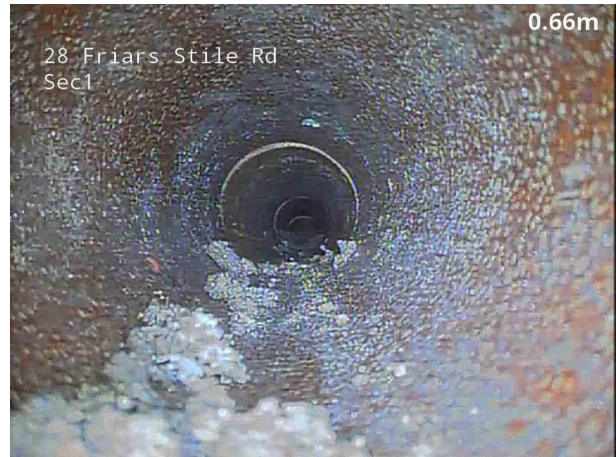
2, 00:01:01, 0.70 m
Settled deposits, coarse, 10% cross-sectional area loss, change

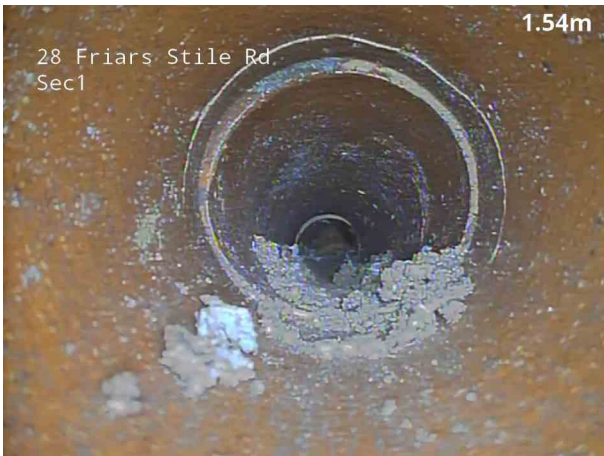
3, 00:00:52, 1.70 m
Fracture, circumferential at joint from 9 o'clock to 5 o'clock

Section	PLR	Grade	Description
1	AX	3	Fracture, circumferential at joint from 9 o'clock to 5 o'clock
4	MH2X	3	Fracture, circumferential at joint from 8 o'clock to 4 o'clock
5	MH1X	3	Multiple defects

<table><tr> <td style="text-align: right;">0.00</td> <td>MH</td> <td>Start node, manhole, reference: MH3</td> <td>00:00:00</td> <td></td> <td></td> </tr><tr> <td style="text-align: right;">1.70</td> <td>FCJ</td> <td>Fracture, circumferential at joint from 9 o'clock to 5 o'clock</td> <td>00:00:52</td> <td>3</td> <td>3 / 2</td> </tr></table>

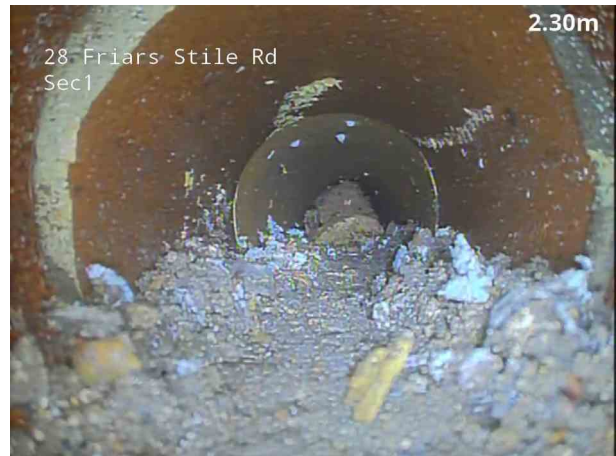
4, 00:00:40, 2.40 m
Settled deposits, coarse, 40% cross-sectional area loss, change

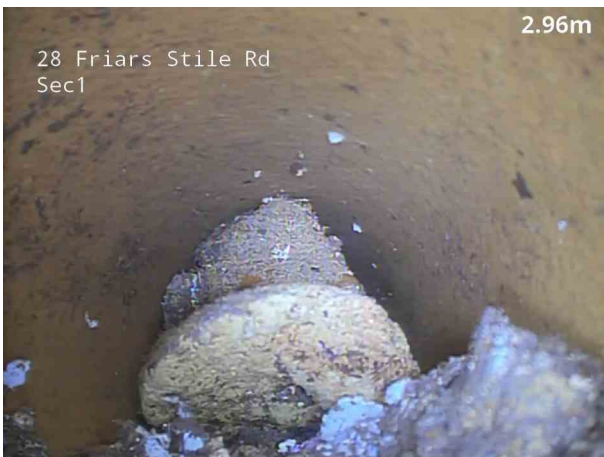
5, 00:00:27, 3.00 m
Settled deposits, coarse, 70% cross-sectional area loss, change

Section	PLR	Grade	Description
1	AX	4	Settled deposits, coarse, 70% cross-sectional area loss, finish
3	MH3X	4	Attached deposits, encrustation at joint from 4 o'clock to 8 o'clock, 30% cross-sectional area loss
4	MH2X	3	Multiple defects
5	MH1X	3	Attached deposits, encrustation at joint from 4 o'clock to 7 o'clock, 5% cross-sectional area loss

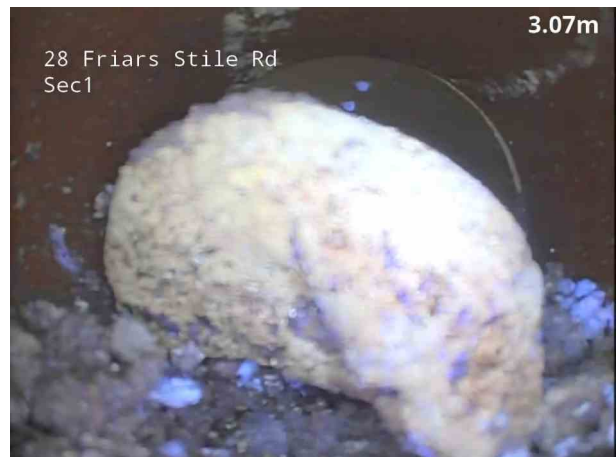
6, 00:00:21, 3.12 m
Survey abandoned, Unable to proceed, assumed redundant.

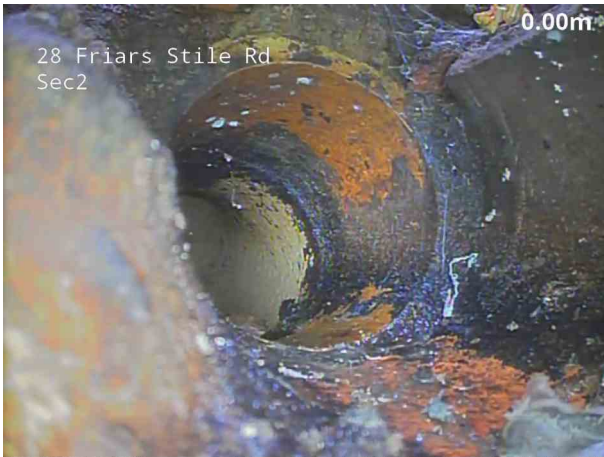
1, 00:00:17, 0.00 m
Water level, 0% of the vertical dimension

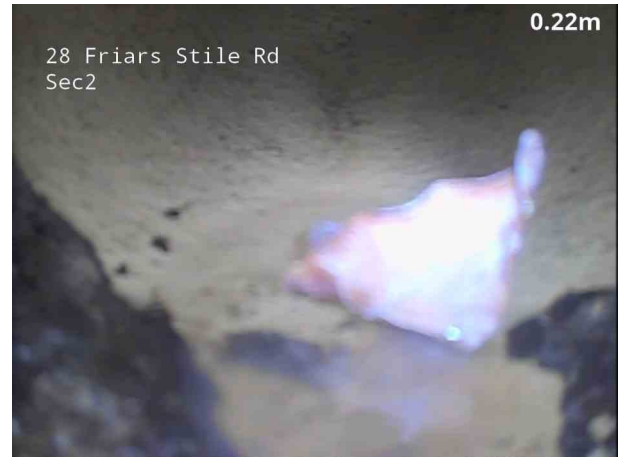
2, 00:00:28, 0.20 m
Line deviates up

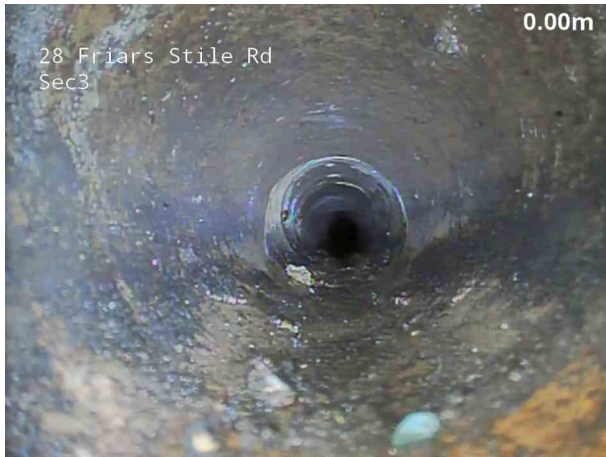
1, 00:01:37, 0.00 m
Water level, 0% of the vertical dimension

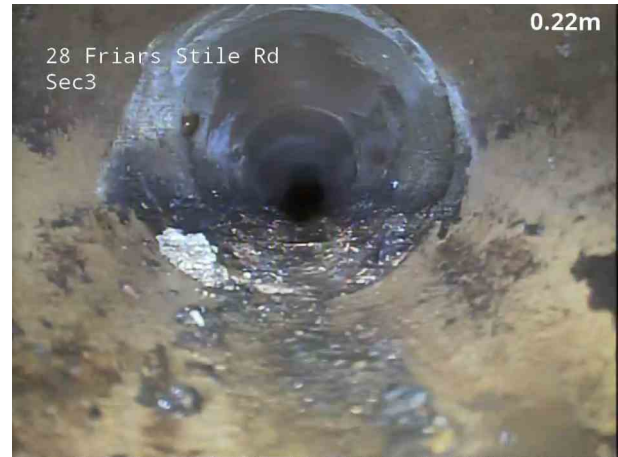
2, 00:01:30, 0.30 m
Attached deposits, encrustation at joint from 4 o'clock to 8 o'clock, 15% cross-sectional area loss

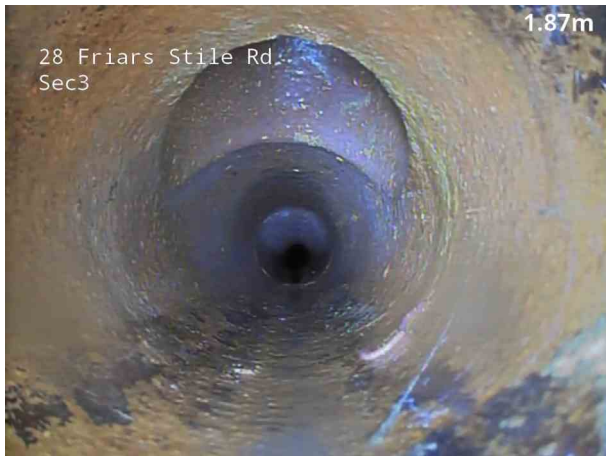
3, 00:01:22, 2.10 m
Junction at 12 o'clock, 100mm dia, Serving WC

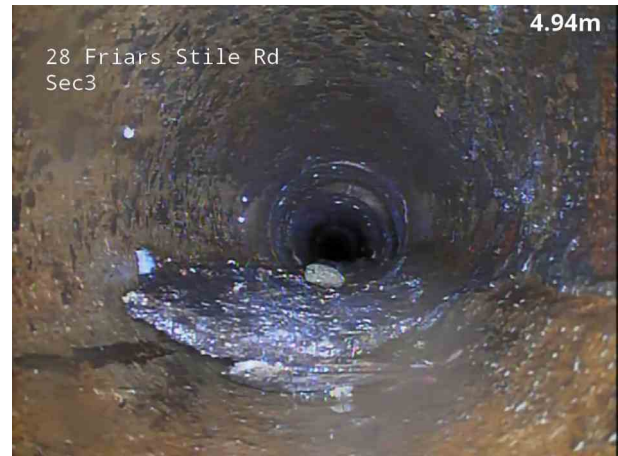
4, 00:00:56, 5.10 m
Attached deposits, encrustation from 4 o'clock to 8 o'clock, 20% cross-sectional area loss

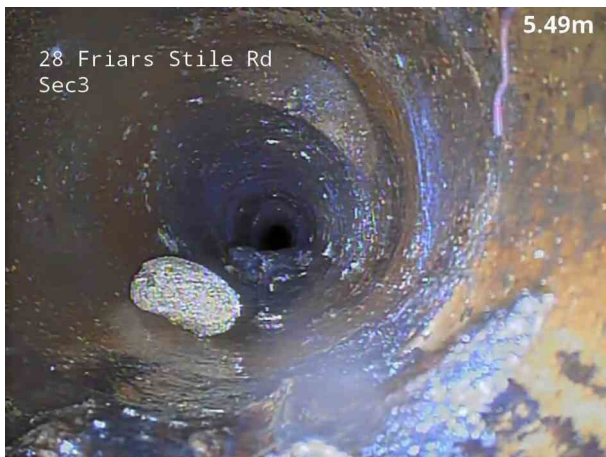
5, 00:00:51, 5.70 m
Junction at 2 o'clock, 100mm dia, Serving SVP

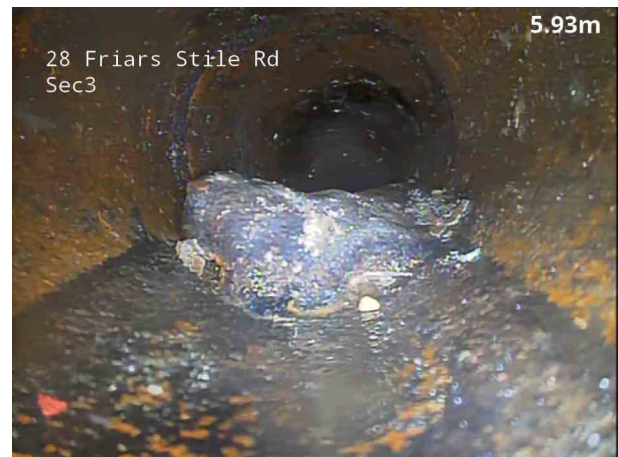
6, 00:00:40, 6.10 m
Attached deposits, encrustation at joint from 4 o'clock to 8 o'clock, 30% cross-sectional area loss

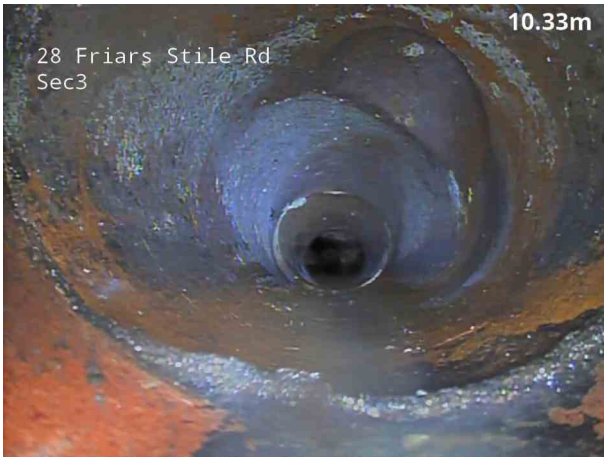
7, 00:00:10, 10.50 m
Junction at 2 o'clock, 100mm dia, Serving CWG

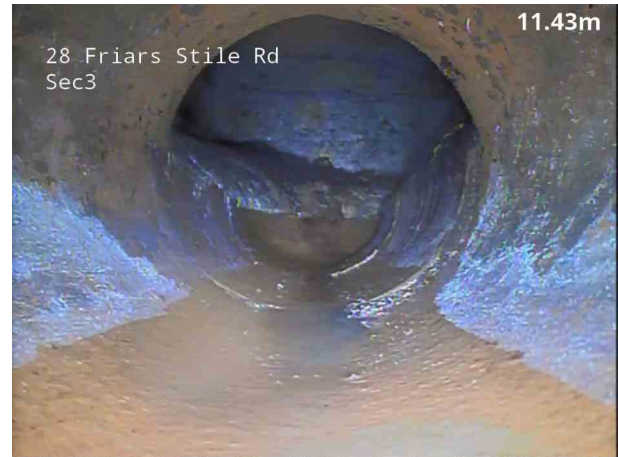
8, 00:00:00, 11.60 m
Finish node, manhole, reference: MH2

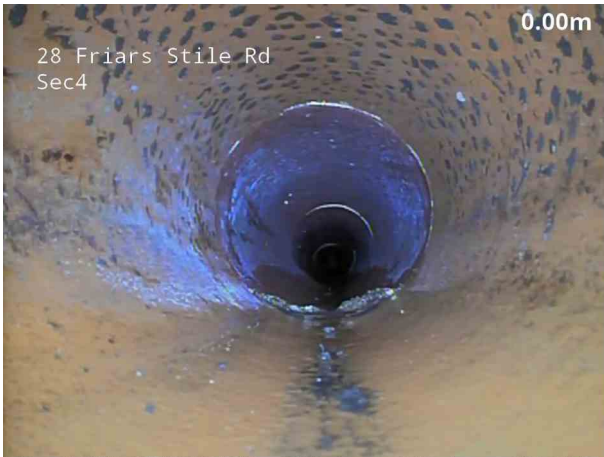
1, 00:00:14, 0.00 m
Water level, 0% of the vertical dimension

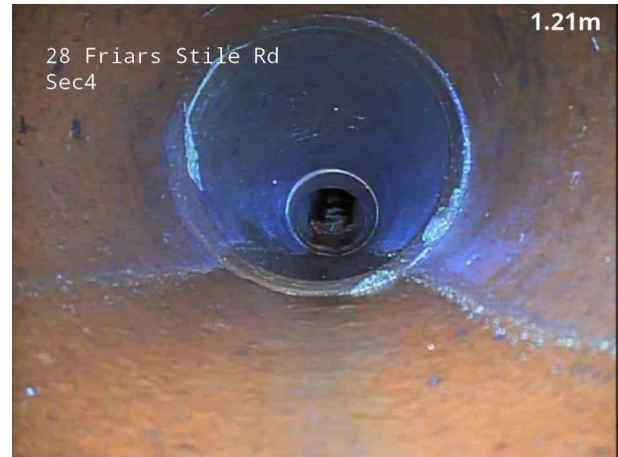
2, 00:00:29, 1.40 m
Fracture, circumferential at joint from 8 o'clock to 4 o'clock

No.	m+	Code	Observation
1	0.00	MH	Start node, manhole, reference: MH2
2	0.00	WL	Water level, 0% of the vertical dimension
3	1.40	FCJ	Fracture, circumferential at joint from 8 o'clock to 4 o'clock
4	2.40	JN	Junction at 3 o'clock, 100mm dia
5	2.50	DEE	Attached deposits, encrustation from 5 o'clock to 7 o'clock, 5% cross-sectional area loss, start
6	5.60	WL	Water level, 10% of the vertical dimension
7	5.80	DEE	Attached deposits, encrustation from 4 o'clock to 8 o'clock, 15% cross-sectional area loss, change
8	6.00	DEE	Attached deposits, encrustation from 4 o'clock to 8 o'clock, 15% cross-sectional area loss, finish
9	6.90	DEE	Attached deposits, encrustation from 3 o'clock to 6 o'clock, 10% cross-sectional area loss
10	7.60	WL	Water level, 5% of the vertical dimension
11	7.90	MHF	Finish node, manhole, reference: MH1

<table><tr> <td style="text-align: center;">0.00</td> <td style="text-align: center;">MH</td> <td>Start node, manhole, reference: MH2</td> <td style="text-align: center;">00:00:00</td> <td></td> <td></td> <td></td> </tr><tr> <td style="text-align: center;">1.40</td> <td style="text-align: center;">FCJ</td> <td>Fracture, circumferential at joint from 8 o'clock to 4 o'clock</td> <td style="text-align: center;">00:00:29</td> <td style="text-align: center;">2</td> <td style="text-align: center;">3 / 2</td> <td></td> </tr></table>

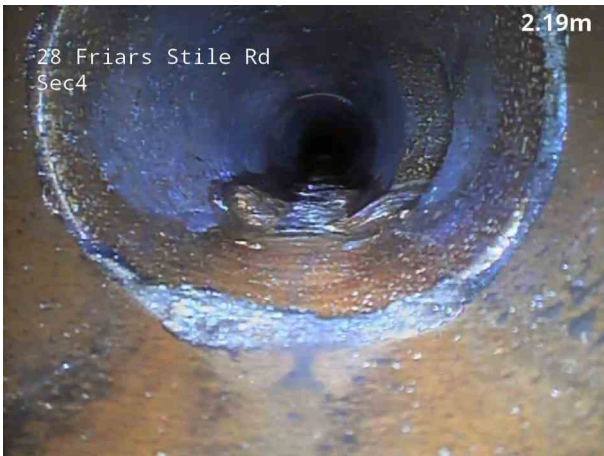
3, 00:00:42, 2.40 m
Junction at 3 o'clock, 100mm dia, Serving basement gully.

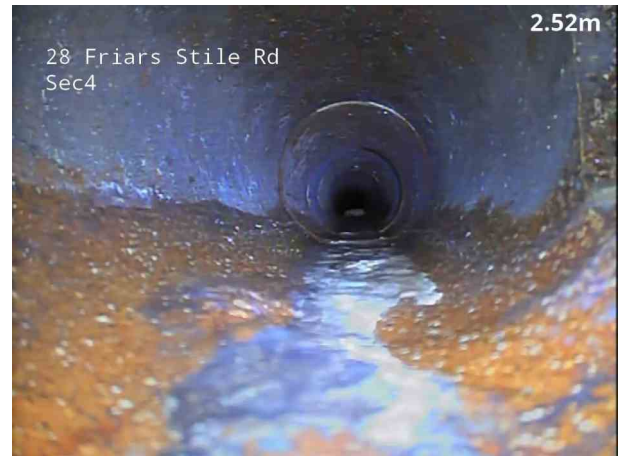
4, 00:00:47, 2.50 m
Attached deposits, encrustation from 5 o'clock to 7 o'clock, 5% cross-sectional area loss, start

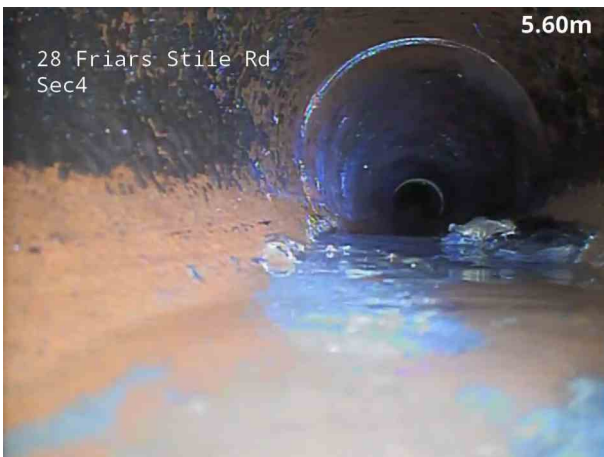
5, 00:01:23, 5.80 m
Attached deposits, encrustation from 4 o'clock to 8 o'clock, 15% cross-sectional area loss, change

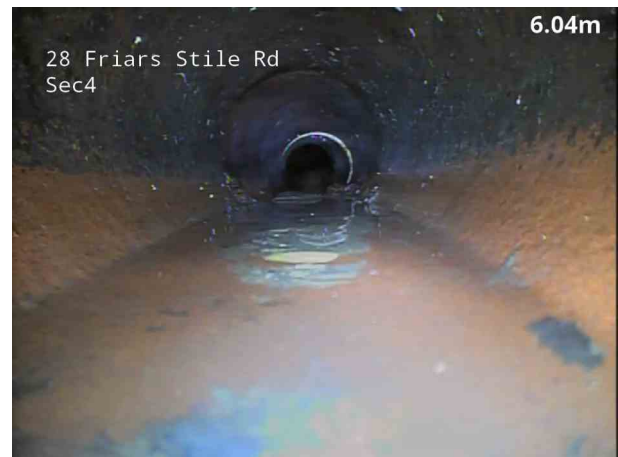
6, 00:01:35, 6.00 m
Attached deposits, encrustation from 4 o'clock to 8 o'clock, 15% cross-sectional area loss, finish

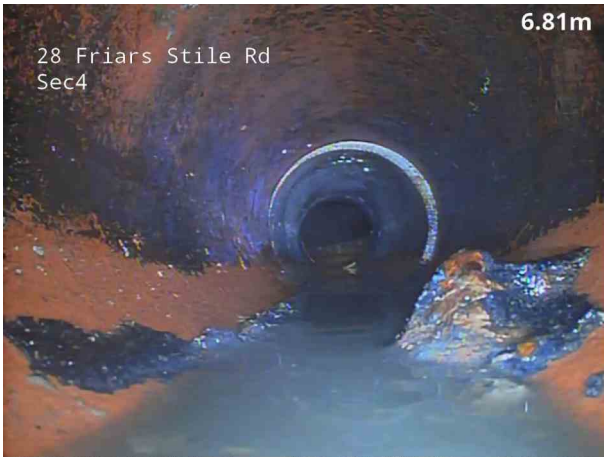
7, 00:02:12, 6.90 m
Attached deposits, encrustation from 3 o'clock to 6 o'clock,
10% cross-sectional area loss

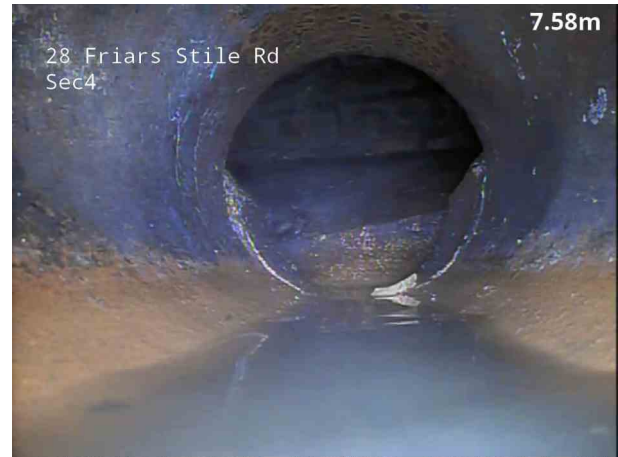
8, 00:02:02, 7.60 m
Water level, 5% of the vertical dimension

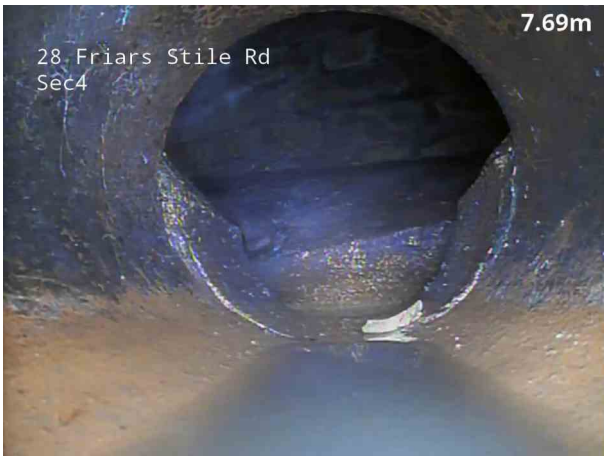
9, 00:01:59, 7.90 m
Finish node, manhole, reference: MH1, Located within
neighbouring garden.

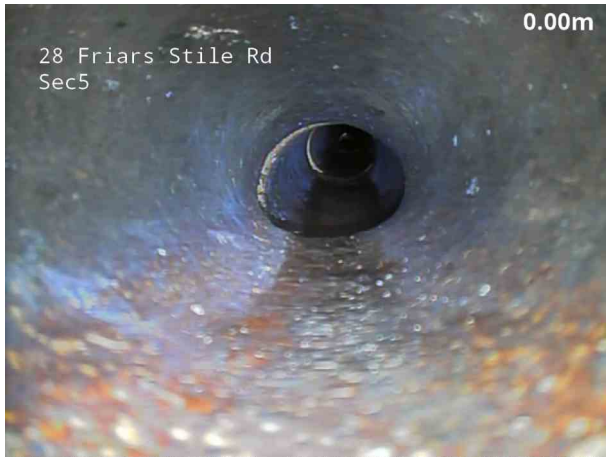
1, 00:01:27, 0.00 m
Water level, 0% of the vertical dimension

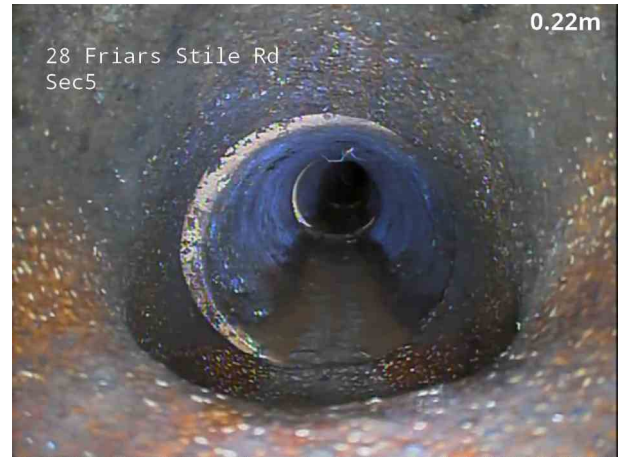
2, 00:01:06, 0.30 m
General remark, Interceptor trap.

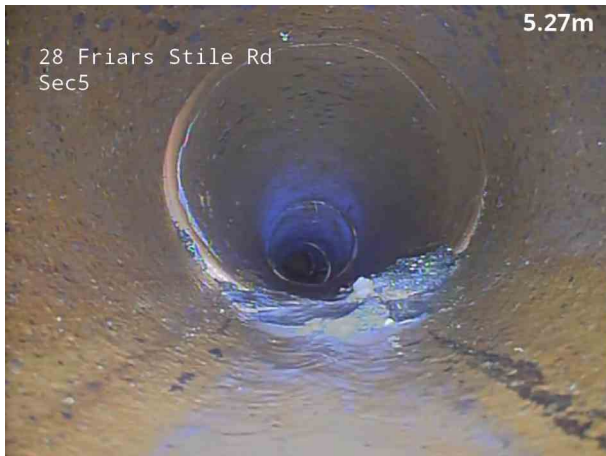
3, 00:00:32, 5.50 m
Fracture, circumferential at joint from 7 o'clock to 3 o'clock

<table><tr> <td style="text-align: center;">0.00</td> <td style="text-align: center;">MH</td> <td>Start node, manhole, reference: MH1</td> <td style="text-align: center;">00:00:00</td> <td></td> <td></td> <td></td> </tr><tr> <td style="text-align: center;">5.50</td> <td style="text-align: center;">FCJ</td> <td>Fracture, circumferential at joint from 7 o'clock to 3 o'clock</td> <td style="text-align: center;">00:00:32</td> <td style="text-align: center;">3</td> <td></td> <td style="text-align: center;">3 / 2</td> </tr></table>

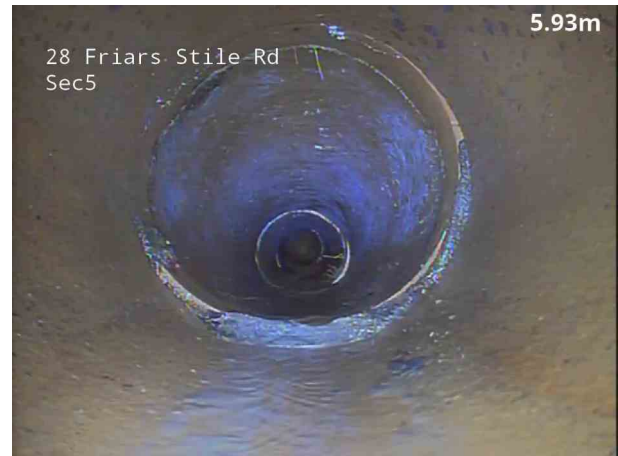
4, 00:00:28, 6.10 m
Fracture, circumferential at joint from 12 o'clock to 12 o'clock

<table><tr> <td style="text-align: center;">0.00</td> <td style="text-align: center;">MH</td> <td>Start node, manhole, reference: MH1</td> <td style="text-align: center;">00:00:00</td> <td></td> <td></td> <td></td> </tr><tr> <td style="text-align: center;">6.10</td> <td style="text-align: center;">FCJ</td> <td>Fracture, circumferential at joint from 12 o'clock to 12 o'clock</td> <td style="text-align: center;">00:00:28</td> <td style="text-align: center;">4</td> <td></td> <td style="text-align: center;">3 / 2</td> </tr></table>

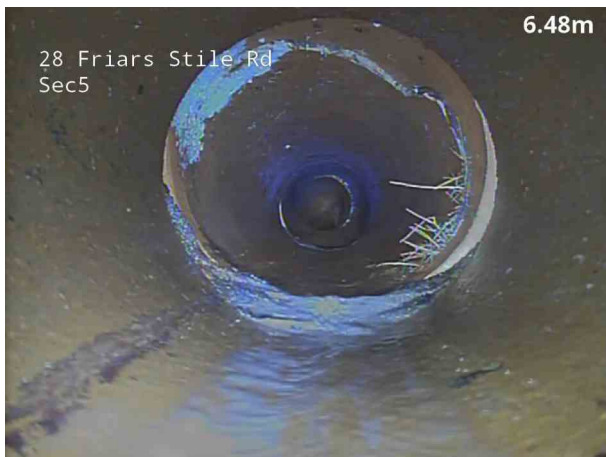
5, 00:00:23, 6.70 m
Fracture, circumferential at joint from 12 o'clock to 12 o'clock

<table><tr> <td style="text-align: center;">0.00</td> <td style="text-align: center;">MH</td> <td>Start node, manhole, reference: MH1</td> <td style="text-align: center;">00:00:00</td> <td></td> <td></td> <td></td> </tr><tr> <td style="text-align: center;">6.70</td> <td style="text-align: center;">FCJ</td> <td>Fracture, circumferential at joint from 12 o'clock to 12 o'clock</td> <td style="text-align: center;">00:00:23</td> <td style="text-align: center;">5</td> <td></td> <td style="text-align: center;">3 / 2</td> </tr></table>

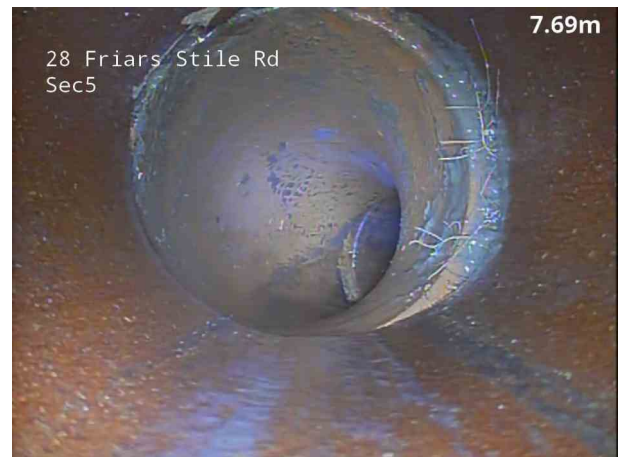
6, 00:00:13, 7.90 m
Roots, fine at joint

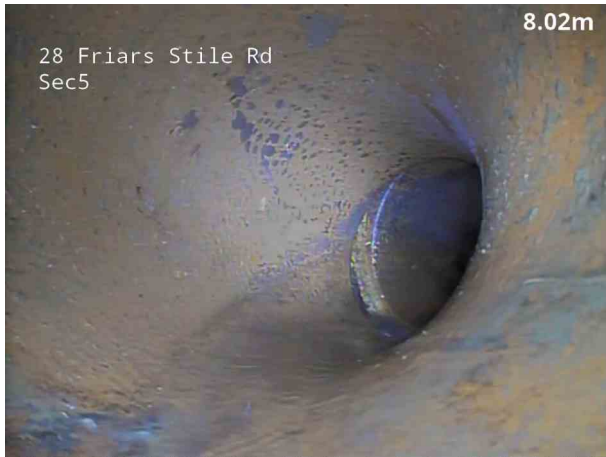
7, 00:00:11, 8.20 m
Line deviates right

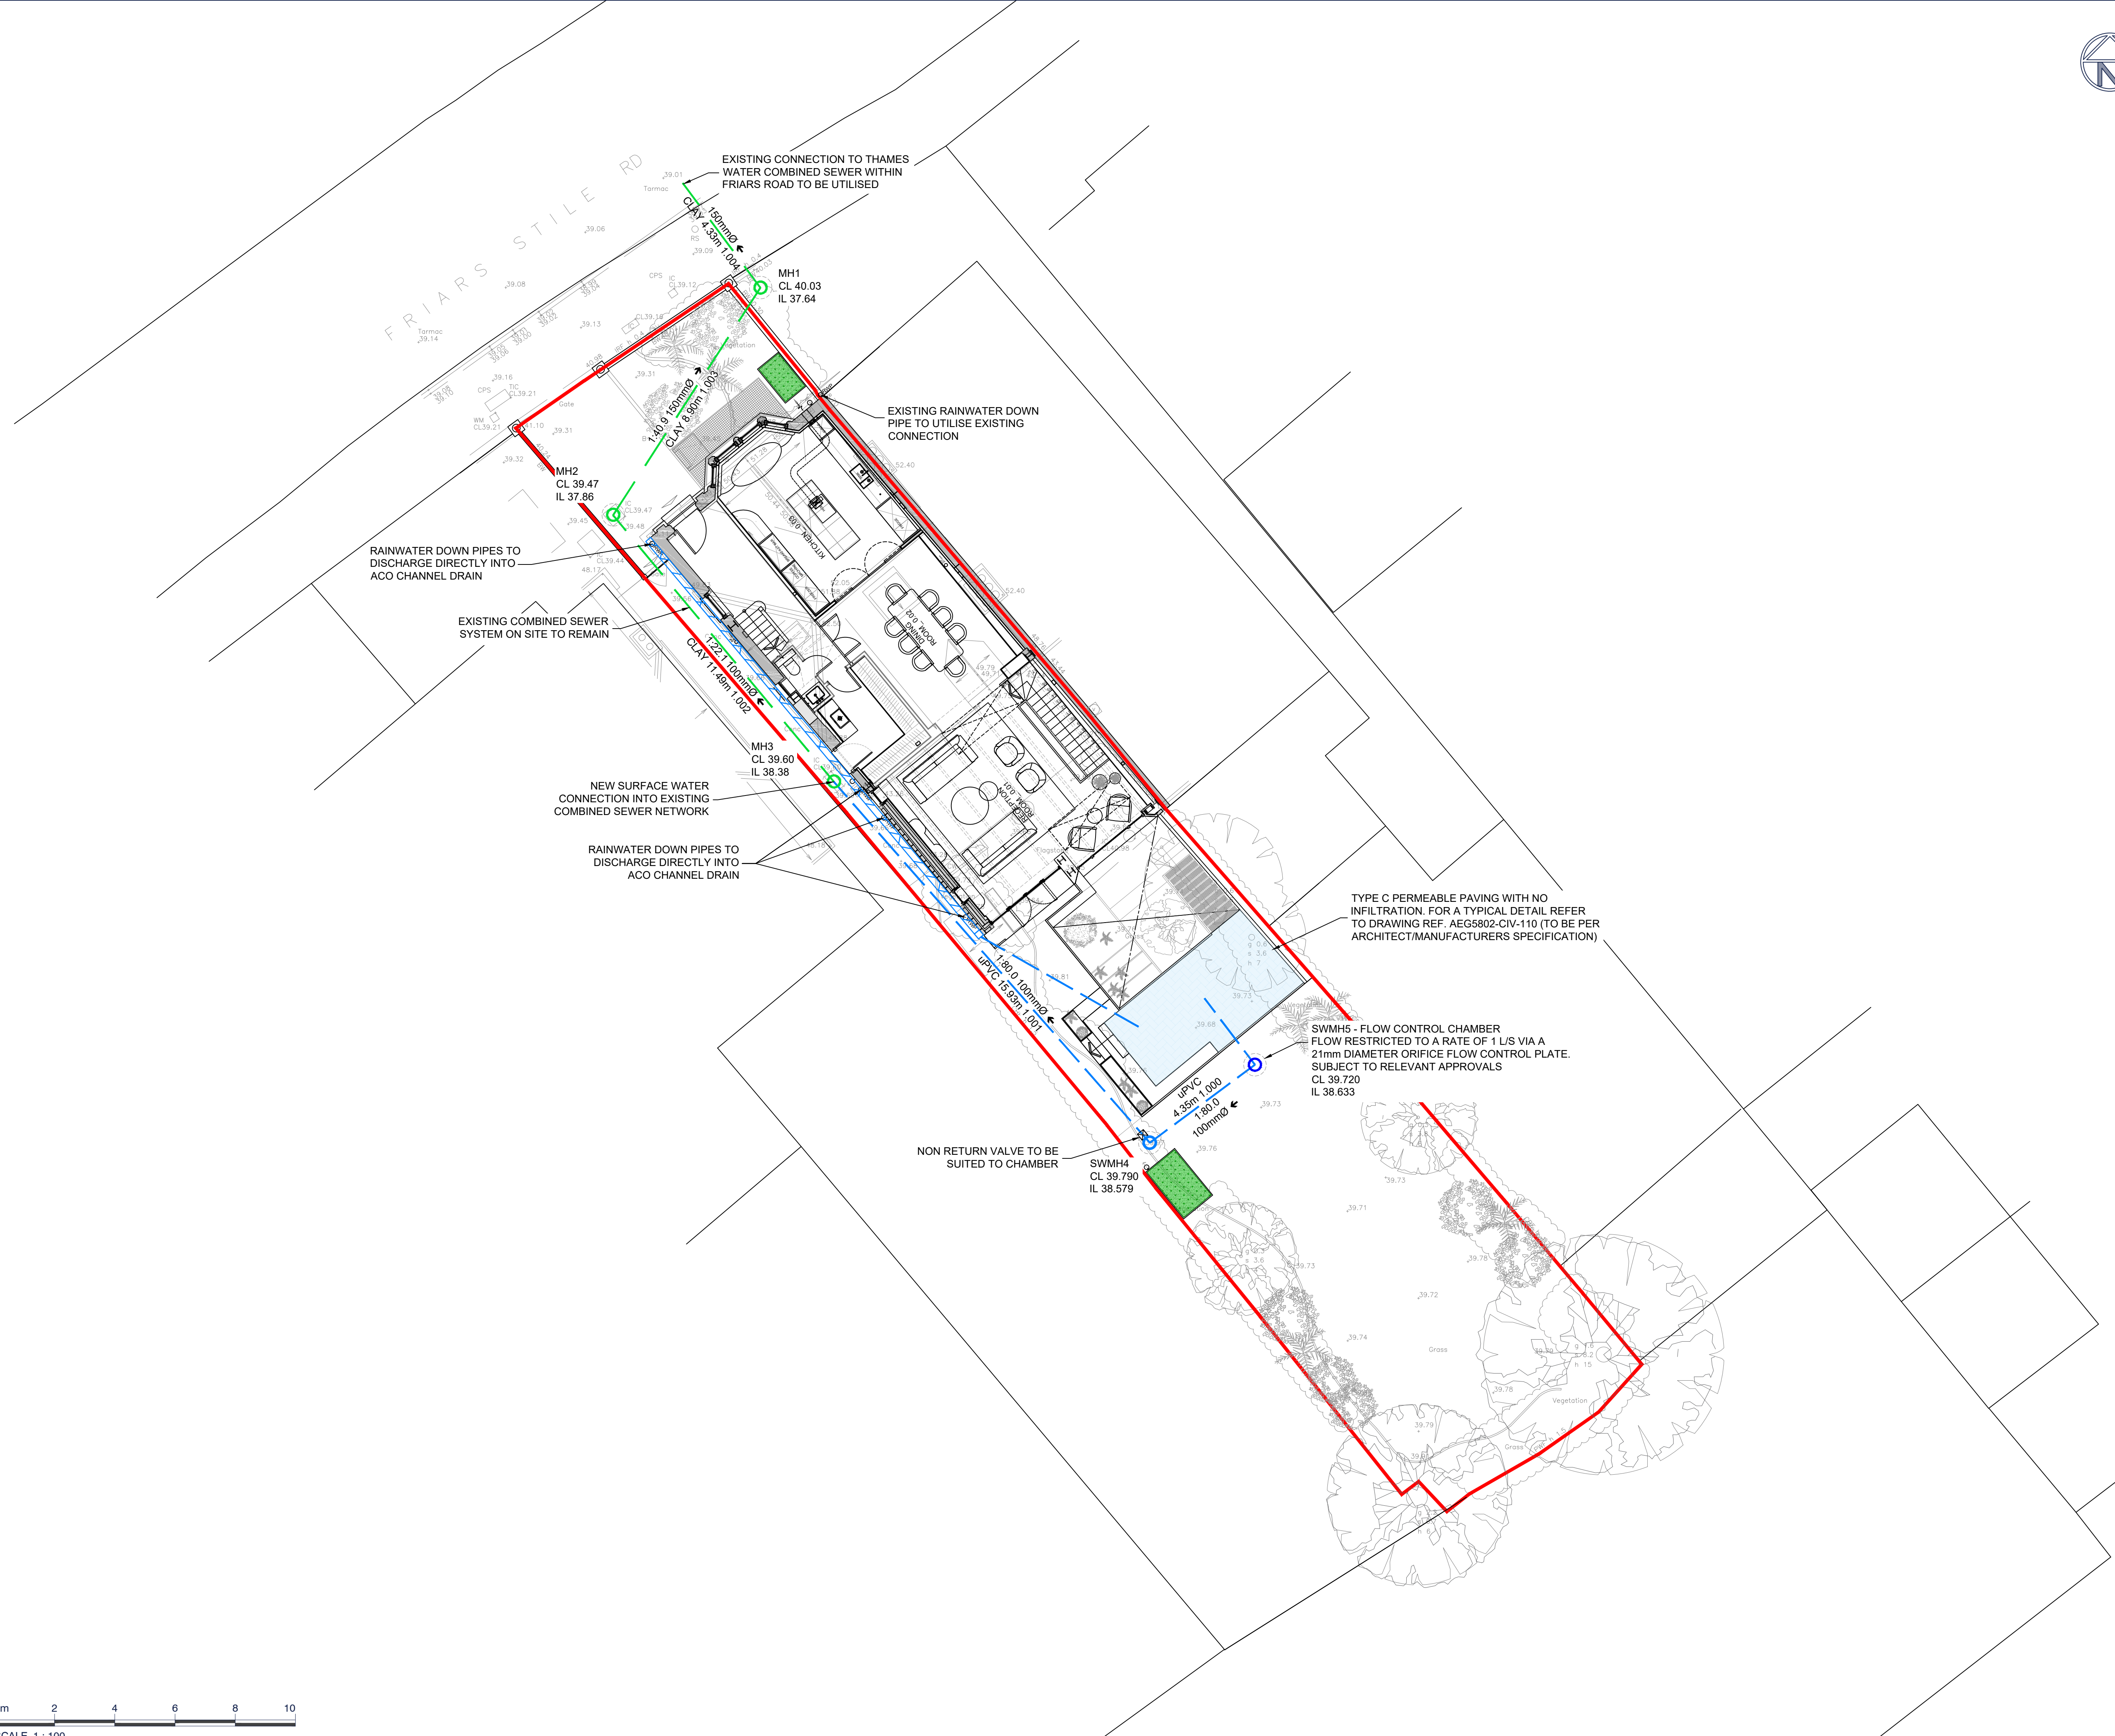
Project No.	Drawing No.	Revision		
AEG5802	CIV-100	A01		
Drawn	Checked	Approved	Date	Scale @ A1
CM	VW	JM	SEPT 2024	1:100

TYPE C PERMEABLE PAVING WITH NO INFILTRATION. FOR A TYPICAL DETAIL REFER TO DRAWING REF. AEG5802-CIV-110 (TO BE PER ARCHITECT/MANUFACTURERS SPECIFICATION)

SWMH5 - FLOW CONTROL CHAMBER
 FLOW RESTRICTED TO A RATE OF 1 L/S VIA A 21mm DIAMETER ORIFICE FLOW CONTROL PLATE. SUBJECT TO RELEVANT APPROVALS
 CL 39.720
 IL 38.633
