job title	Chapel in The Woods
client	St.Mary's University, Twickenham

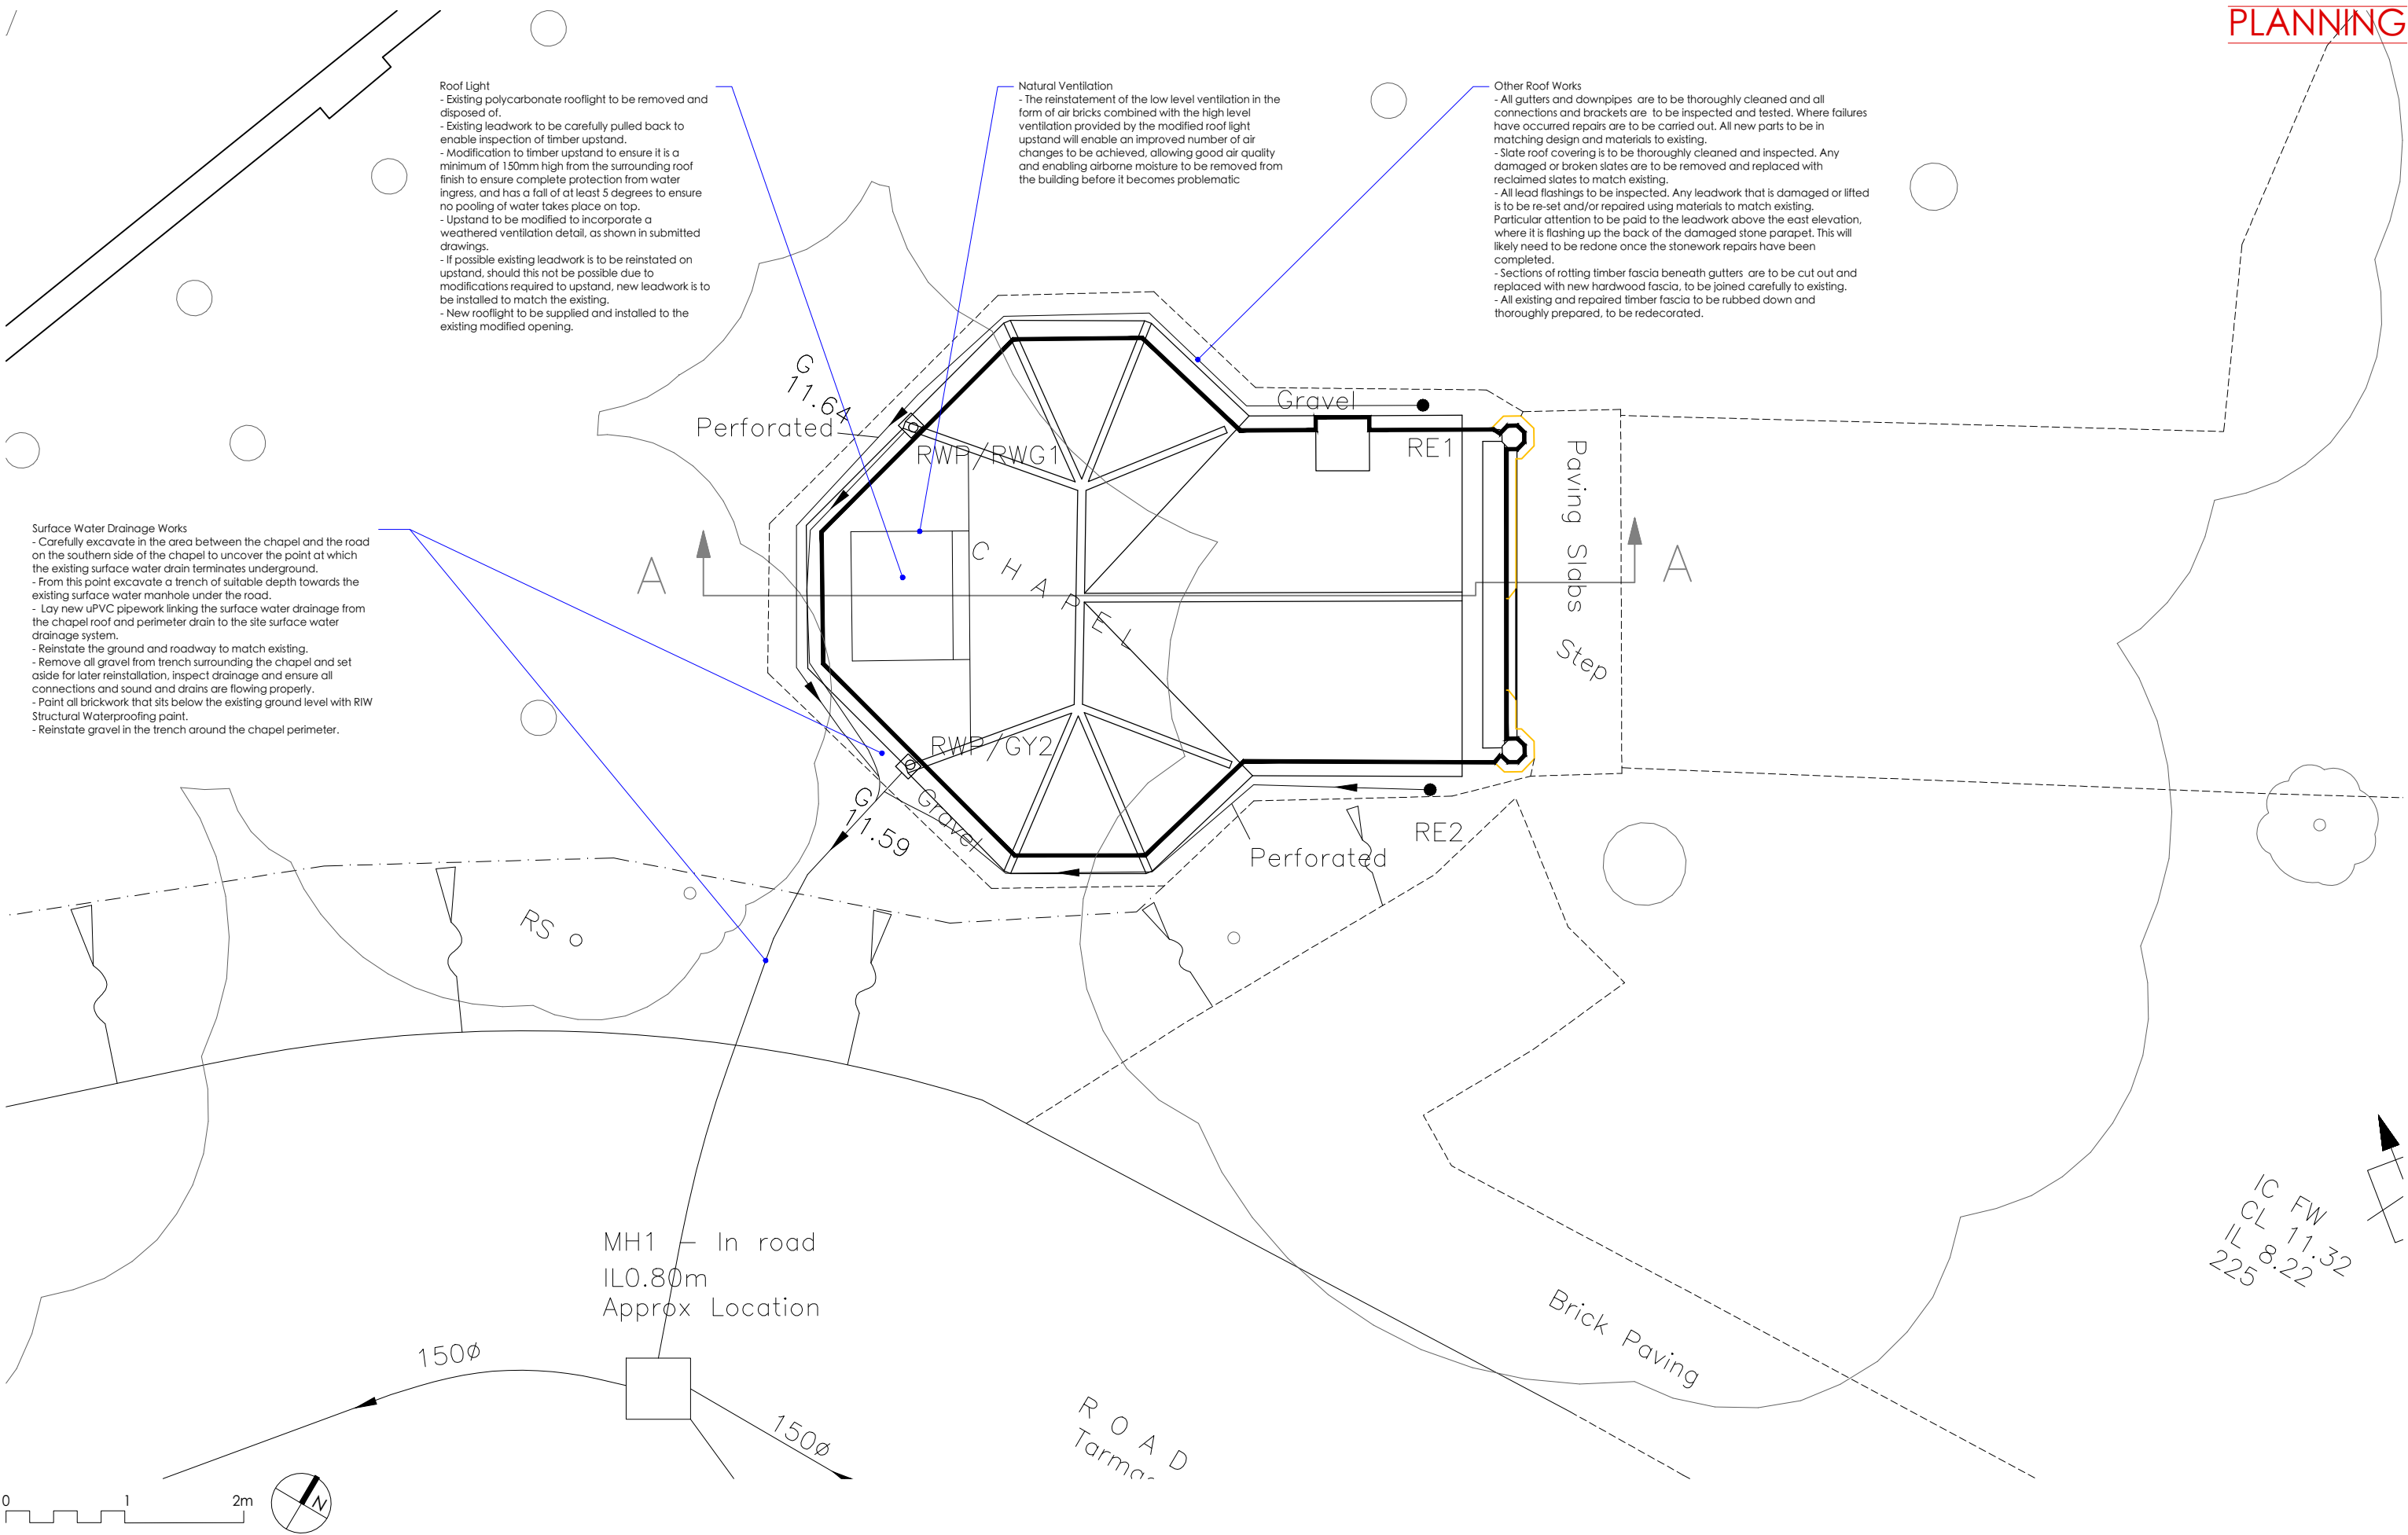
**Roof Light**

- Existing polycarbonate rooflight to be removed and disposed of.
- Existing leadwork to be carefully pulled back to enable inspection of timber upstand.
- Modification to timber upstand to ensure it is a minimum of 150mm high from the surrounding roof finish to ensure complete protection from water ingress, and has a fall of at least 5 degrees to ensure no pooling of water takes place on top.
- Upstand to be modified to incorporate a weathered ventilation detail, as shown in submitted drawings.
- If possible existing leadwork is to be reinstated on upstand, should this not be possible due to modifications required to upstand, new leadwork is to be installed to match the existing.
- New rooflight to be supplied and installed to the existing modified opening.

**Natural Ventilation**

- The reinstatement of the low level ventilation in the form of air bricks combined with the high level ventilation provided by the modified roof light upstand will enable an improved number of air changes to be achieved, allowing good air quality and enabling airborne moisture to be removed from the building before it becomes problematic

**Other Roof Works**

- All gutters and downpipes are to be thoroughly cleaned and all connections and brackets are to be inspected and tested. Where failures have occurred repairs are to be carried out. All new parts to be in matching design and materials to existing.

- Slate roof covering is to be thoroughly cleaned and inspected. Any damaged or broken slates are to be removed and replaced with reclaimed slates to match existing.

- All lead flashings to be inspected. Any leadwork that is damaged or lifted is to be re-set and/or repaired using materials to match existing. Particular attention to be paid to the leadwork above the east elevation, where it is flashing up the back of the damaged stone parapet. This will likely need to be redone once the stonework repairs have been completed.

- Sections of rotting timber fascia beneath gutters are to be cut out and replaced with new hardwood fascia, to be joined carefully to existing.
- All existing and repaired timber fascia to be rubbed down and thoroughly prepared, to be redecorated.
