**SOUTH ELEVATION - (COLONNADE NOT SHOWN)
PROPOSED EXTERNAL REPAIRS**

JOB TITLE:
KNELLER HALL

DRAWING TITLE:
SOUTH ELEVATION - PROPOSED EXTERNAL REPAIRS

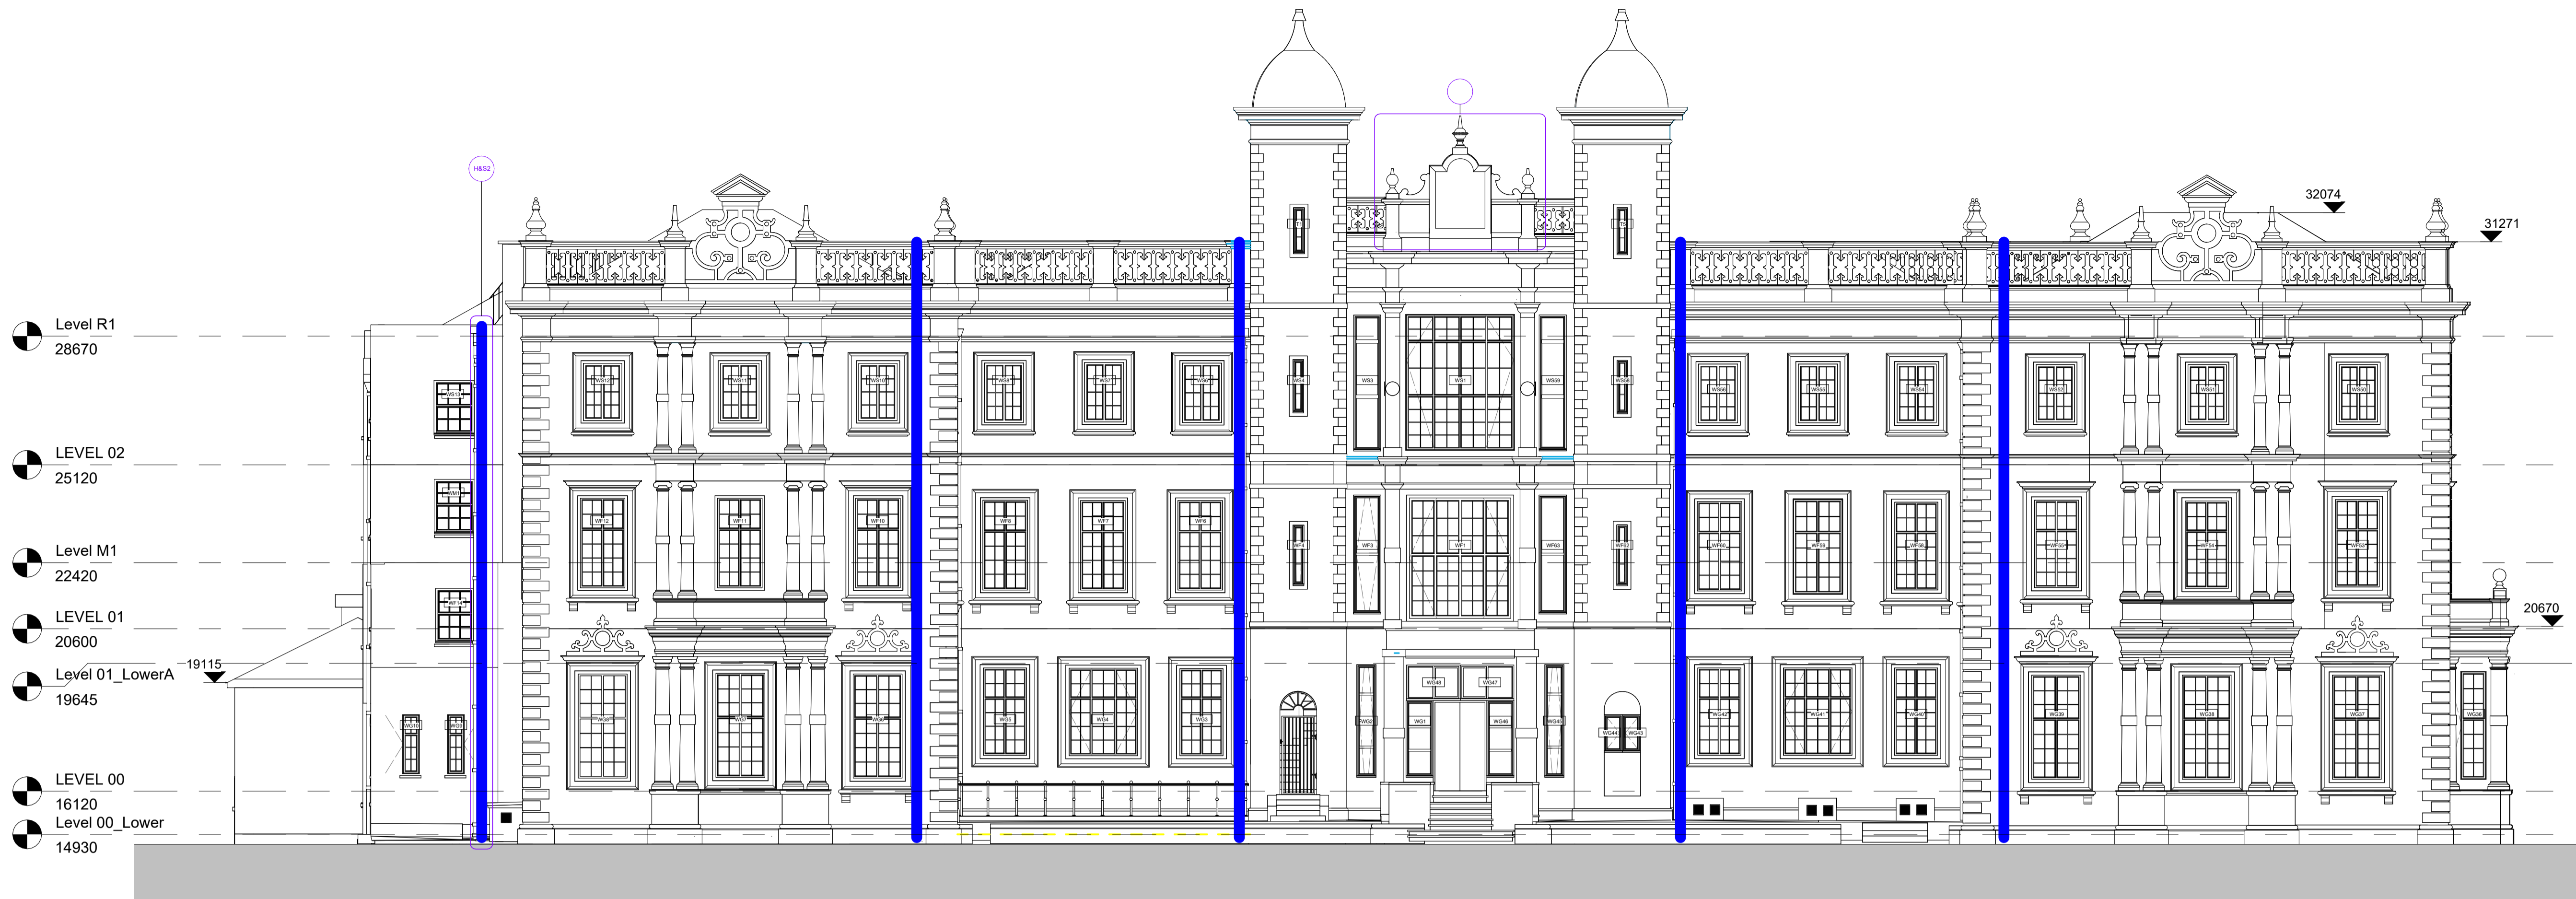
1
1 : 100

FOR THE PURPOSE OF THIS DRAWING THE COLONNADE HAS NOT BEEN SHOWN IN ORDER TO REVEAL THE PROPOSED REPAIRS ON THE GROUND FLOOR OF THE ELEVATIONS
THERE ARE NO EXTENSIONS/DEMOLITION OR ALTERATIONS
PLEASE REFER TO ADP-01-XX-DR-A-1211 FOR REPAIRS TO THE COLONNADE

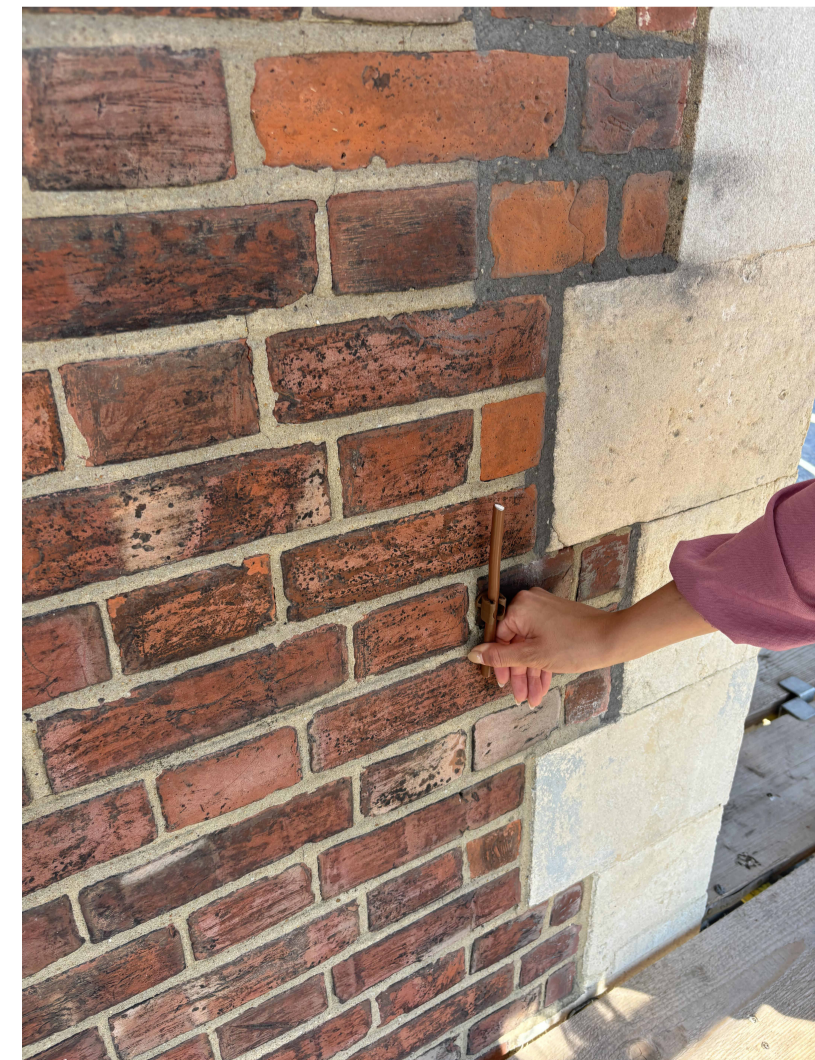
Image 1
Thin copper Lightening Protection tubes dropped down on elevations as per locations on drawing above

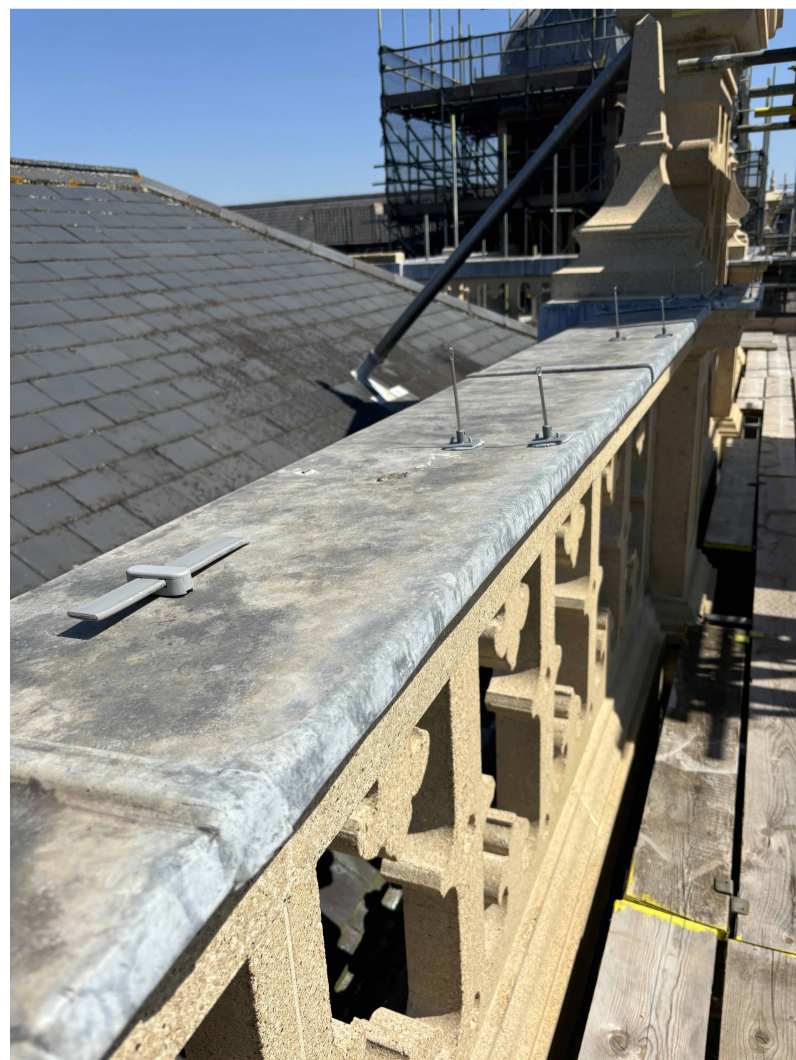
Image 2
Lightening Protection tape at roof level - refer to A-1005 & suppliers drawings for locations
