LISTED BUILDING APPLICATION

DRAWING TITLE:
EAST ELEVATION PROPOSED EXTERNAL REPAIRS

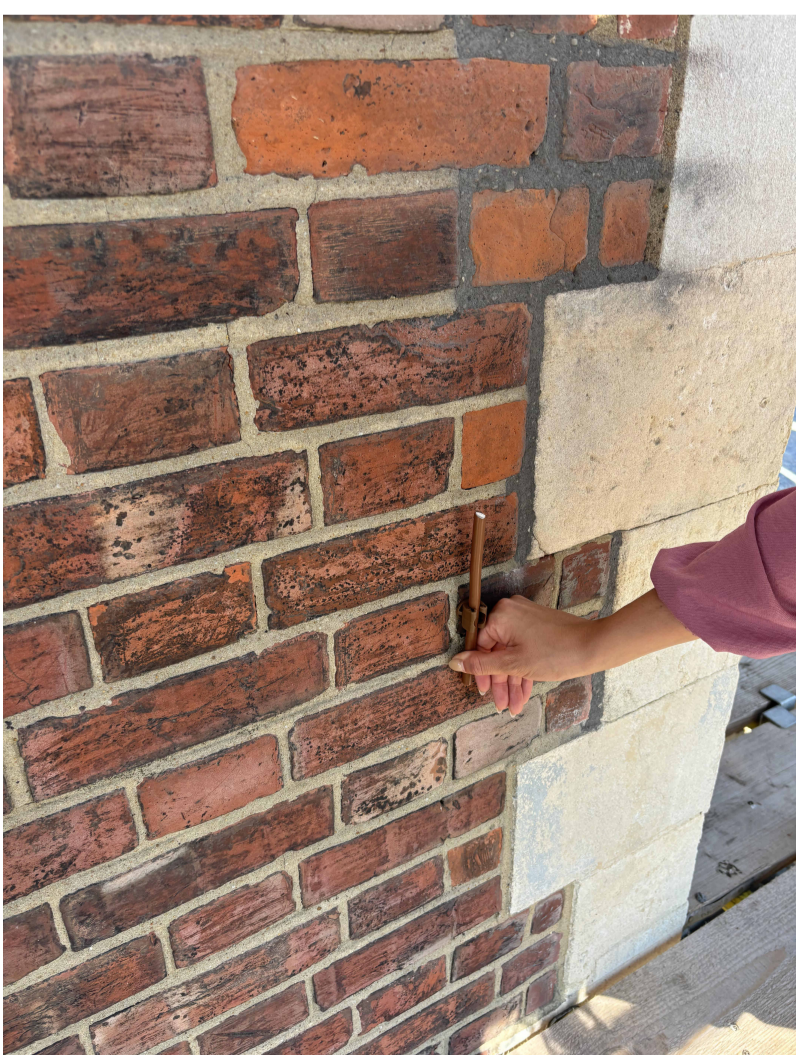
Image 1
Thin copper Lightning Protection tubes dropped down on elevations as per locations on drawing above

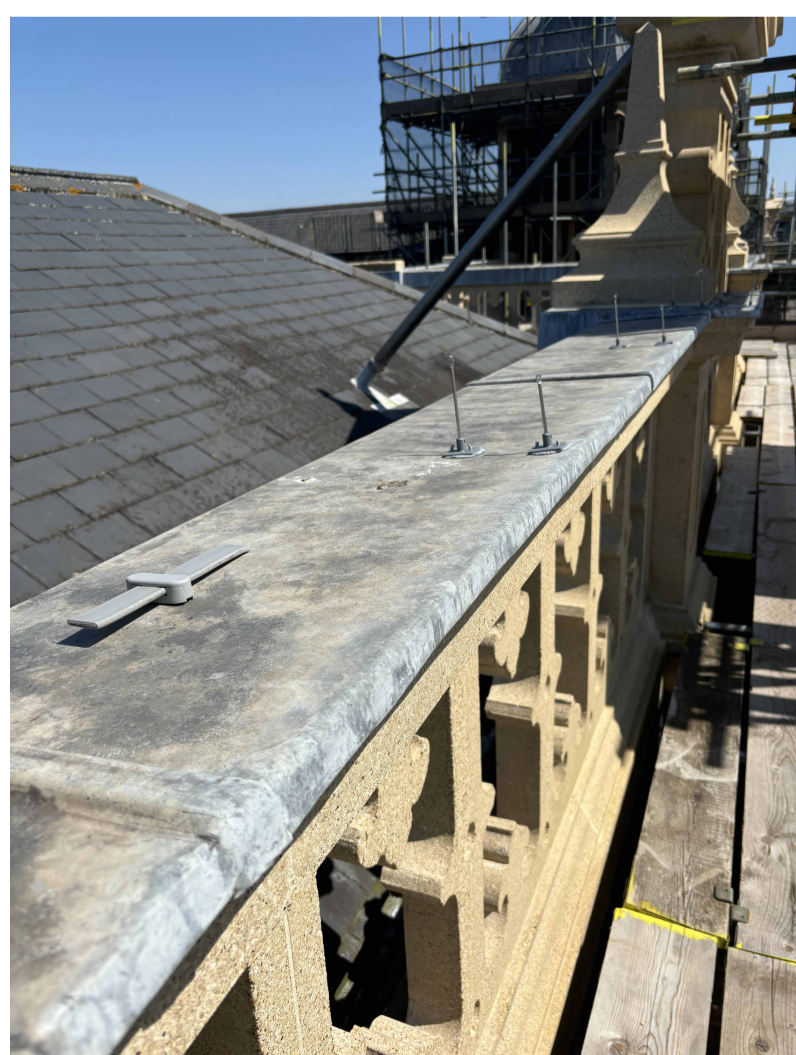
Image 2
Lightening Protection tape at roof level - refer to A-1005 & suppliers drawings for locations
