Site Investigation, Land Contamination Assessment and Remediation Strategy October 2018

Proposed redevelopment Melliss Avenue Richmond London

Ground Investigation Report Revision 01

GROUND INVESTIGATION REPORT

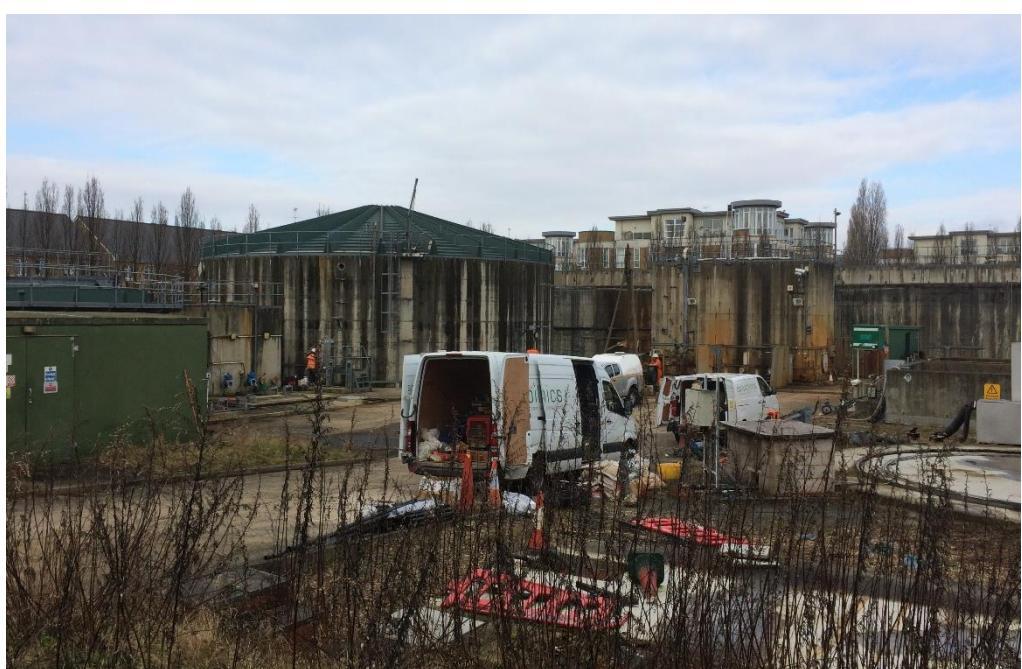
Photograph 01 - View of the site looking north-west.

- 3.2.3 At the time of the investigation, the tank structures and infrastructure associated with the former biothane plant remained on site, although were fully decommissioned (see photographs 01 and 02). The central area of the site contained the main structures and was surfaced in concrete, which extended to the site access to the south. The surrounding areas were generally laid to grass with some concrete pathways and ancillary structures present.

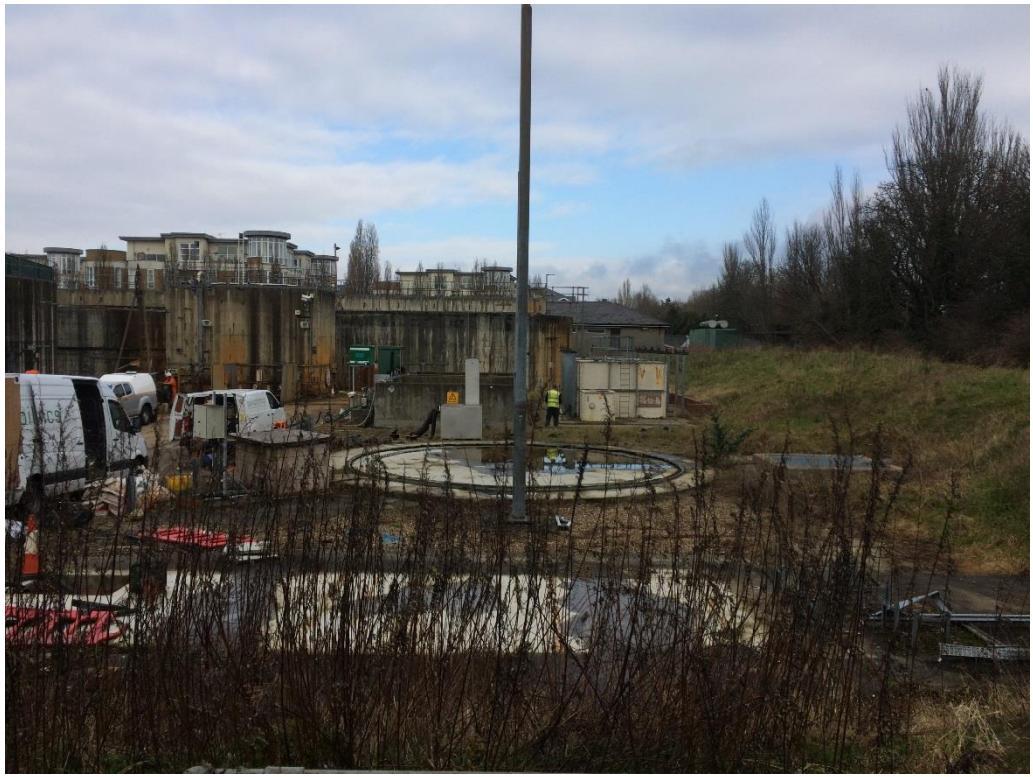
Photograph 02 - View of the site looking north.

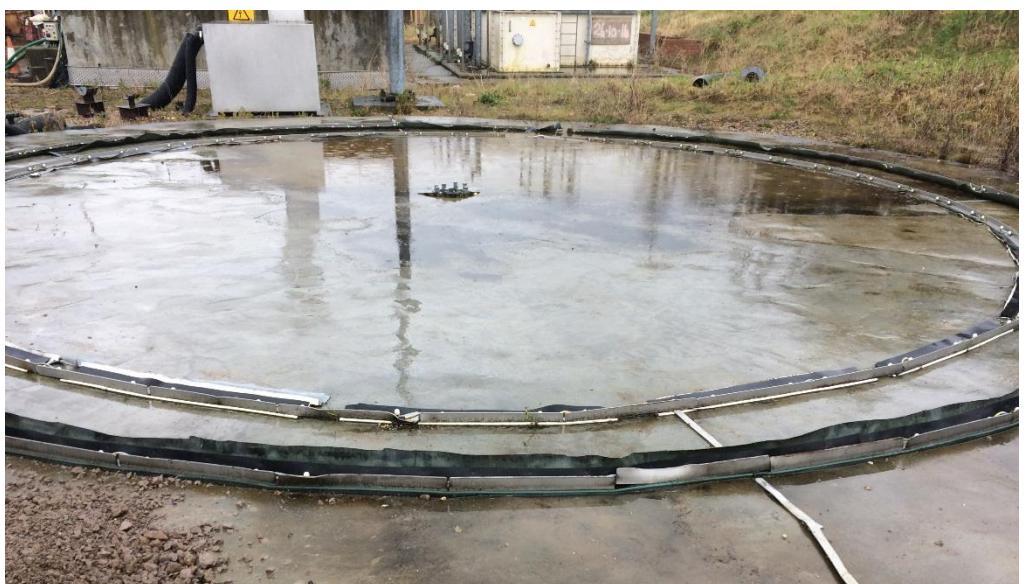
Photograph 03 - View of the former gas holder base in south eastern corner of the site. View looking north.

3.2.4 In the central part of the site, four large above ground tanks were located to the north and west, while the base of a gas holder and Biothane Generator (which had already been removed) were present toward the south-east (see photograph 03). Former hydrochloric acid and sodium hydroxide tanks were located to the east of the central area. A metal framed structure was located in the south western corner of the site which housed a number of large pipes and presumed storage tanks on the top of the structure (see photograph 04).

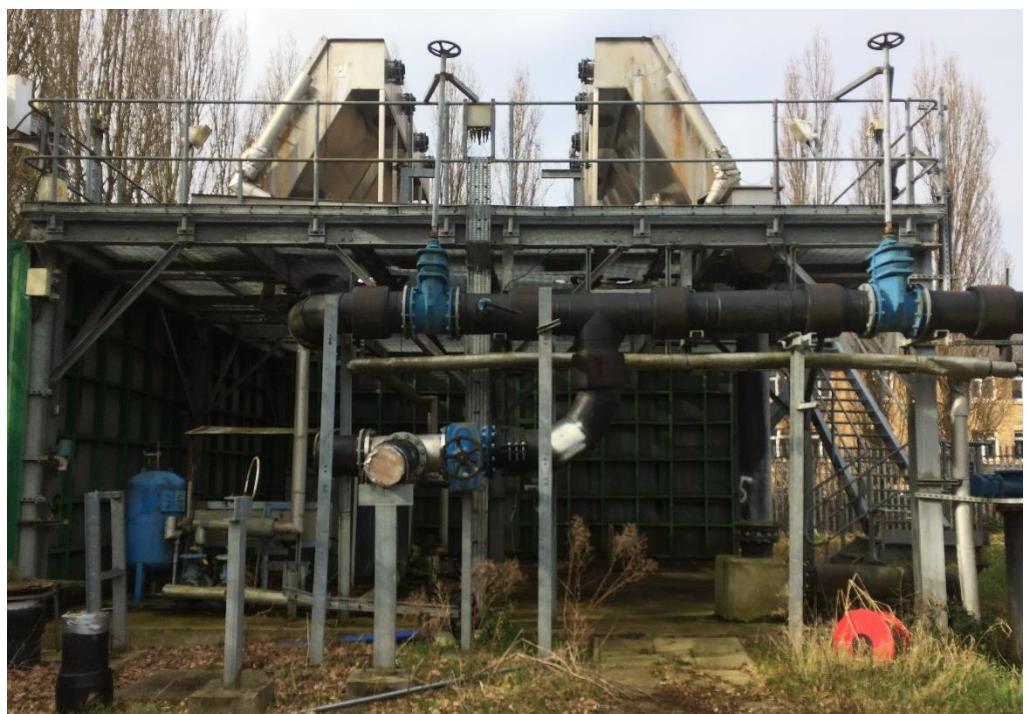
Photograph 04 - View of the metal framed building in the south-western corner of the site. View looking west.

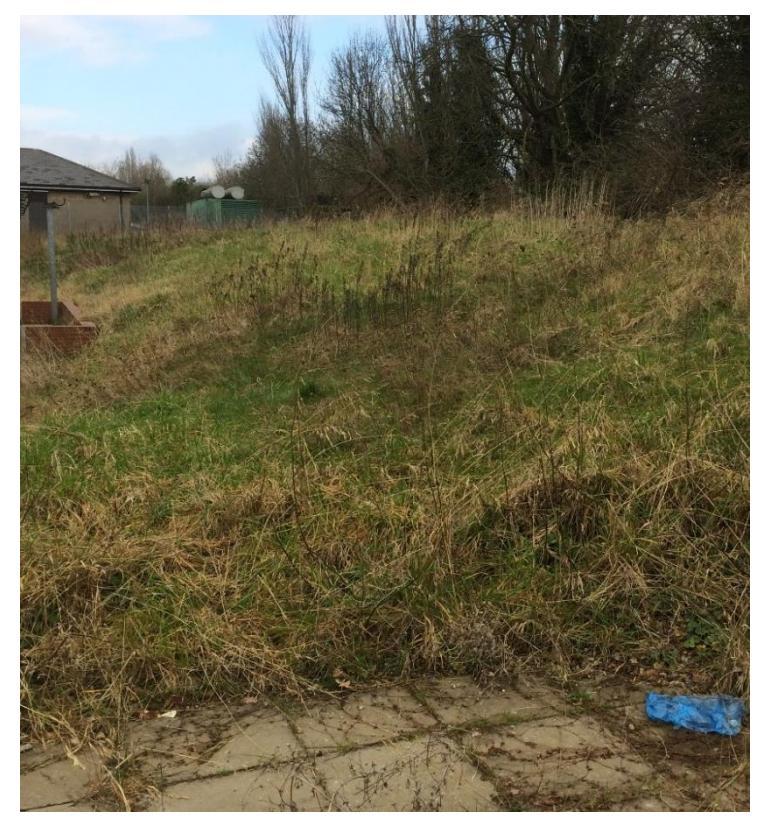
Photograph 05 –

View of the bund along the eastern boundary of the site. View looking north.

3.2.5 The levels on site slope from the northern, southern and western boundaries, toward the centre of the site. A bund, approximately 2m high, is located along the eastern boundary (see photograph 05). Levels beyond the bund slope down towards the footpath to the east.

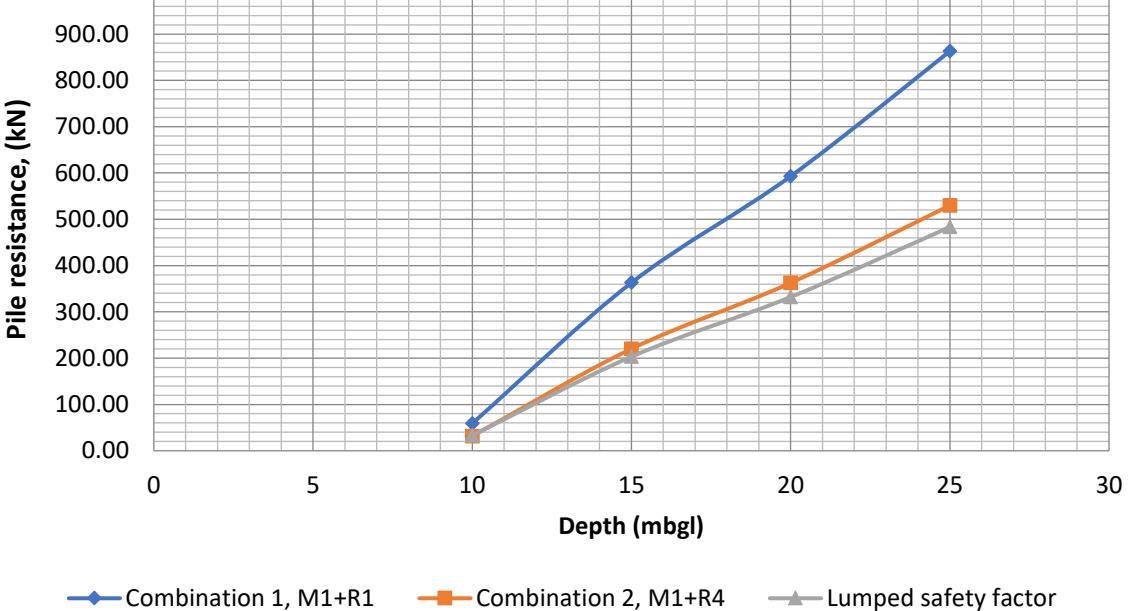
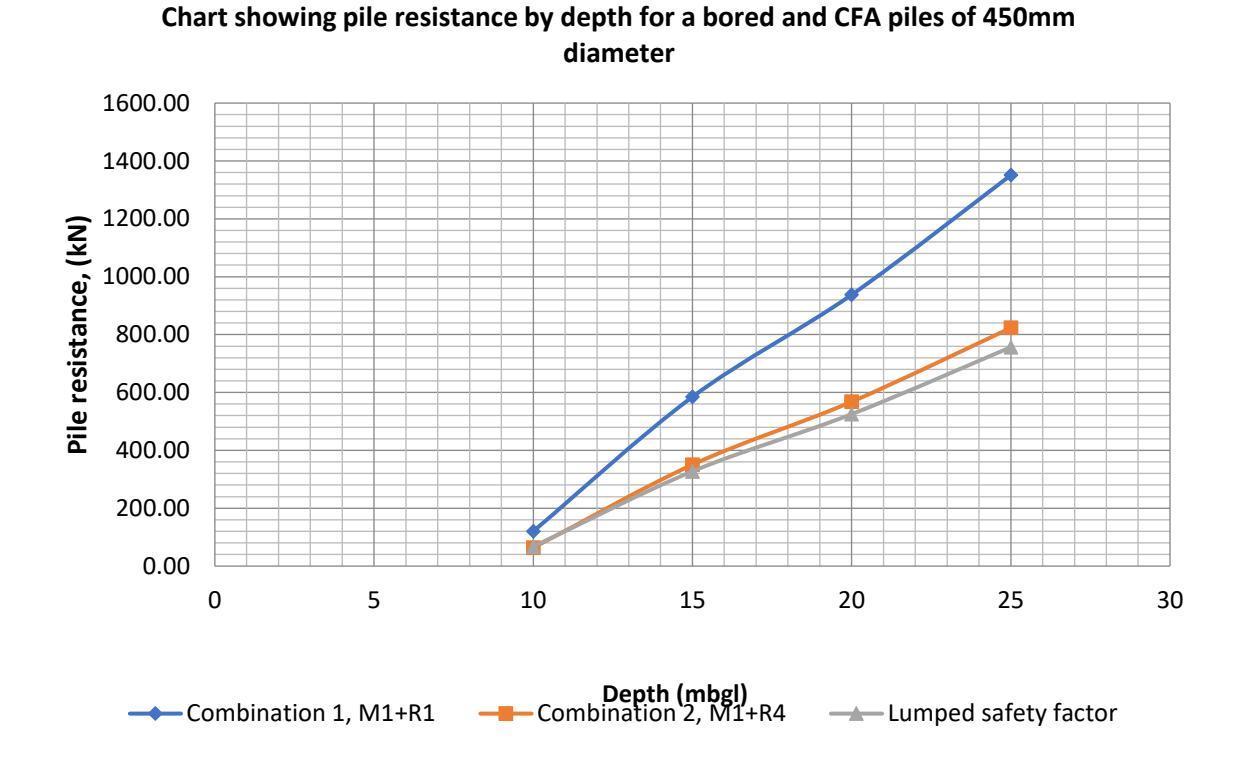
Chart showing pile resistance by depth for a bored and CFA piles of 300mm

- 7.5.8.1 The following charts provide pile resistances for differing pile diameters, pile types, and indeed the two combinations associated with design approach 1. In using these charts, the following is very important to note:
 - 1. These charts are to assist the foundation designer in establishing a foundation layout. It is for the pile designer (commonly as part of a design and build contract) to take design liability. We do not take pile design responsibility.
 - 2. Actions associated with the two combinations will require the application of appropriate partial factors described in Eurocodes.

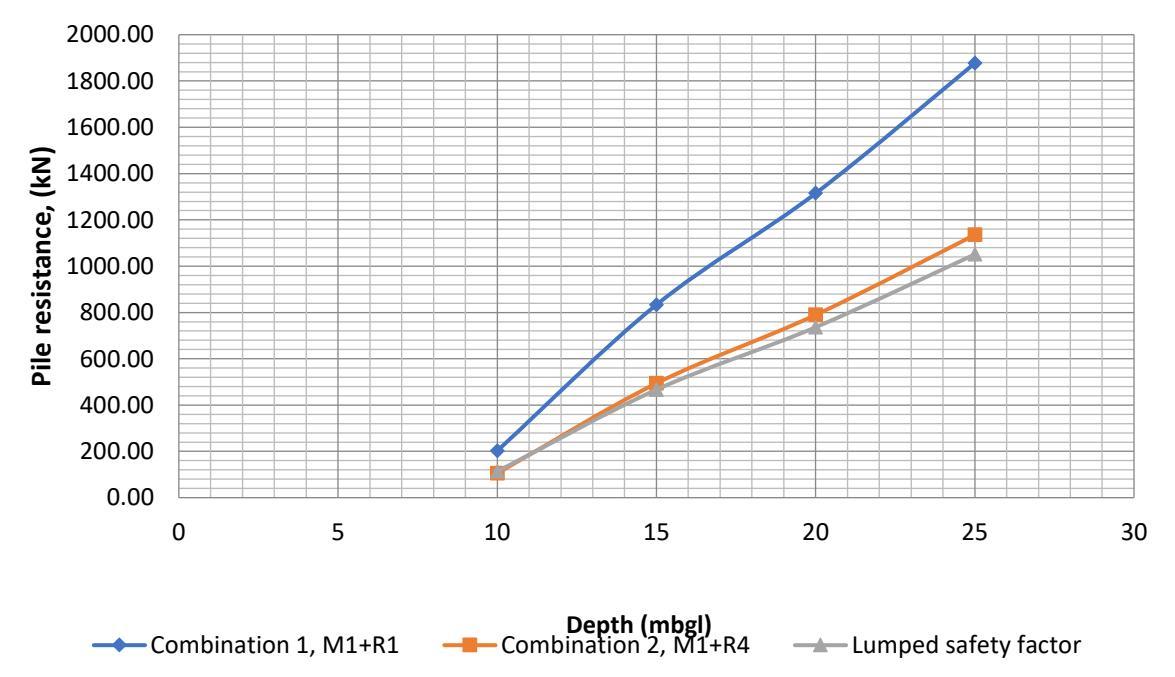
Chart showing pile resistance by depth for a bored and CFA piles of 600mm diameter
