CLIENT  
 English Heritage

PROJECT  
 Marble Hill House

TITLE  
 Sports Centre:  
 Ground Floor Plan; as existing

DRAWING N°  
 610

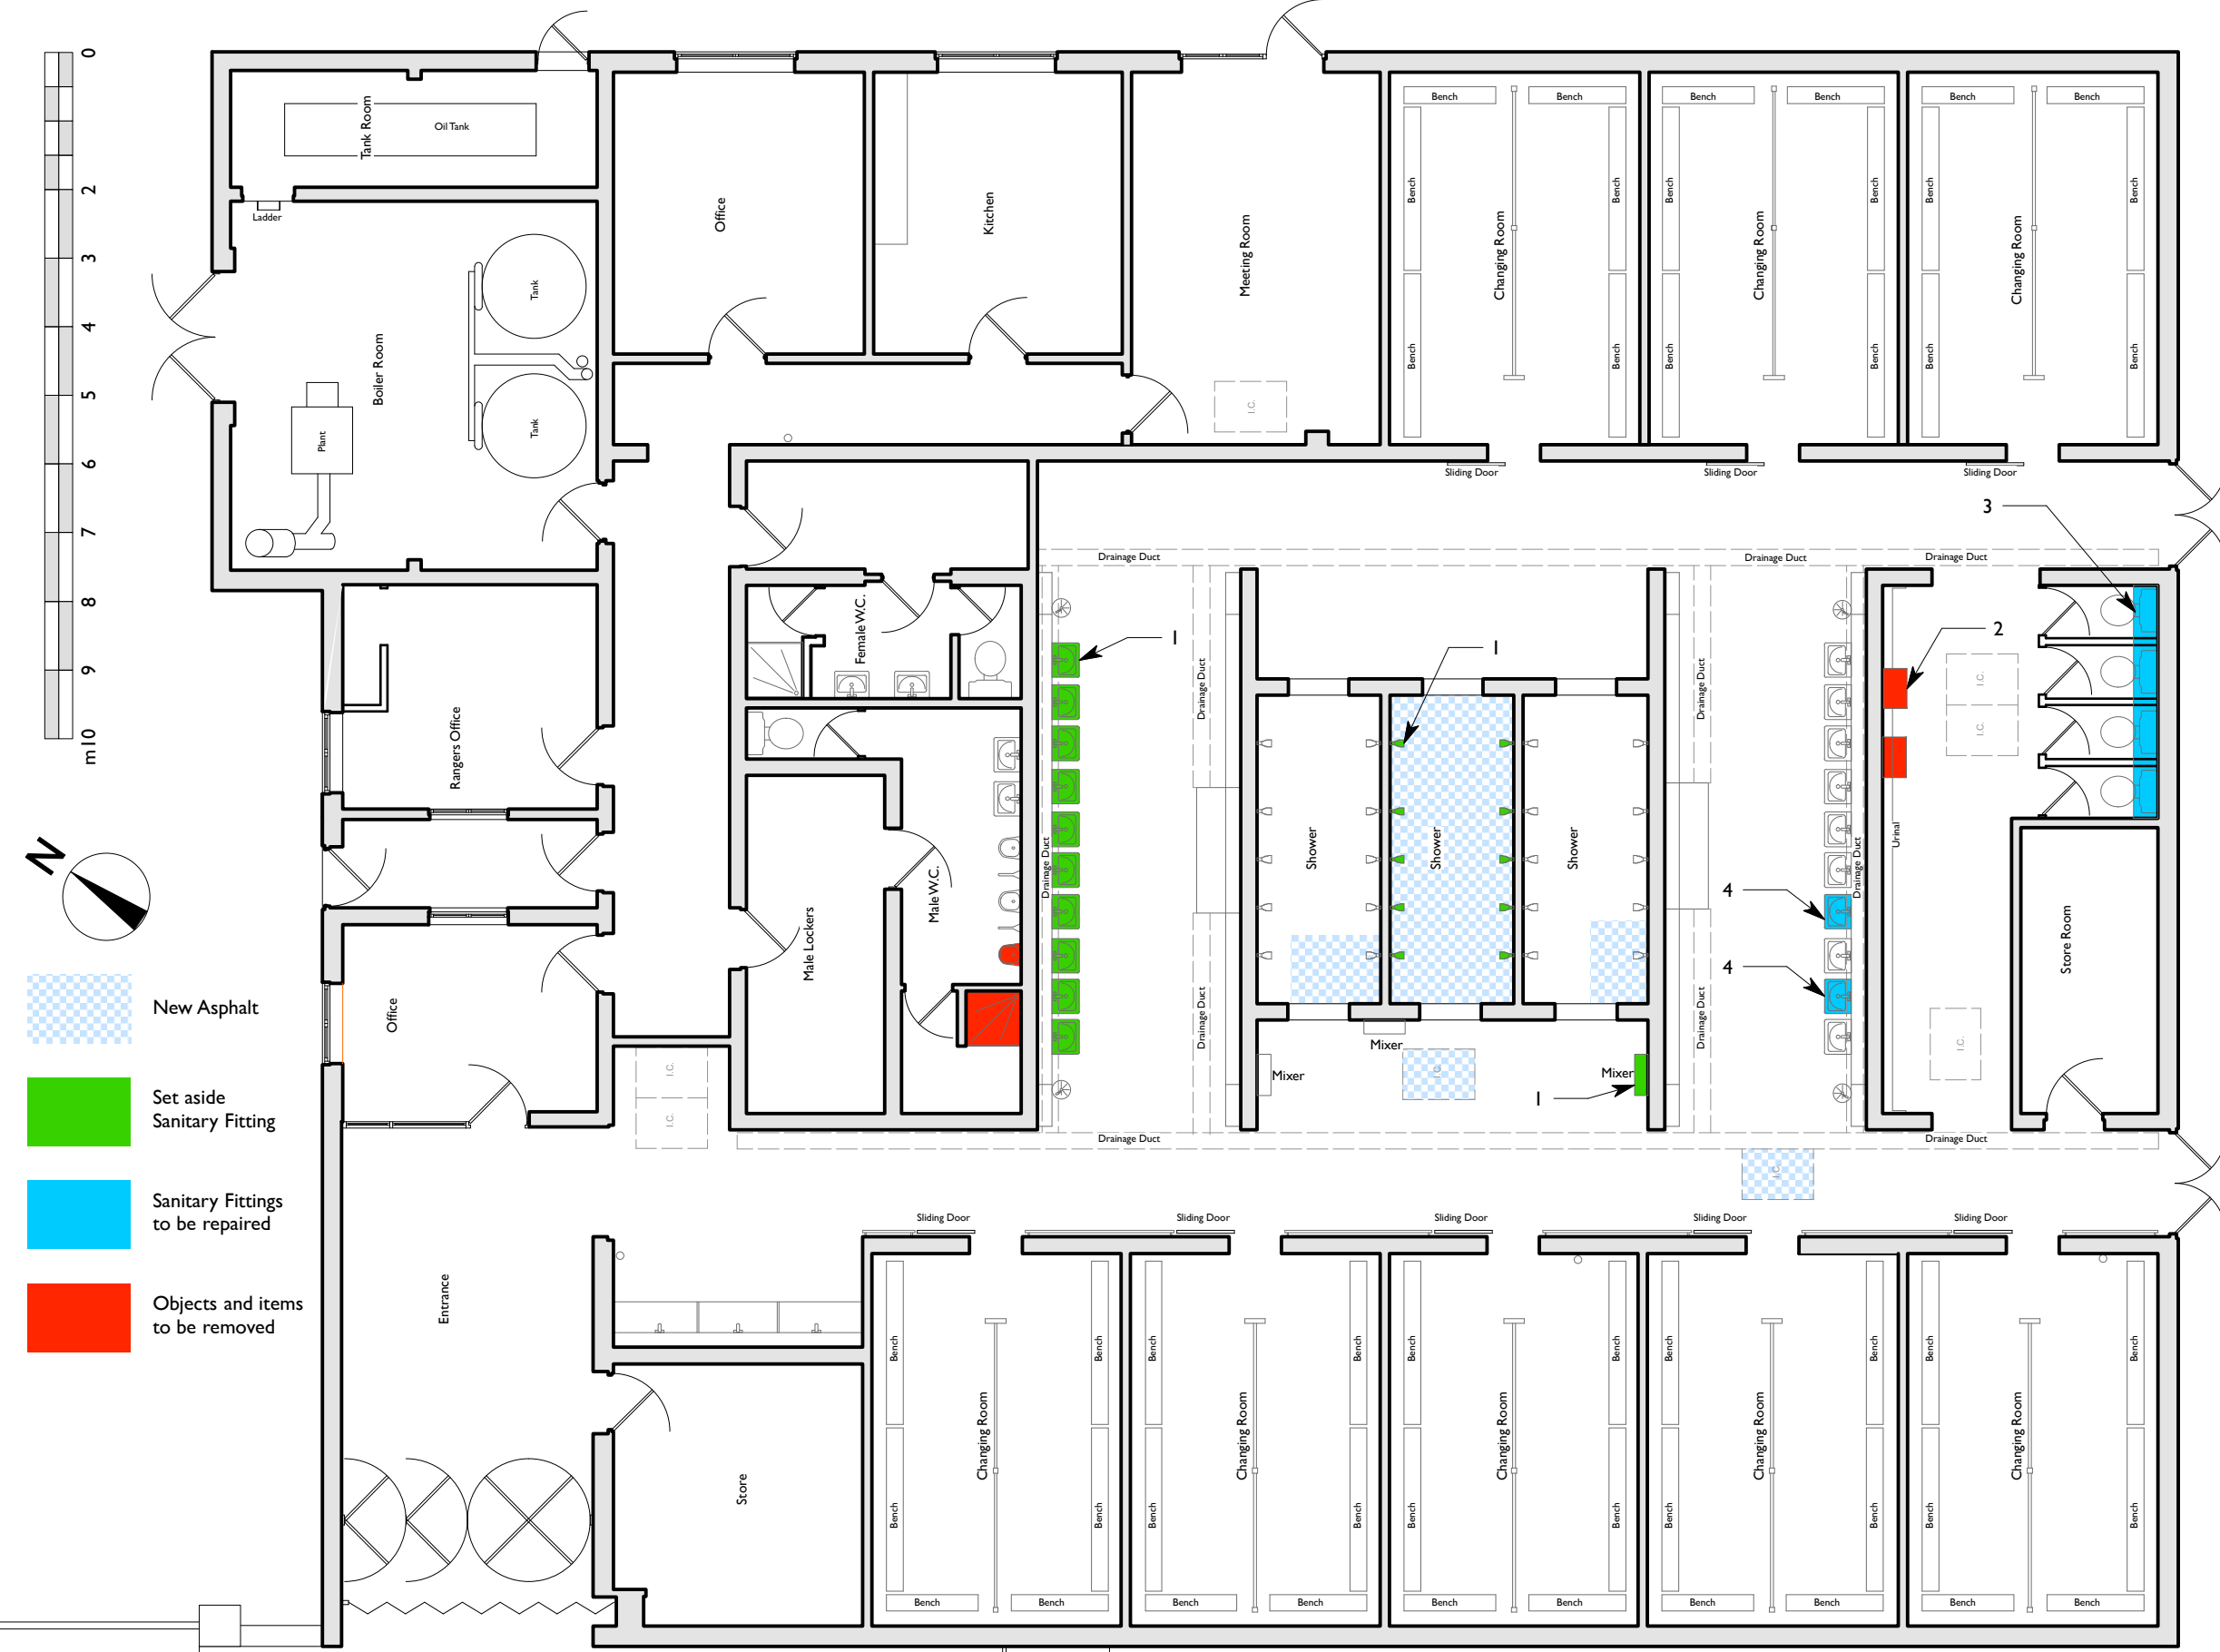
- New Asphalt
- Set aside Sanitary Fitting
- Sanitary Fittings to be repaired
- Objects and items to be removed

- Notes**
1. Sinks, shower heads and mixer taps to be disconnected and set aside for reuse
  2. Asbestos cistern to be removed and replaced with new black plastic cisterns.
  3. Existing cistern to be repaired, this may require completely replumbing the cistern.
  4. Taps to sinks bent and require replacement; 3no taps in total.
