Sports Building: East Elevation
721 Scale: 1:100 @ A3

Marble Hill House

Sports Centre: North & East Elevations; as proposed

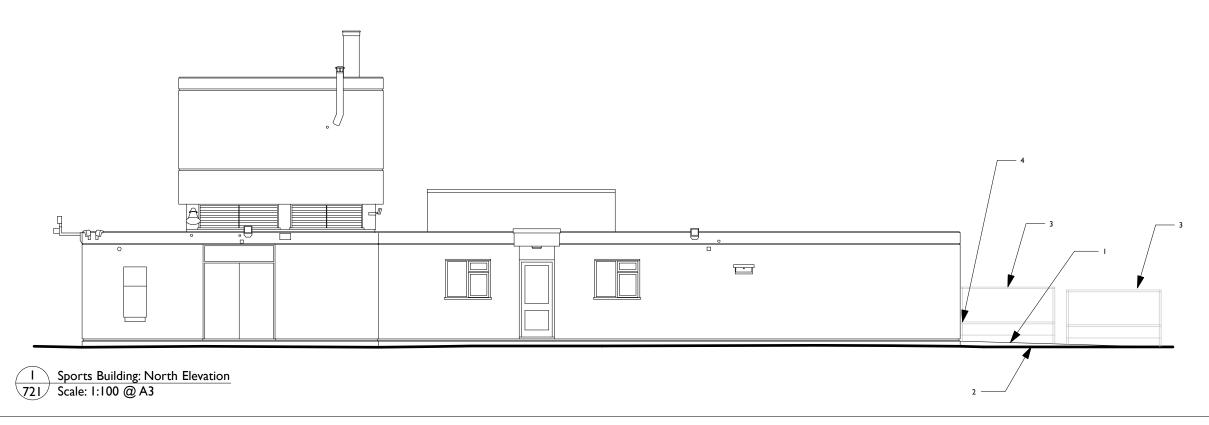
I. Main Entrance Area; paving lifted and relaid to a minimum 1:25 fall to provide level access to the
- main entrance.

To the left of the door, the kerb to the road is to be removed to allow equal access for users who come to the Sports Building via the access road.
- Existing Railing Boot Scrapers; reset to suit the new paving level.
 New External Tap; for cleaning mud from wheelchair wheels.
