# STRAWBERRY HILL HOUSE

FIRST FLOOR AS PROPOSED

DWG NO SCALE 1:100 @A2 DATE FEB 2006 SHT GA 015

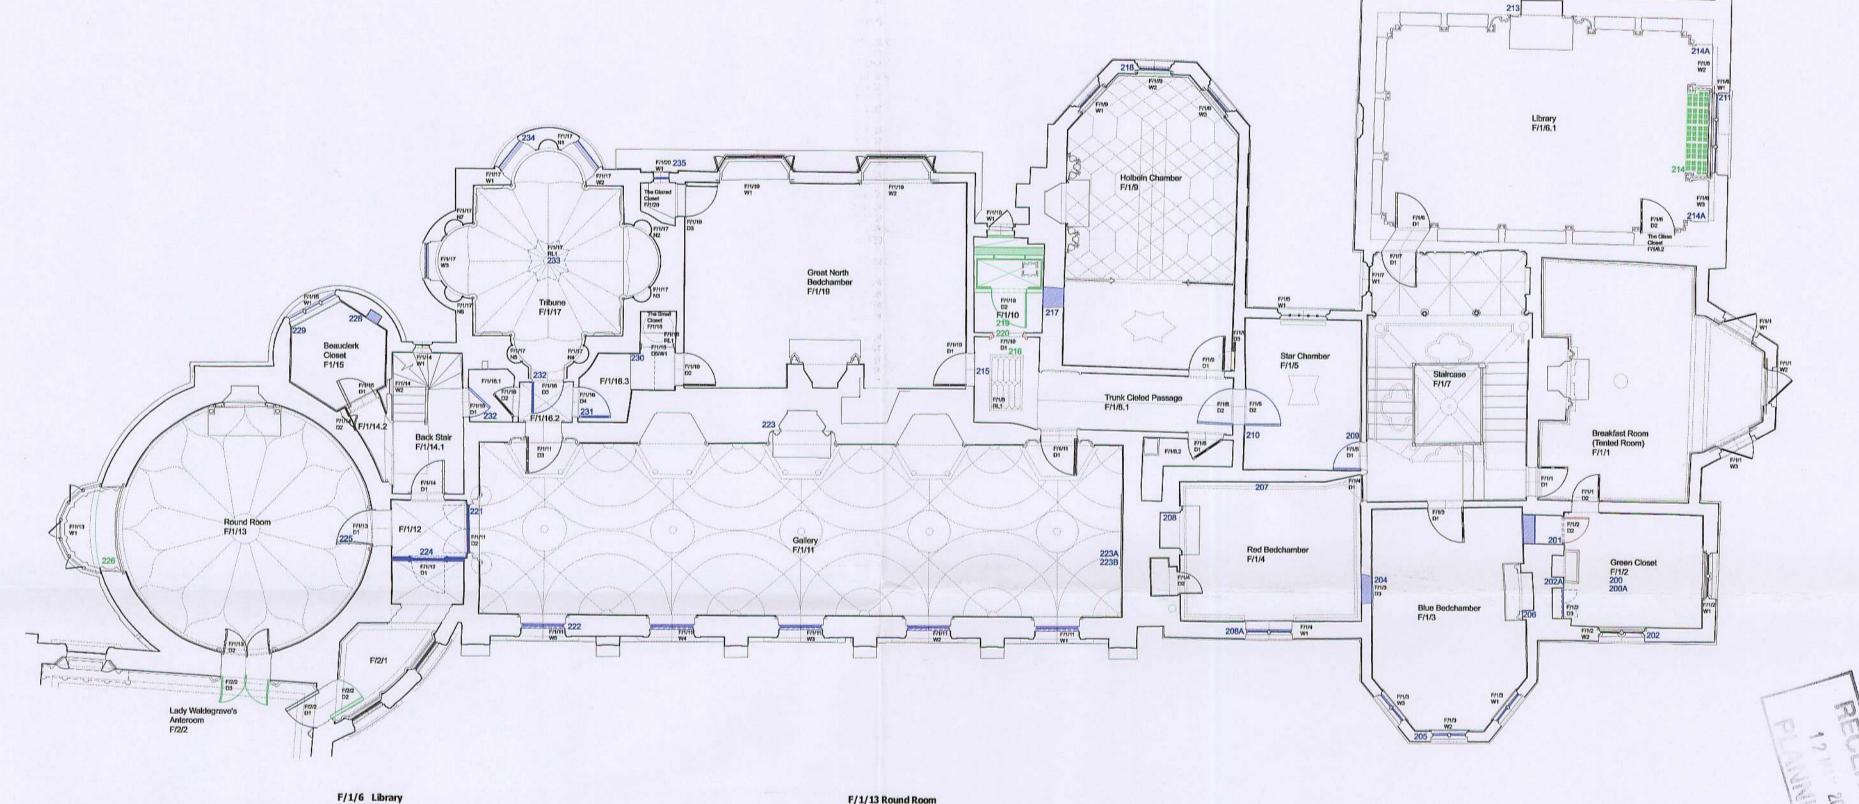
### INTERIOR FIRST FLOOR

Restorations
200. Remove bathrooms and raised floor to restore original volume.

200A. Restore ceiling. 201. Restore cupboards by blocking up 1861 doorway F/1/3 D2. Rehang as door F/1/2 D2. New door F/1/2 D3 to

match construction detail of F/1/2 D2. 202. Dismantle 1950s fish-scale leaded lights to restore decorative glazing to F/1/2 W1 and W2 subject to further

203. Remove 1972 fibrous plaster comice. Replacement comice subject to further research and opening up.
204. Block up F/1/3 D3 to restore original arrangement.
205. Remove 1972 casement windows to restore horizontal sliding sash windows and shutters to F/1/3 W1, W2 and

207. Remove 1990 dado rail to restore original wall plane.

208. Unblock chimneypiece. Take out 1890s cast iron register grate and store.

209. Restore missing door F/1/5 D1 to match original F/1/4 D1 based upon documentary and archaeological

210. Restore missing two doors F/1/5 D2 to match original F/1/4 D1 and F/1/8 D2 to match F/1/9 D1 based upon documentary and archaeological evidence.

211. Restore horizontal sliding end sashes and centre fixed sash to F/1/6 W1 based upon C18 views. 212. Remove the 1958 cupboard height doors to each bay flanking the chimneypiece.

217. Block up F/1/9 D2 to 1861 bathroom.
218. F/1/9 W1 - W3: Take out upper lancet glazing bars (1984) to restore decorative glazing panels based upon documentary evidence.

Alterations
2.19. Remove bathroom floor, ceiling and roof structure to construct new disabled lift and service riser. Construct new ceiling/floor structure for new bathroom above.
2.20. Take out fixed panel F/1/10 D1. Widen doorway to facilitate disabled access. New architraves to match

221. Restore double doors F/1/11 D2 as shown on the 1922 Country Life photographs and as drawn.

222. Take out 1856 glazing bars to all sashes F/1/11 W1-W5 to restore original pattern based upon C18 drawing and decorative glazing based upon Revd Cole 1762 drawings and documentary research.

Restorations
224. Restore partition and door F/1/12 D1 to former China Closet to match original F/1/14 D1 opposite.

228. Block up niche with sink. Remove 1958 Gothic lancet door F/1/15 D2. Relocate sink to G/2/3 toilets.
229. Restore plain and coloured glass leaded lights to original arrangement based upon 1922 Country Life photographic evidence. Reinstate decorative glazing based upon documentary evidence.

233. Restore glazing to laylight based upon Edwards 1783 watercolour. 234. Restore vertical sliding sash windows to F/1/17 W1 - W3 to their original configuration as shown on 1922 photograph, glazing bar profiles to match drawn and photographic models. Restore shutters to F/1/17 W1 - W3 based on photographic and archaeological evidence. Restore decorative glazing patterns to each window based upon
