5 5 - 5 7 H I G H S T R E E T

HDH.43.07
FRONT ELEVATION

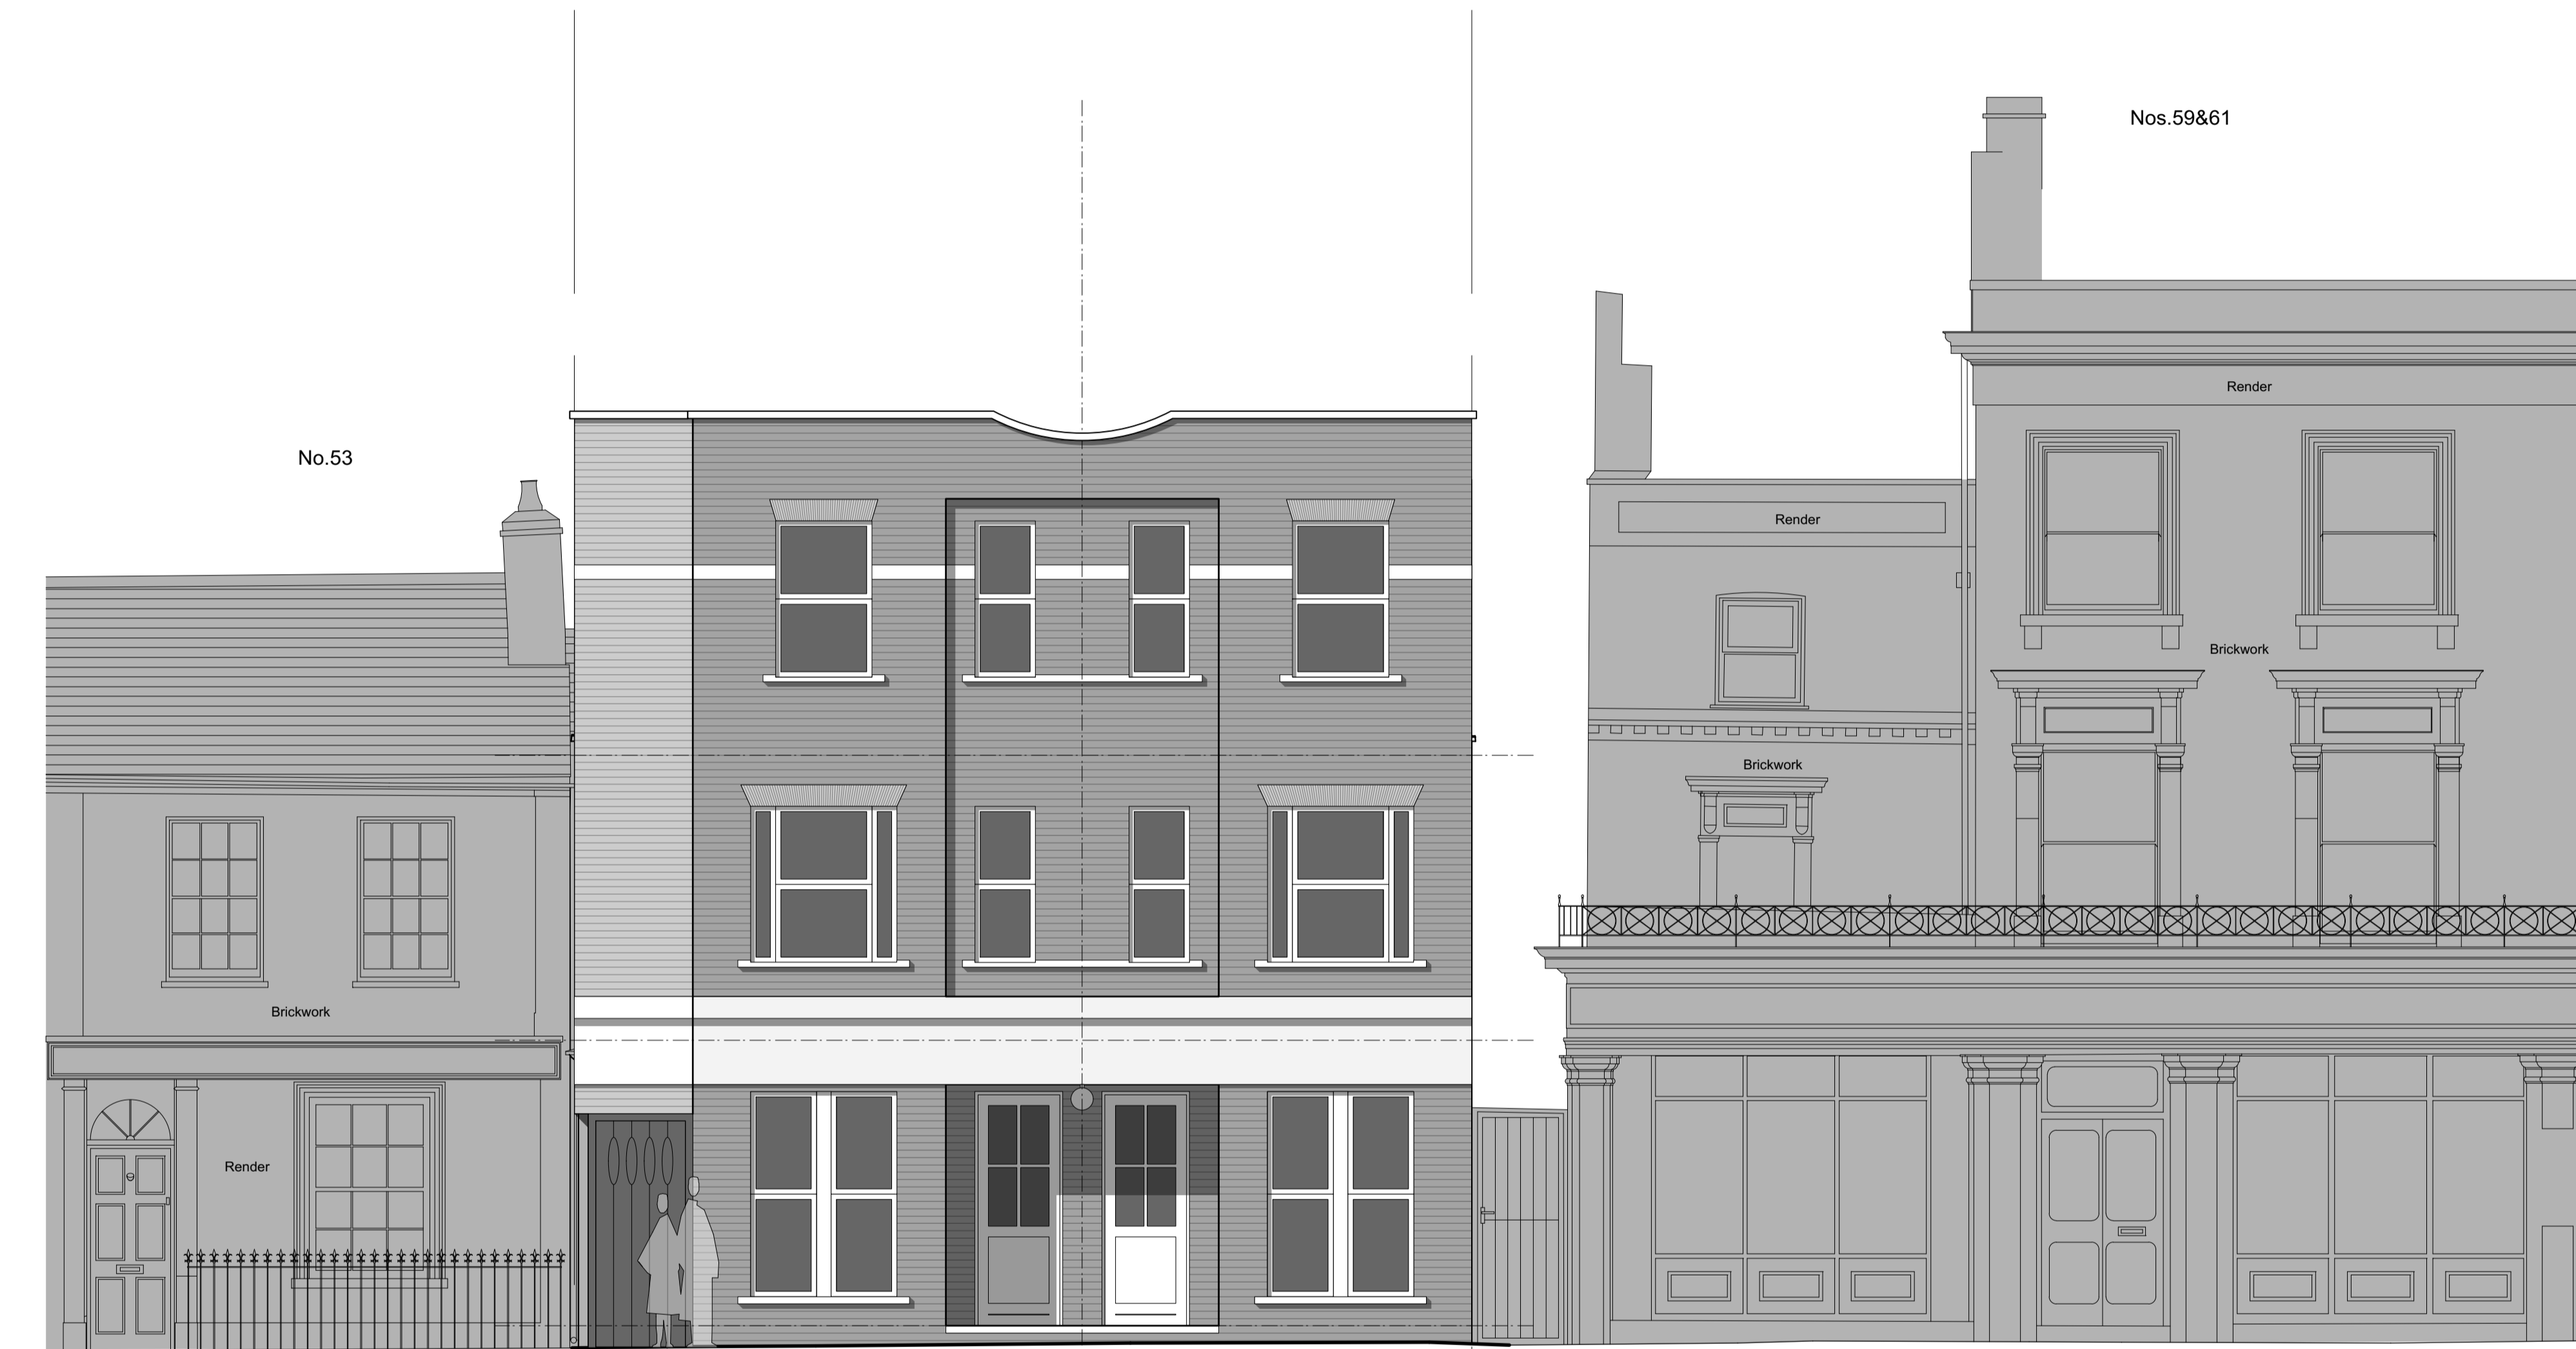
Materials:

Walls
Windows and doors
Cills, coping and trim
Rear bays
Rainwater pipe (rear)

Facing brick
Painted timber
Reconstituted stonework
Standing seam metal
Galvanised steel
