5 5 - 5 7 H I G H S T R E E T

HDH.43.10

SIDE (NW) ELEVATION

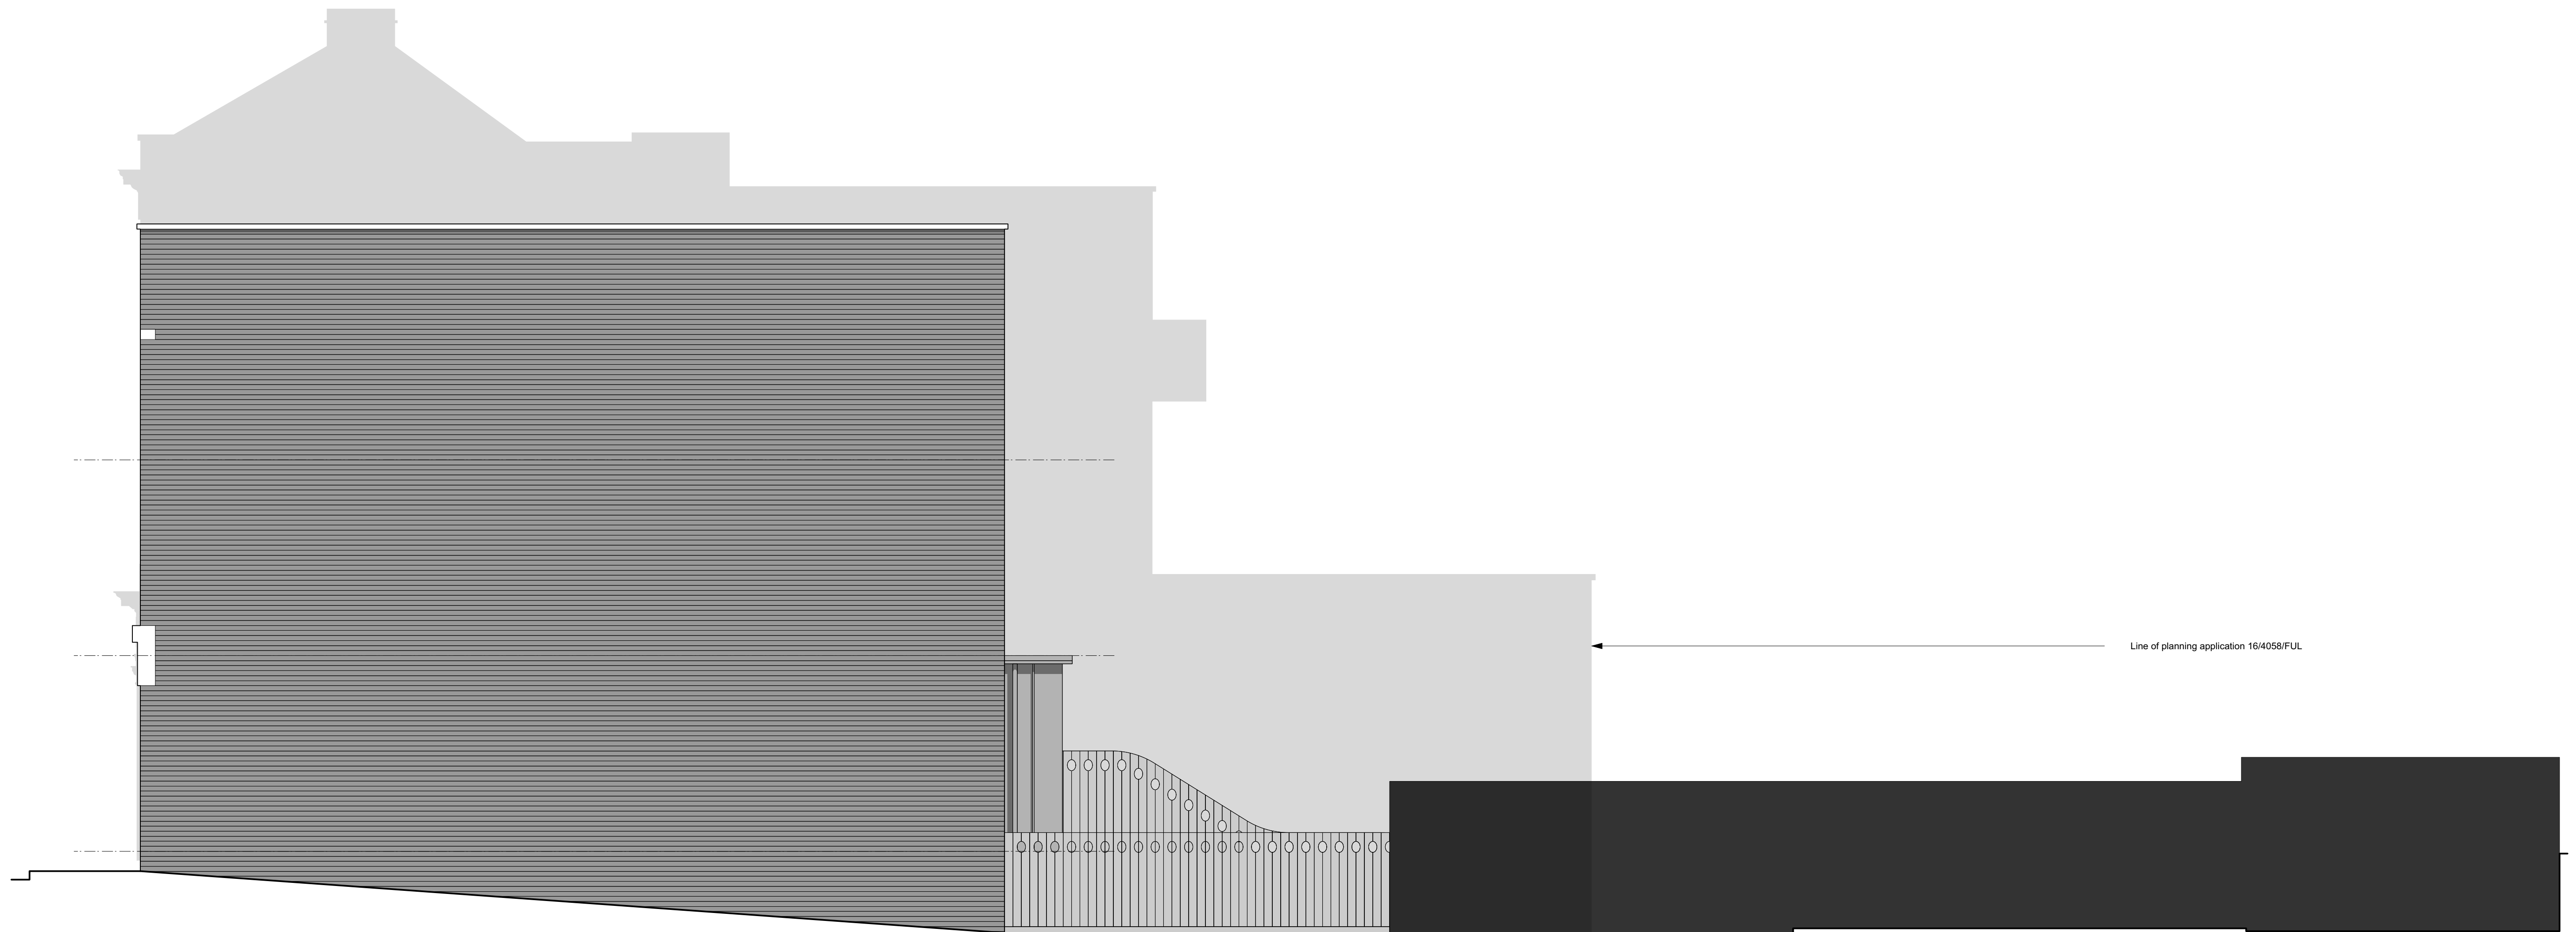
Walls
Windows and doors
Cills, coping and trim
Rear bays
Rainwater pipe (rear)

Facing brick
Painted timber
Reconstituted stonework
Standing seam metal
Galvanised steel
