5 5 - 5 7 H I G H S T R E E T

rev.A 09.02.18 Window details adjusted.
HDH.43.07a
FRONT ELEVATION
December 2017 scale 1:50 at A1

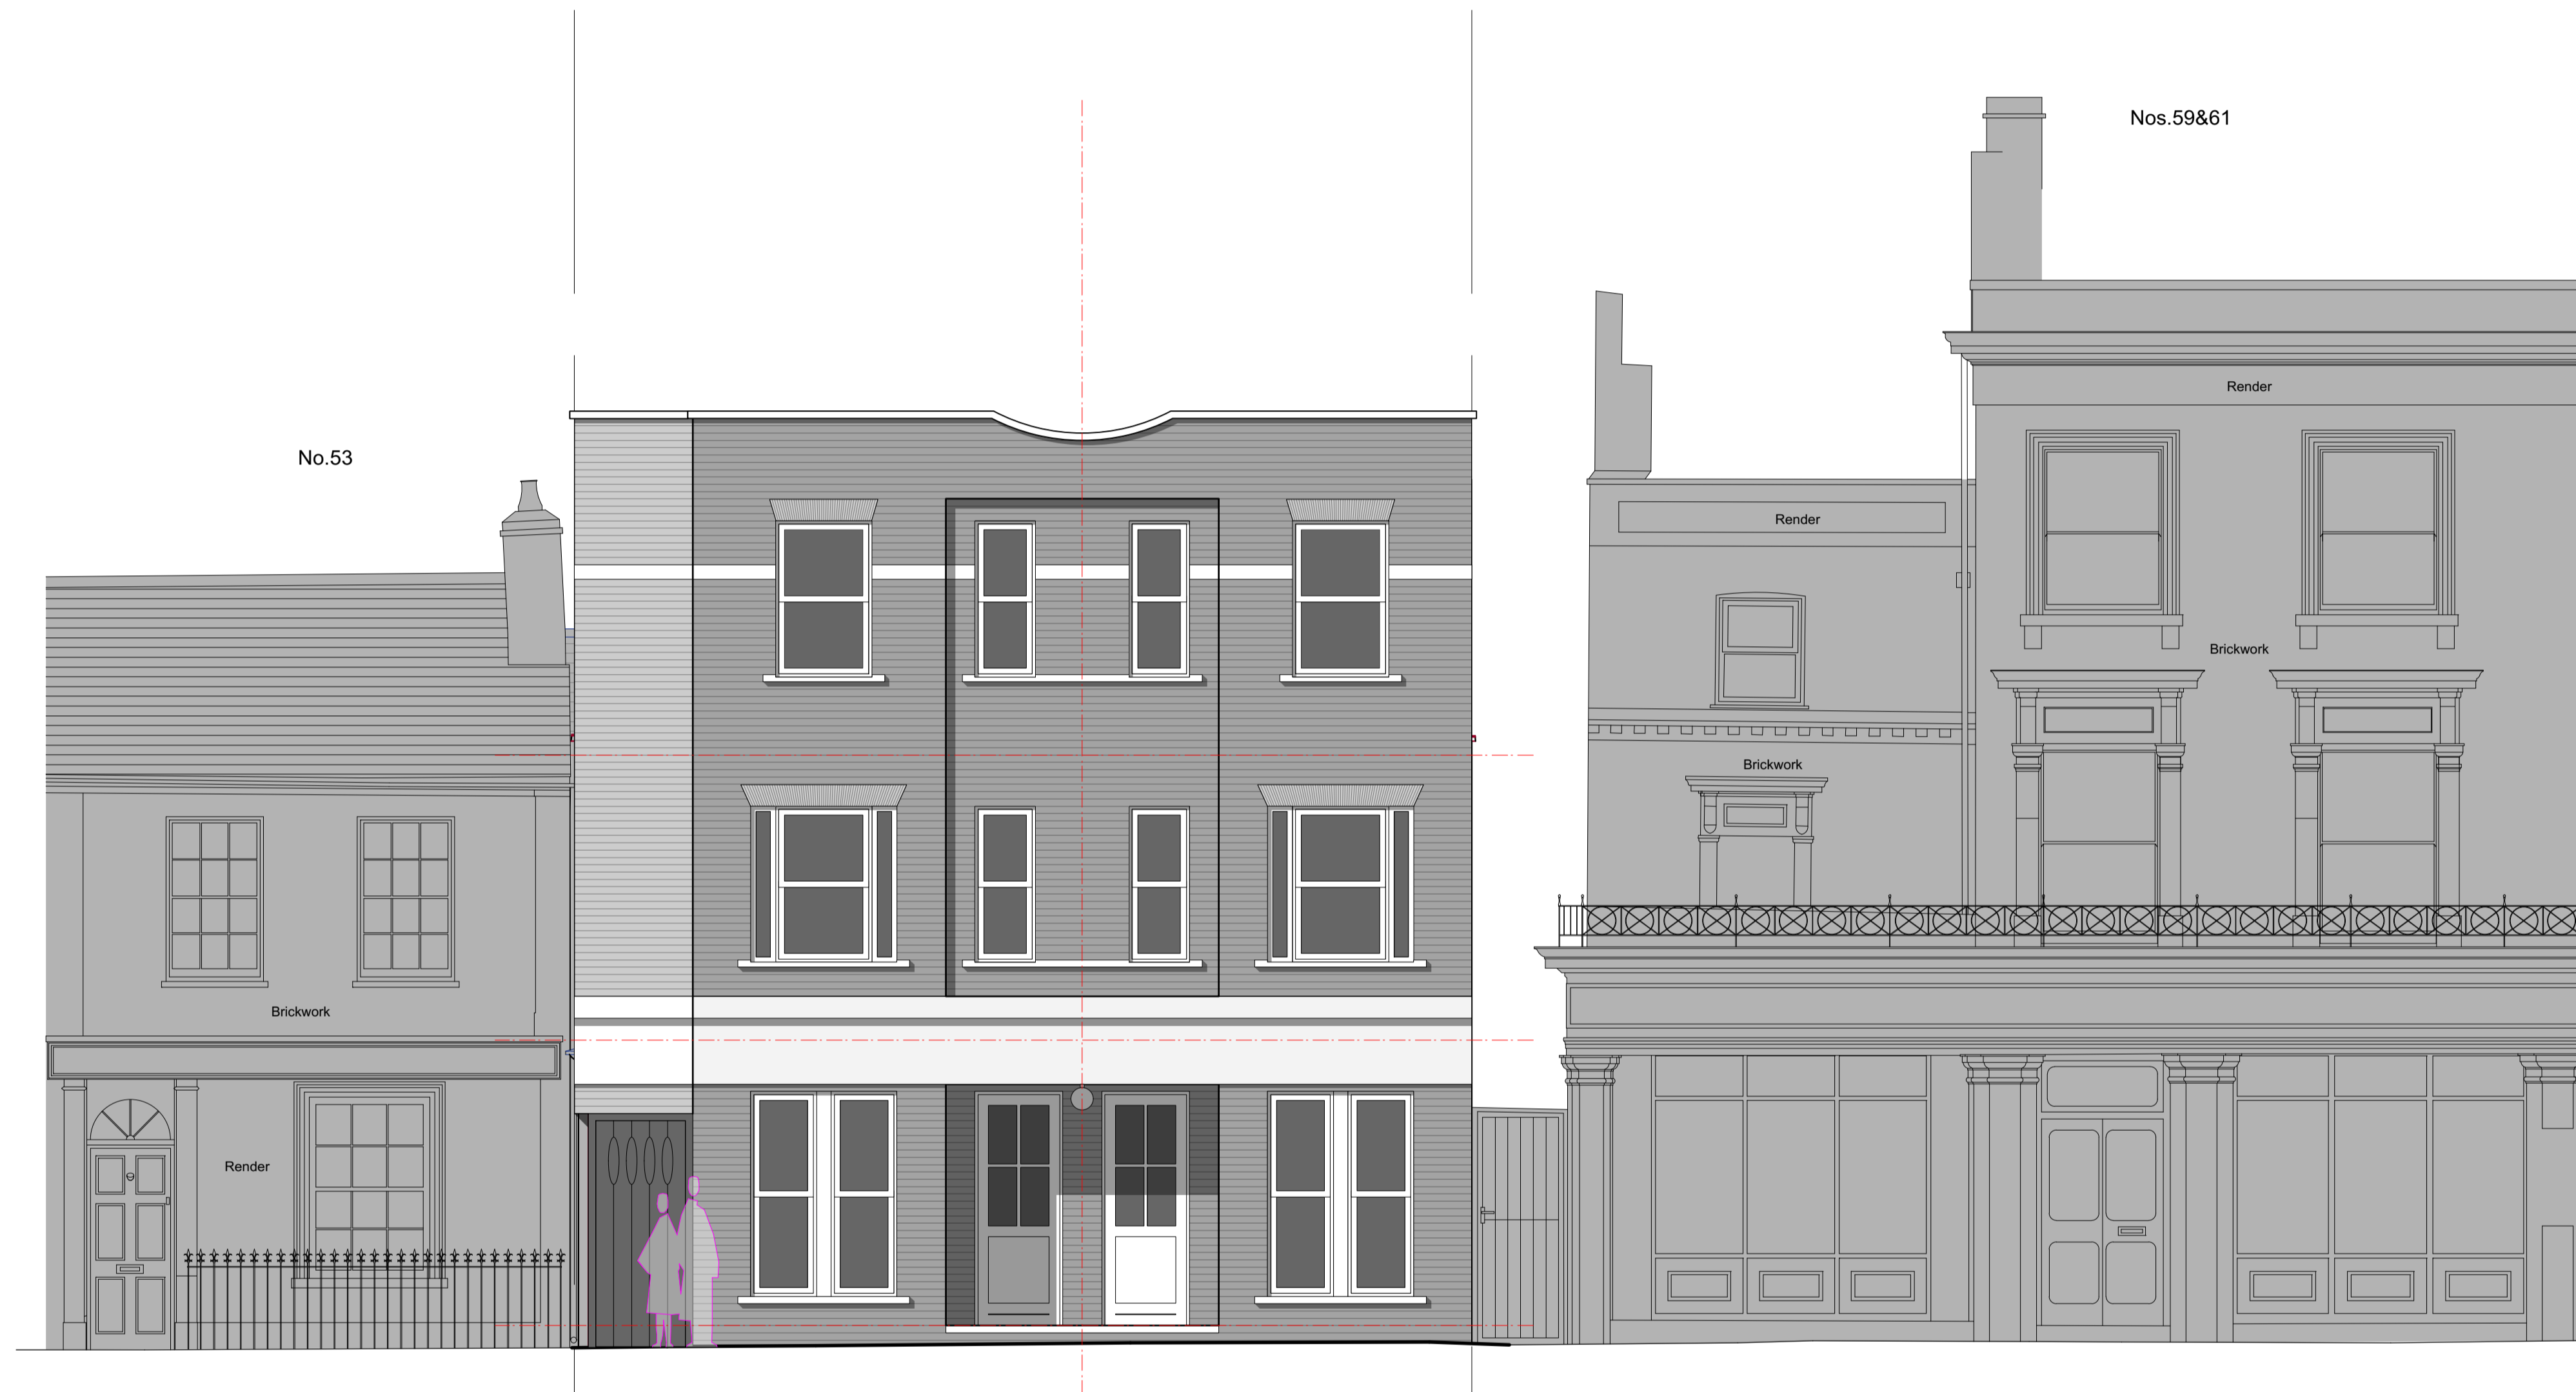
Materials:

Walls
Windows and doors
Cills, coping and trim
Rear bays
Rainwater pipe (rear)

Facing brick
Painted timber
Reconstituted stonework
Standing seam metal
Galvanised steel
