**APPENDIX 11.2**  
**ENVIRONMENTAL RISK ASSESSMENT (THE STAG BREWERY EAST**  
**SITE)**

## **Environmental Risk Assessment**

The Former Stag Brewery East Site, Mortlake, London

February 2018

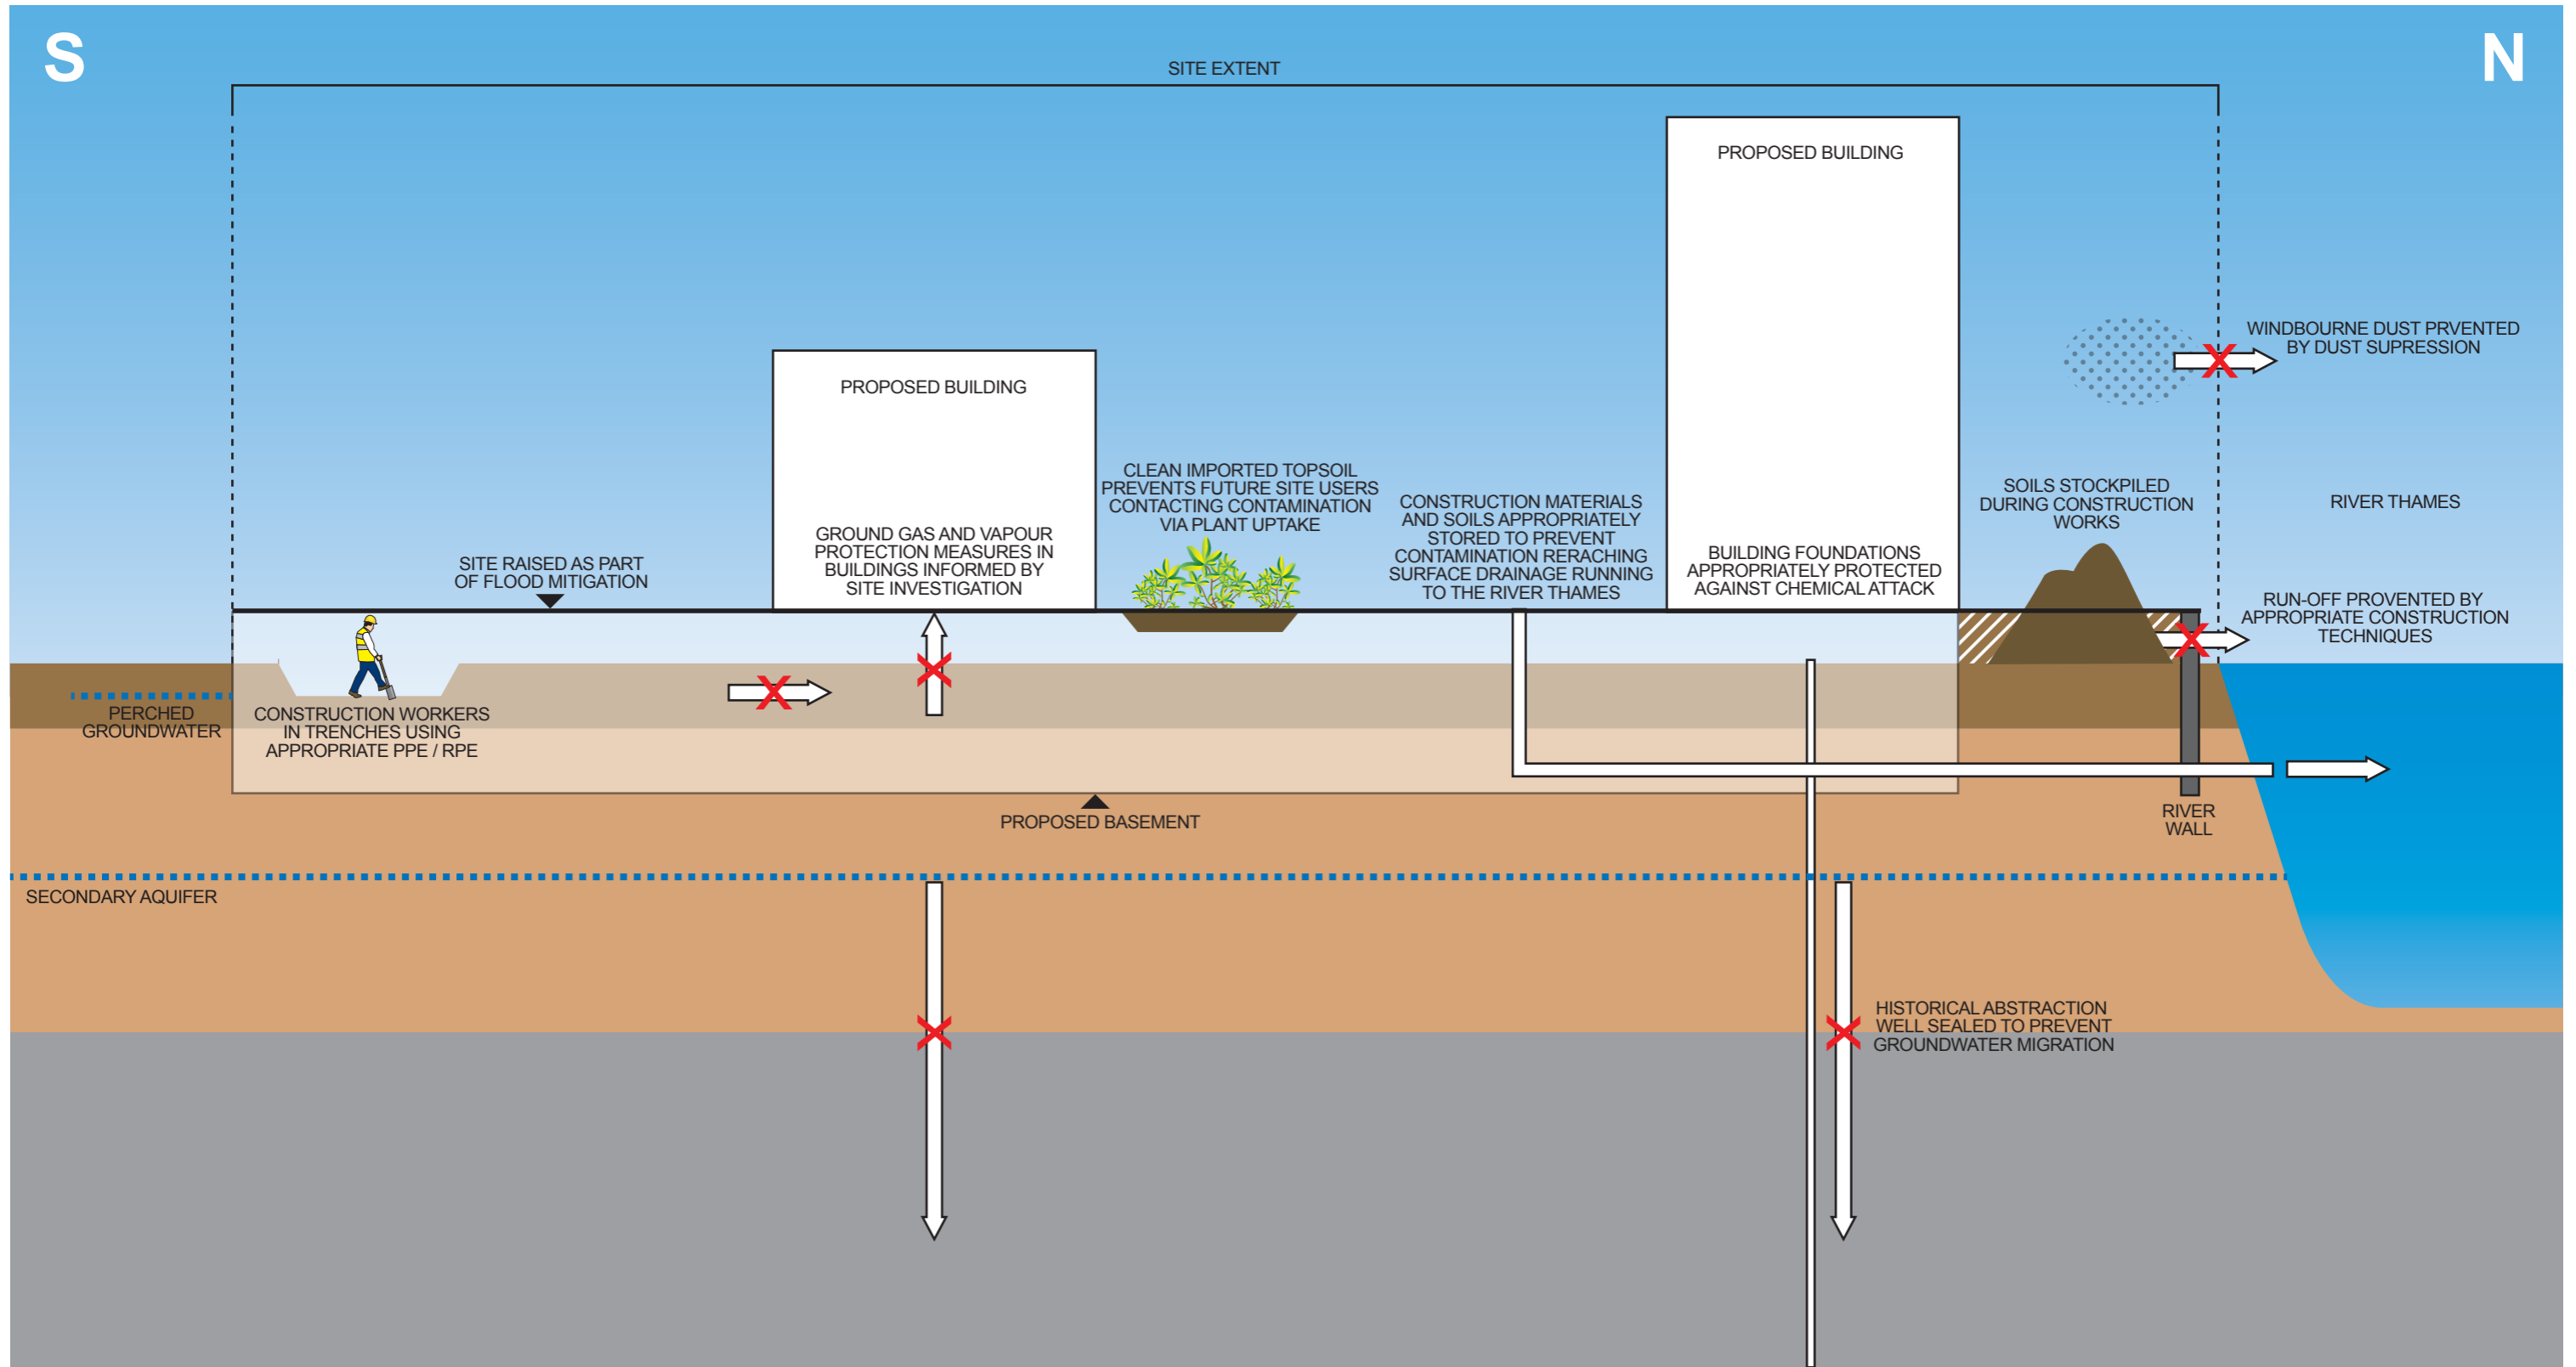
Project Details	WIE10667-101: Stag Brewery, Mortlake
Figure Title	Figure A3: Conceptual Site Model
Figure Ref	WIE10667-101_GR_PERA_A3B
Date	2017
File Location	\\s-Incs\wiel\projects\wie10667\101\graphics\pera\issued figures

- MADE GROUND
- ALLUVIUM AND RIVER TERRACE DEPOSITS
- LONDON CLAY FORMATION
