PROJECT  
Marble Hill House

TITLE  
Main House:  
Basement Floor Plan, as existing  
(showing demolition & stripout)

DRAWING N°  
109 C

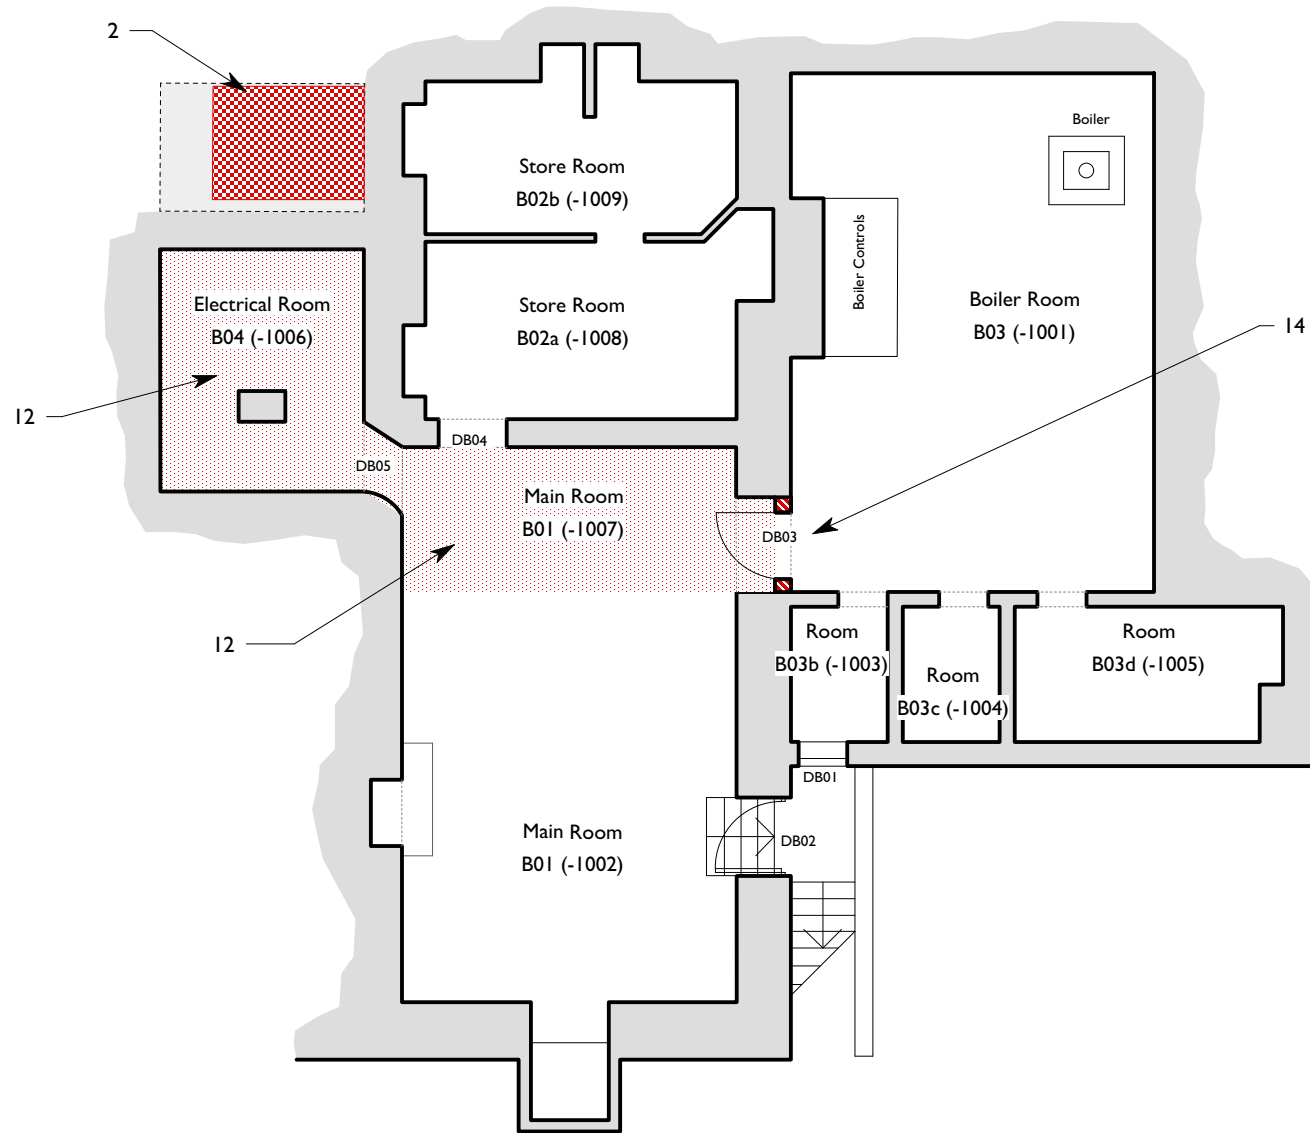
## Basement Plan

2. At basement level, dependant upon the infill composition, it may be necessary to excavate deeper to consolidate the sub-surface infill to provide a firm footing for the new lift. Refer to Key Hatch 'H'; Drawings 209, 210 & 211;

14. Remove the existing timber stud nib walls and door to doorway DB03.

12. Strip out the existing mechanical & electrical installation. Refer to Key Hatch 'E'.

-   B. walls to be removed
-   E. strip out existing services
-   H. careful excavation or opening up of floor to accommodate the new lift
-   I. identified asbestos.
