**Builders Works In Connection with M&E Improvements**

PROJECT  
Marble Hill House

TITLE  
Main House:  
First Floor Plan;  
Builders Work In Connection With  
M&E

DRAWING N°  
261 B

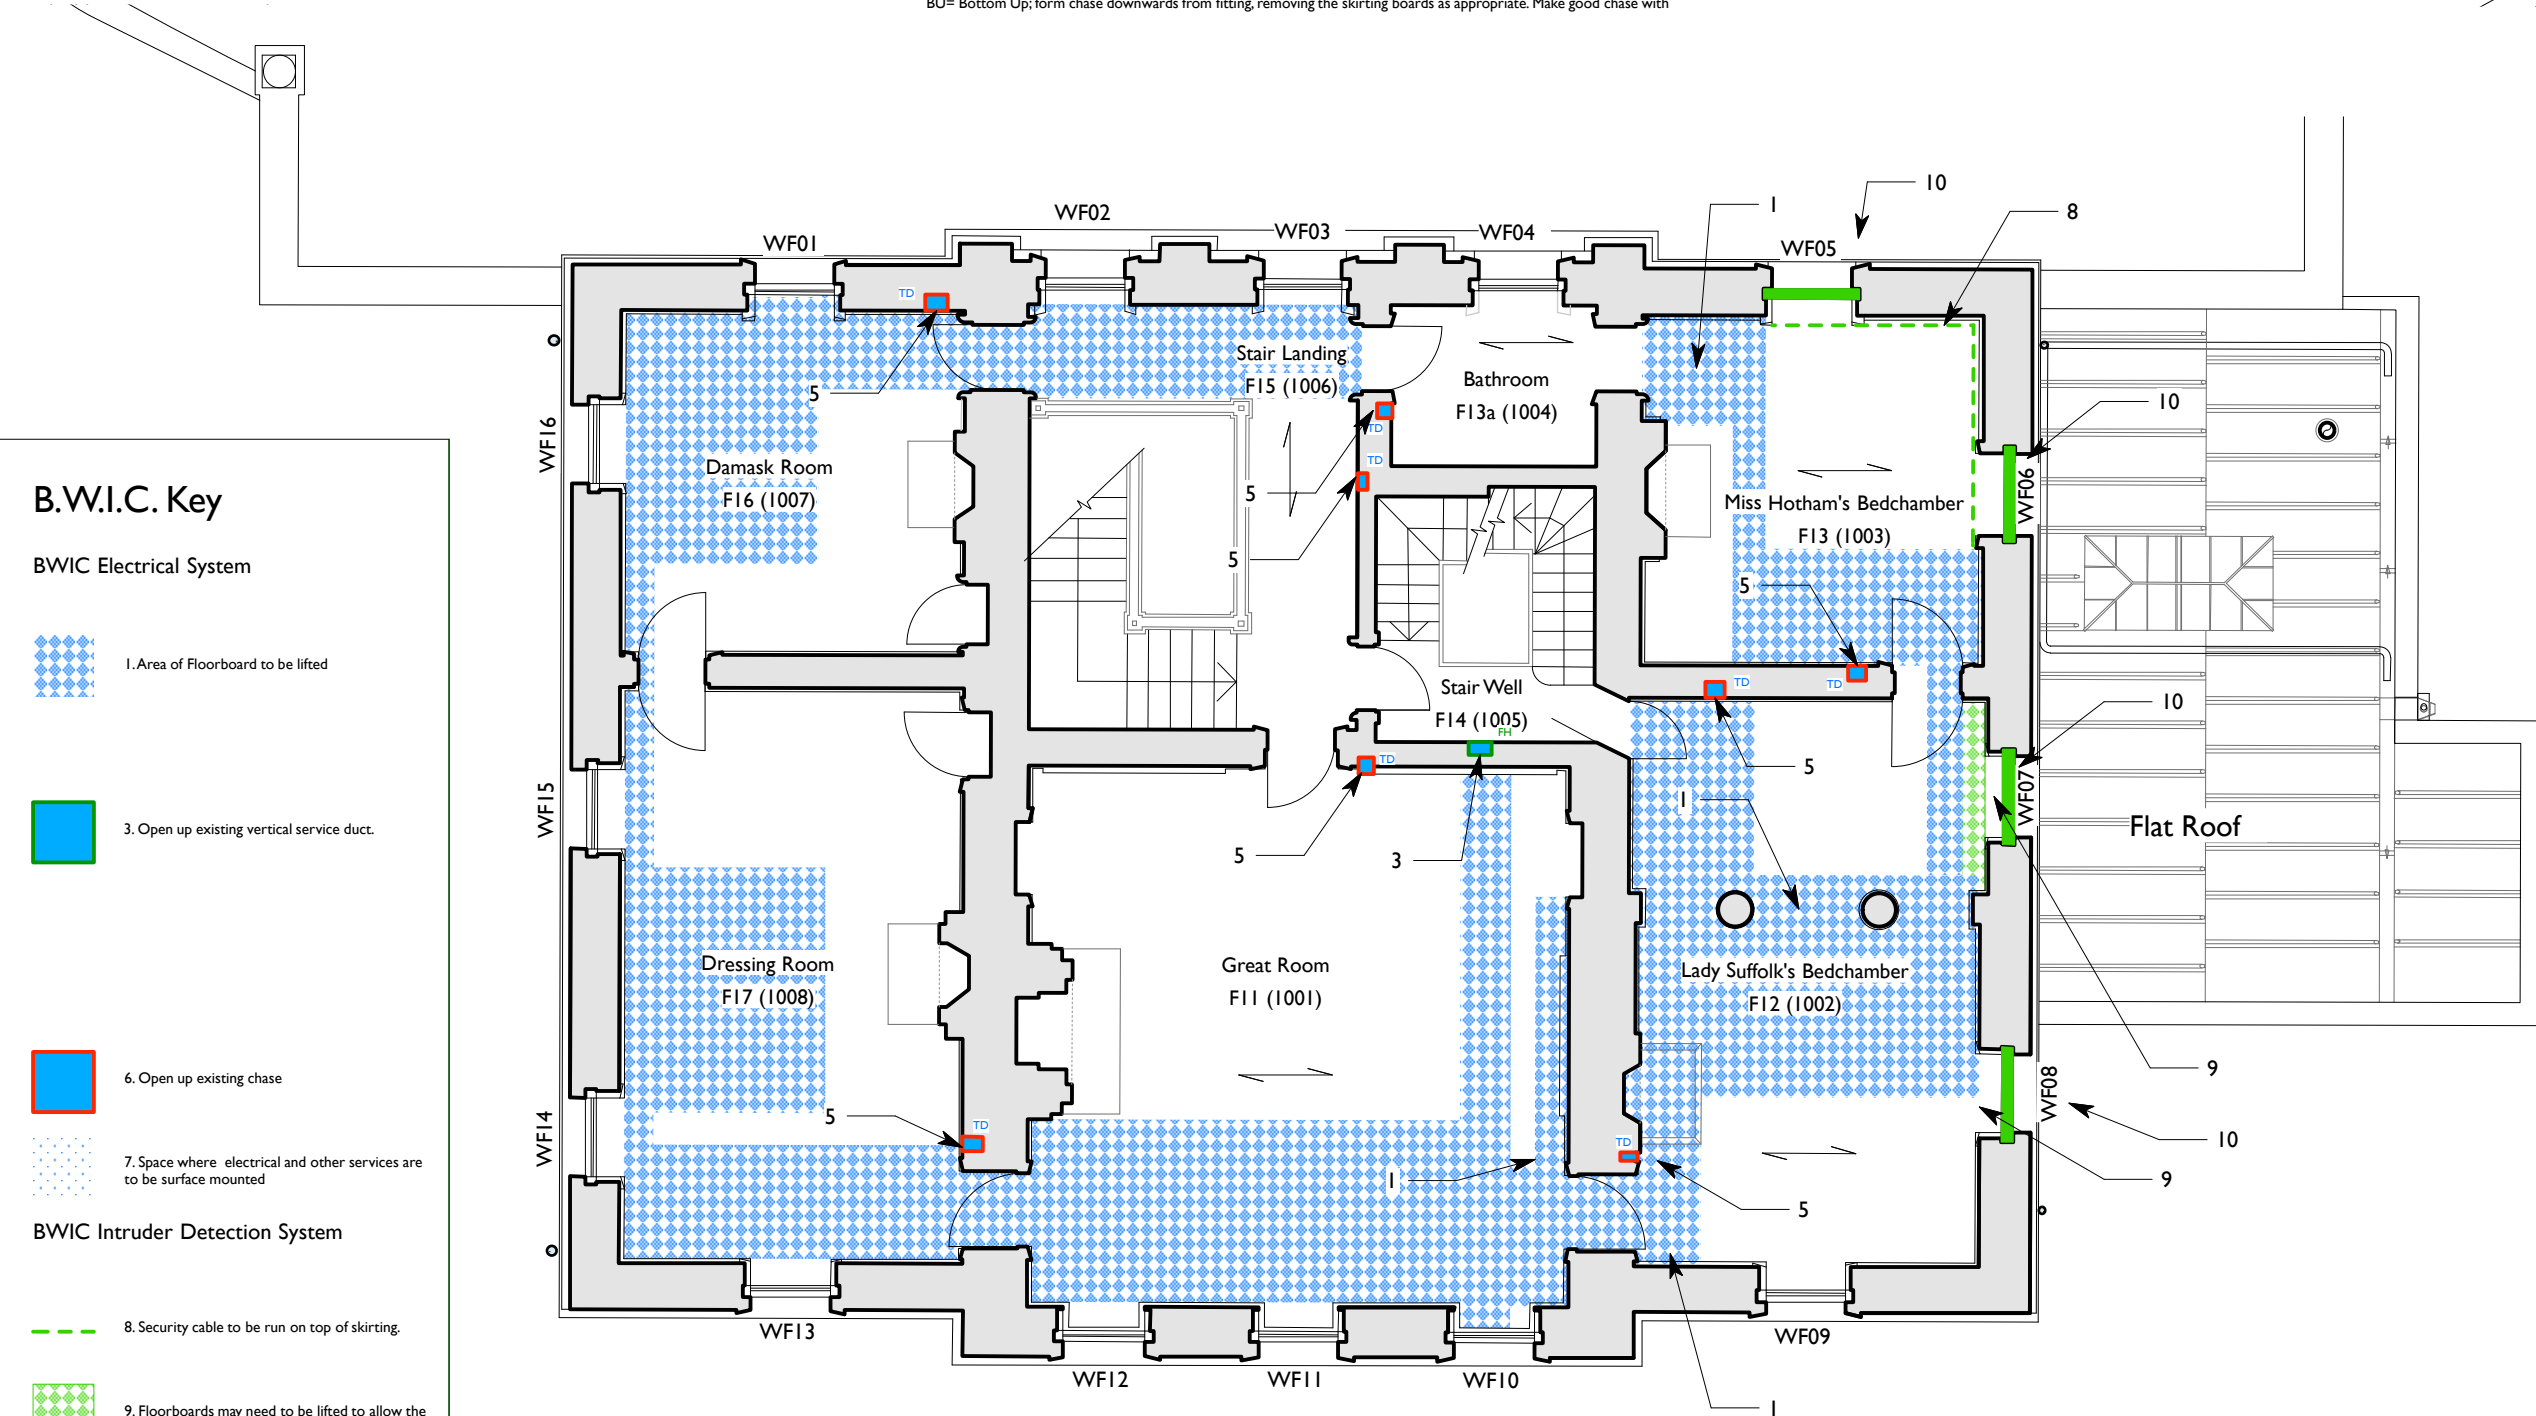
**First Floor Plan**

It is proposed for new wiring to follow the existing routes; allow for additional notching joists to facilitate the installation of wiring (refer to structural engineer's drawing 17549-SK-N1 for details); where possible the existing routes will be used. Allow to carefully reinstall the boarding in the same manner as they were found. This will include the filling/waxing of nail head entry points with joiners wax, to match in with the existing wood. Allow as a provisional item, to replace 5% of the boards lifted, in a like for like quality, size and finish as the existing.

- 1) Sub-main cabling from main MCCC panel to final circuit DB's on Attic floor; run in 100 x 50 mm trunking.
- 2) From Attic lighting and power circuits will run to the Second Floor; run in 100 x 50 mm trunking.
- 3) From Basement, lighting and power circuits will be fed to the Ground & First Floors; run in 100 x 50 mm trunking.

- 1. Area of Floorboard to be lifted
- 3. Open up existing vertical service duct.
- 6. Open up existing chase
- 7. Space where electrical and other services are to be surface mounted

- 8. Security cable to be run on top of skirting.
- 9. Floorboards may need to be lifted to allow the replacement of failed security wiring.
- 10. Security fittings to door or window to be possibly replaced; this is pending report from security installation specialist.
