PROJECT
 Marble Hill Sports Building
 Refurbishment

TITLE
 Ground Floor Plan
 As Proposed

DRAWING N°
 210 D

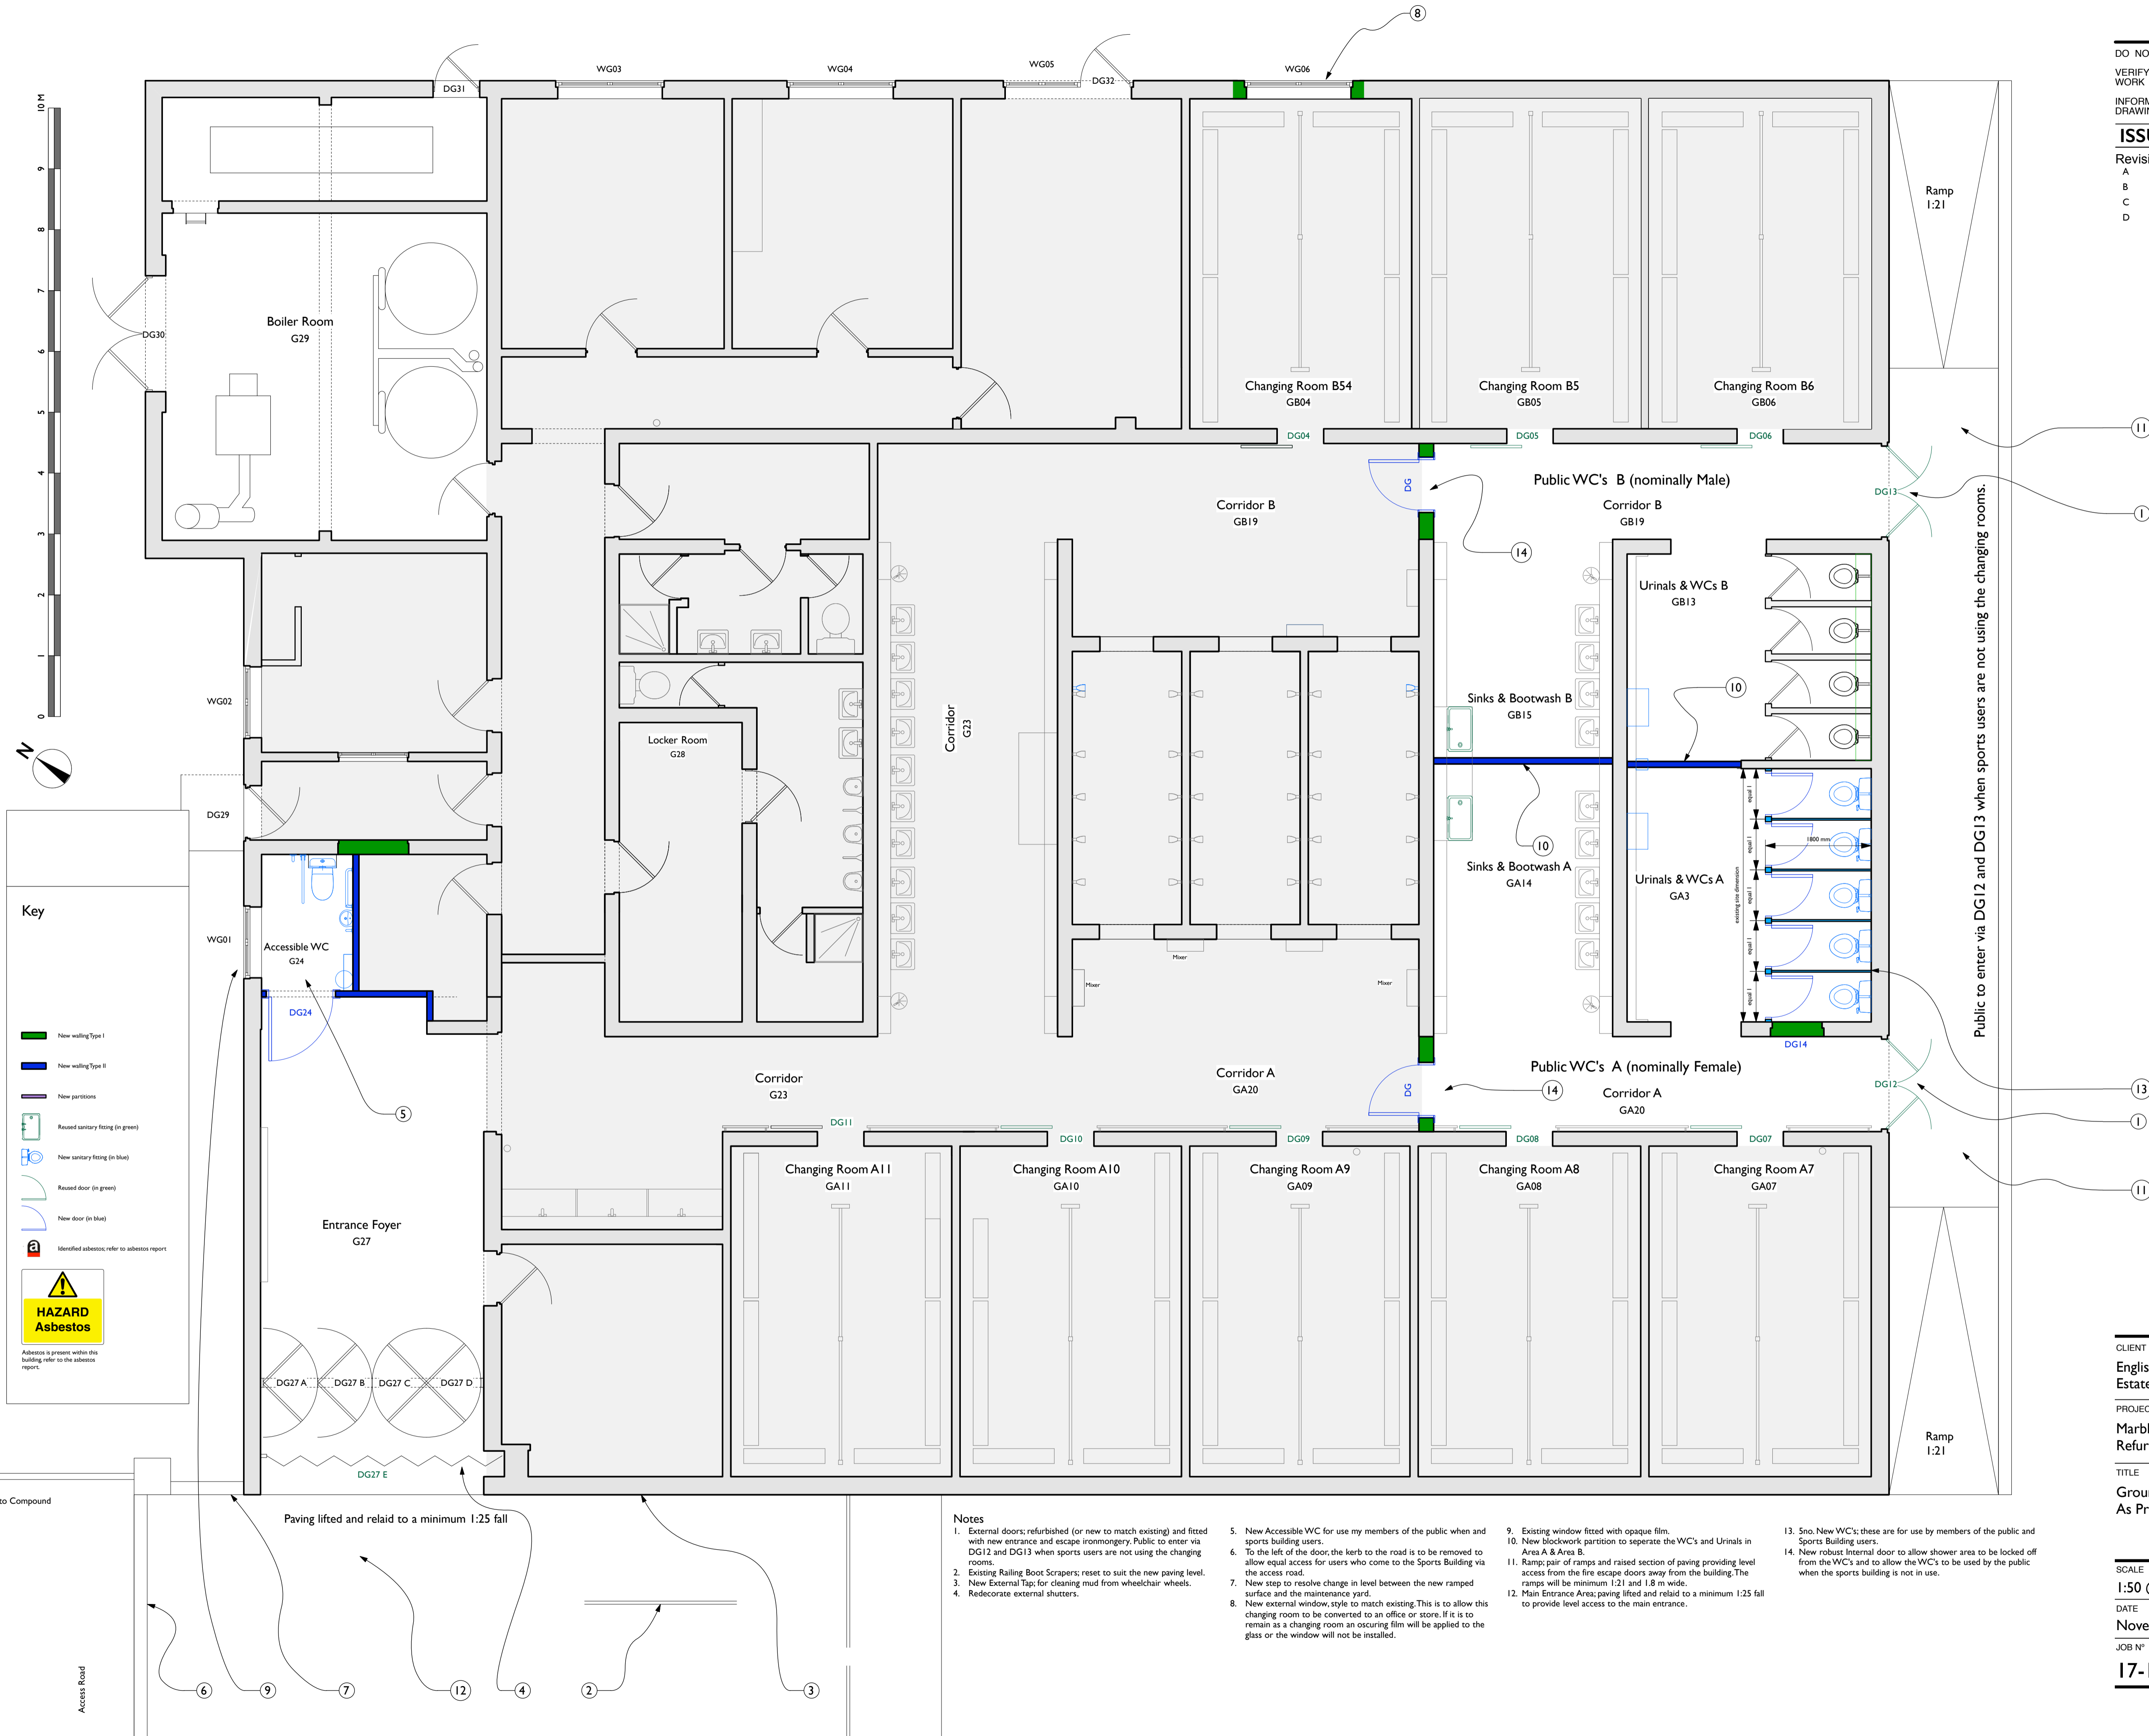
- Notes**
- External doors; refurbished (or new to match existing) and fitted with new entrance and escape ironmongery. Public to enter via DG12 and DG13 when sports users are not using the changing rooms.

- Existing Railing Boot Scrapers; reset to suit the new paving level.
 - New External Tap; for cleaning mud from wheelchair wheels.
 - Redecorate external shutters.

- New Accessible WC for use by members of the public when and sports building users.
 - To the left of the door; the kerb to the road is to be removed to allow equal access for users who come to the Sports Building via the access road.

- New step to resolve change in level between the new ramped surface and the maintenance yard.
 - New external window; style to match existing. This is to allow this changing room to be converted to an office or store. If it is to remain as a changing room an obscuring film will be applied to the glass or the window will not be installed.

- Existing window fitted with opaque film.
 - New blockwork partition to separate the WCs and Urinals in Area A & Area B.
 - Ramp; pair of ramps and raised section of paving providing level access from the fire escape doors away from the building. The ramps will be minimum 1:21 and 1.8 m wide.

- Main Entrance Area; paving lifted and relaid to a minimum 1:25 fall to provide level access to the main entrance.
 - 5no. New WCs; these are for use by members of the public and Sports Building users.

- New robust internal door to allow shower area to be locked off from the WCs and to allow the WCs to be used by the public when the sports building is not in use.
