Client:	Bowmer and Kirkland Ltd	Drawing Title:	Tree Works Plan
Site:	Turing House, Hospital Bridge Road, Twickenham, London, TW2 6LH		
Date:	24/06/19	Drawn By:	KFJ
Scale:	1:1000 (A1)	Checked By:	NH
		Drawn No.:	6924-D-TWP
		Rev.:	-

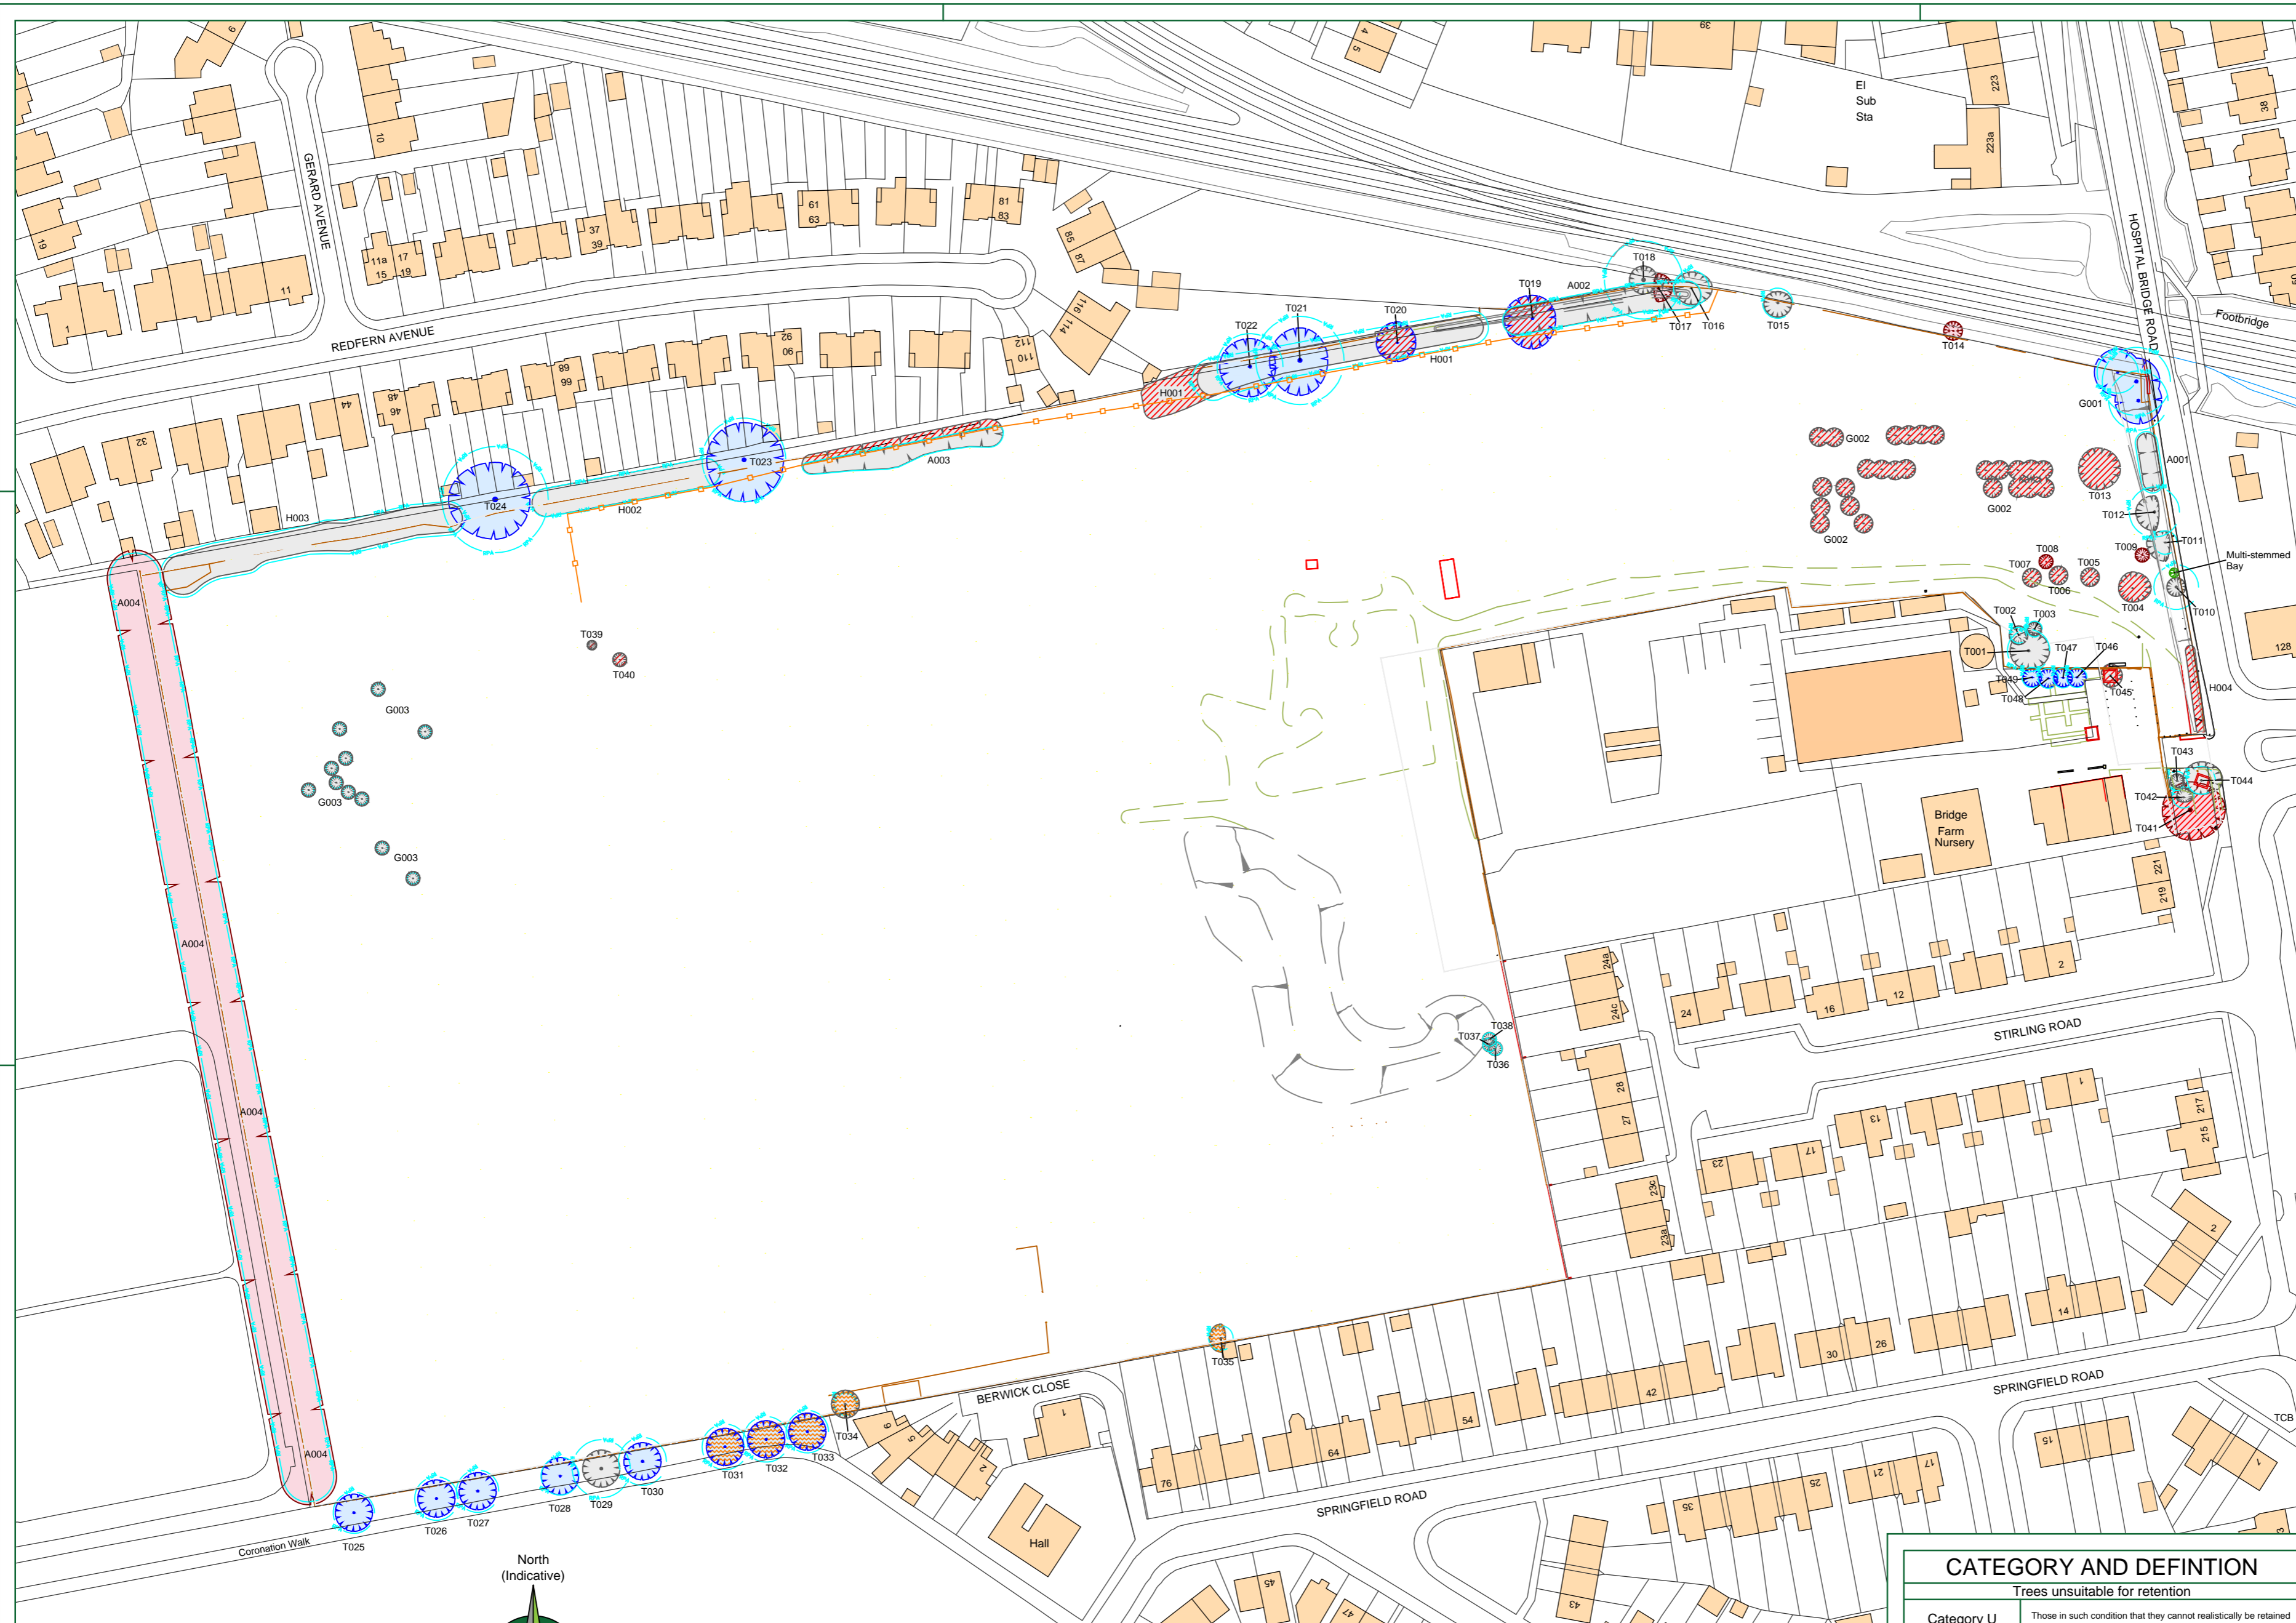
Existing Site Plan

Location of boundary fencing positioned as per discussions at meeting on 19/06/19
