Existing Site Plan

Proposed Site Plan

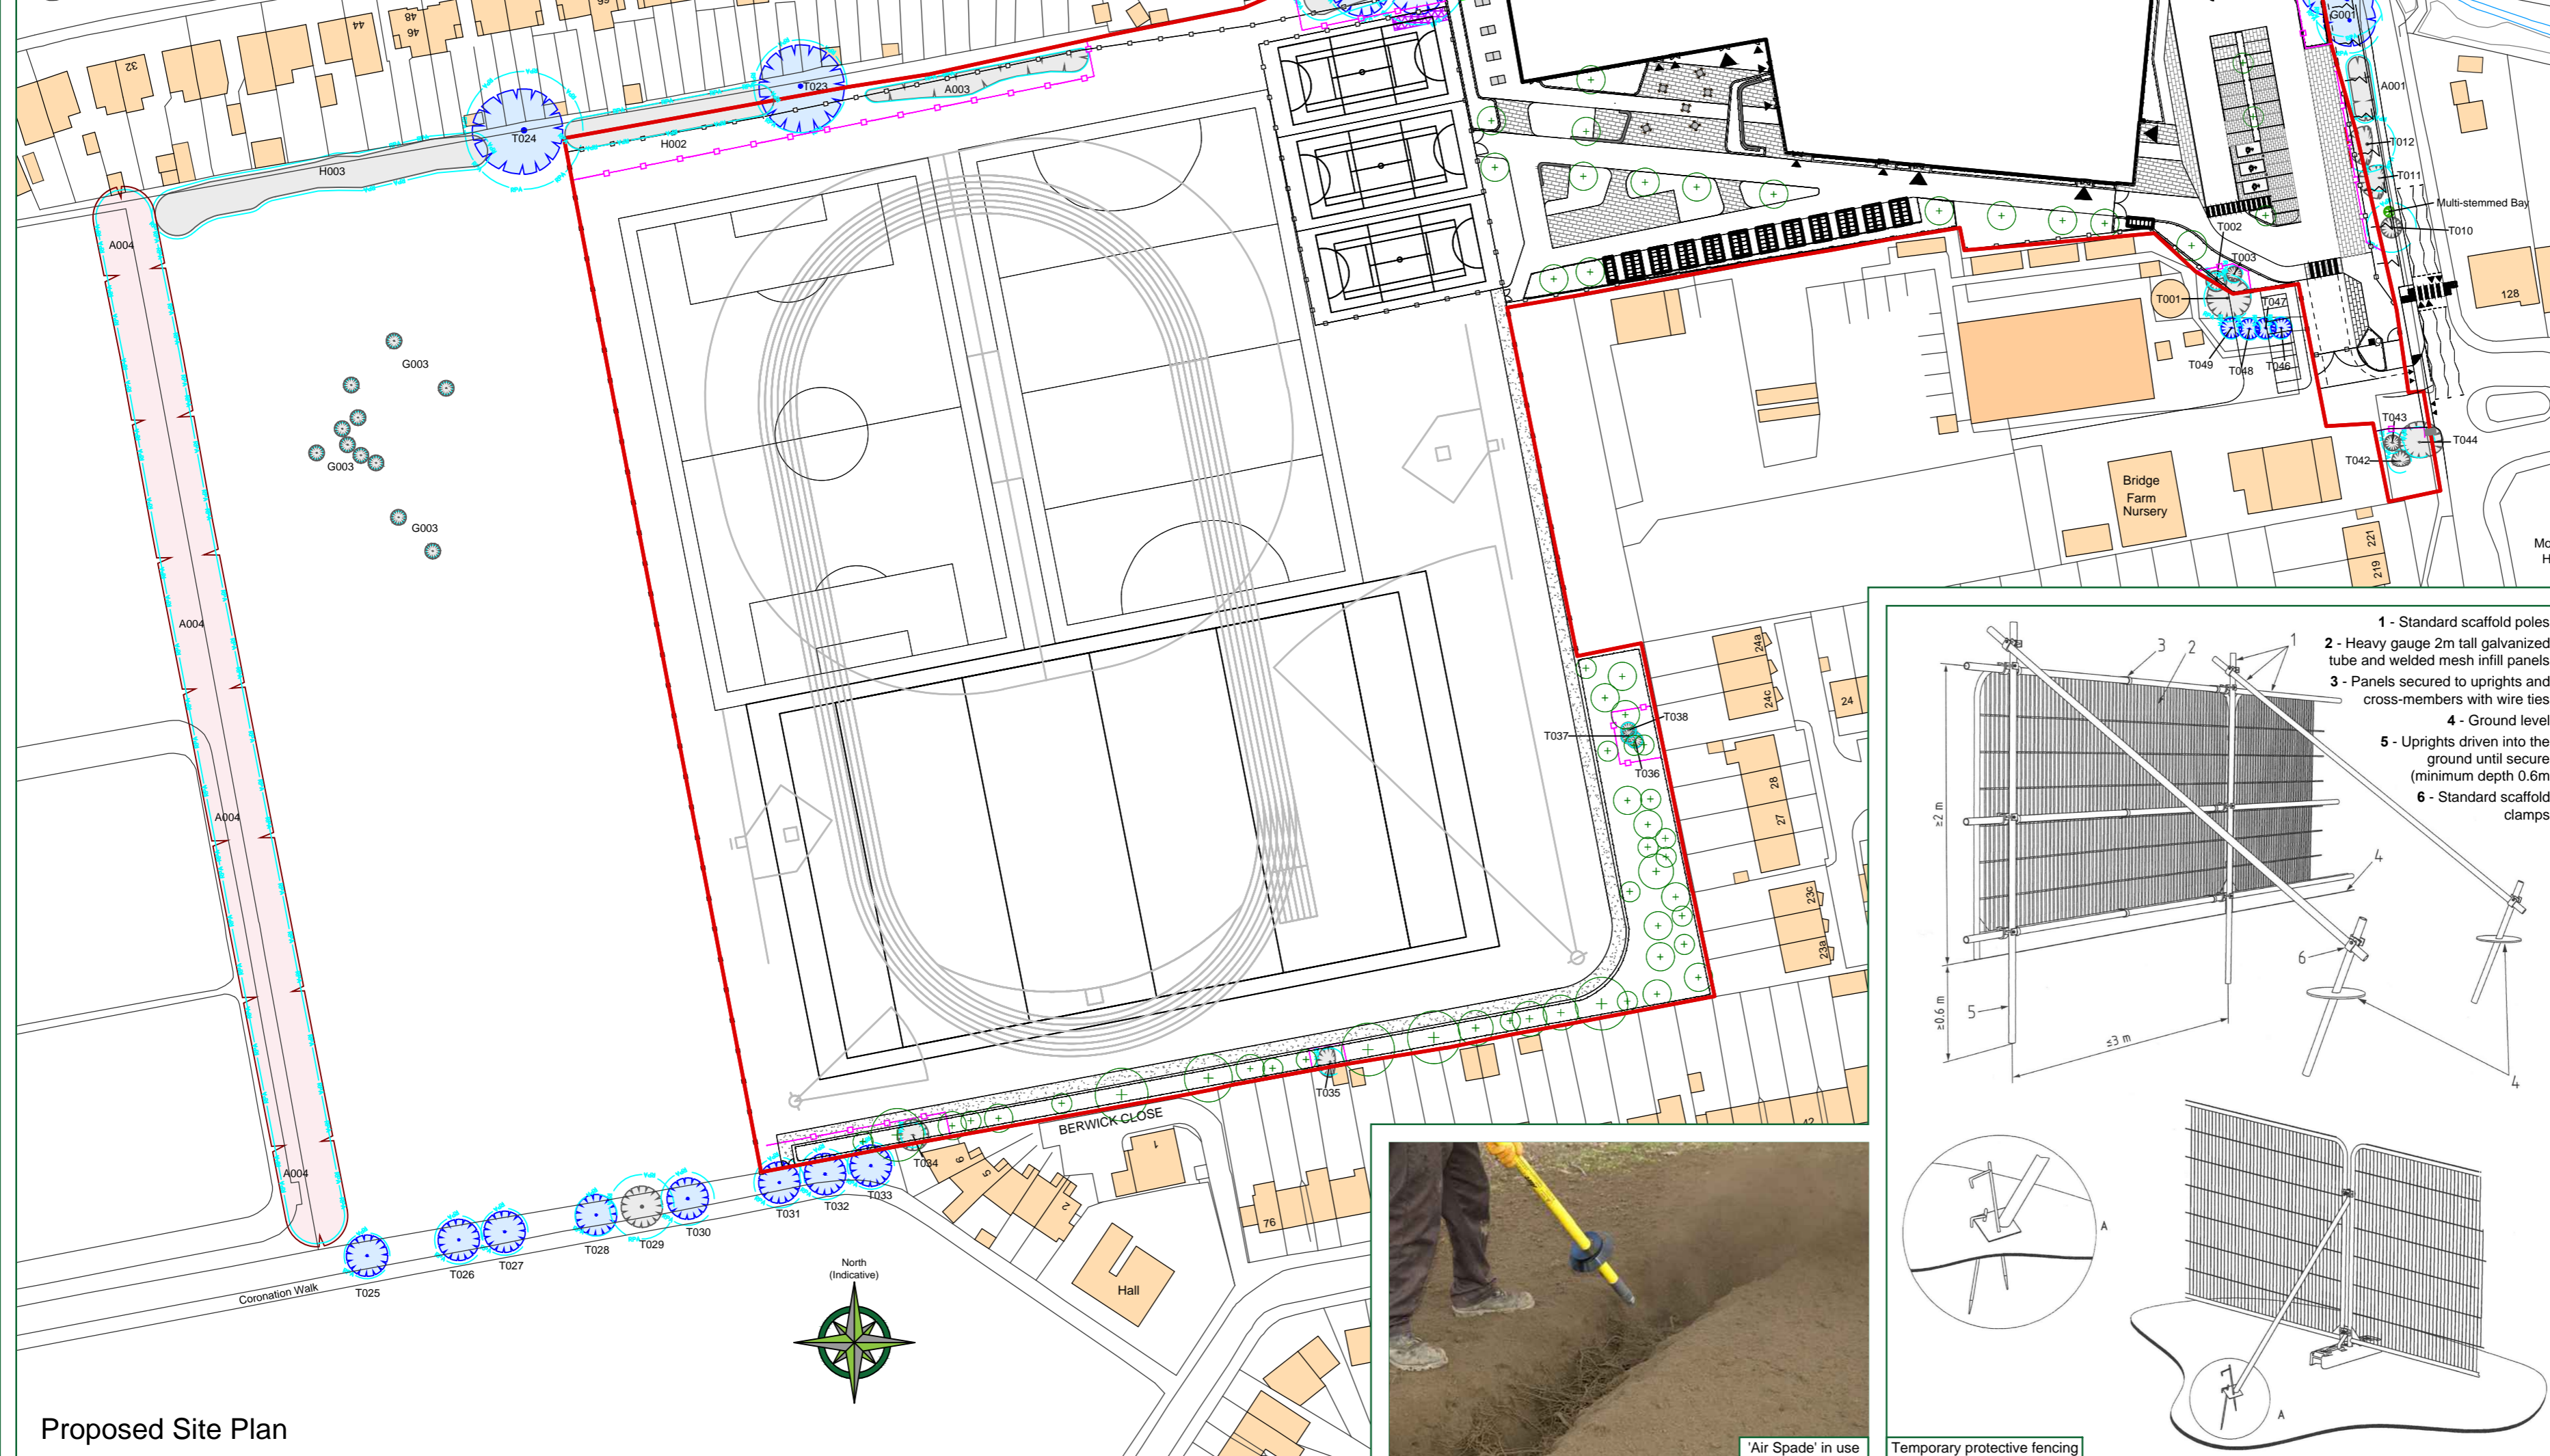
- Line of proposed temporary protective barrier
- Line of proposed Root Pruning (T012 & H001)
- Proposed development within & close to the RPA to be constructed following the 'No Dig' Specification
- Proposed Sports Courts to be constructed using a 'No Dig' permeable surfacing system (to be specified)
