# Phase II Site Investigation Report

***Sheldon House, Cromwell Road, Teddington, TW11 9EJ***

Client Name: Richmond Housing Partnership

Project Number: P4301.3.0

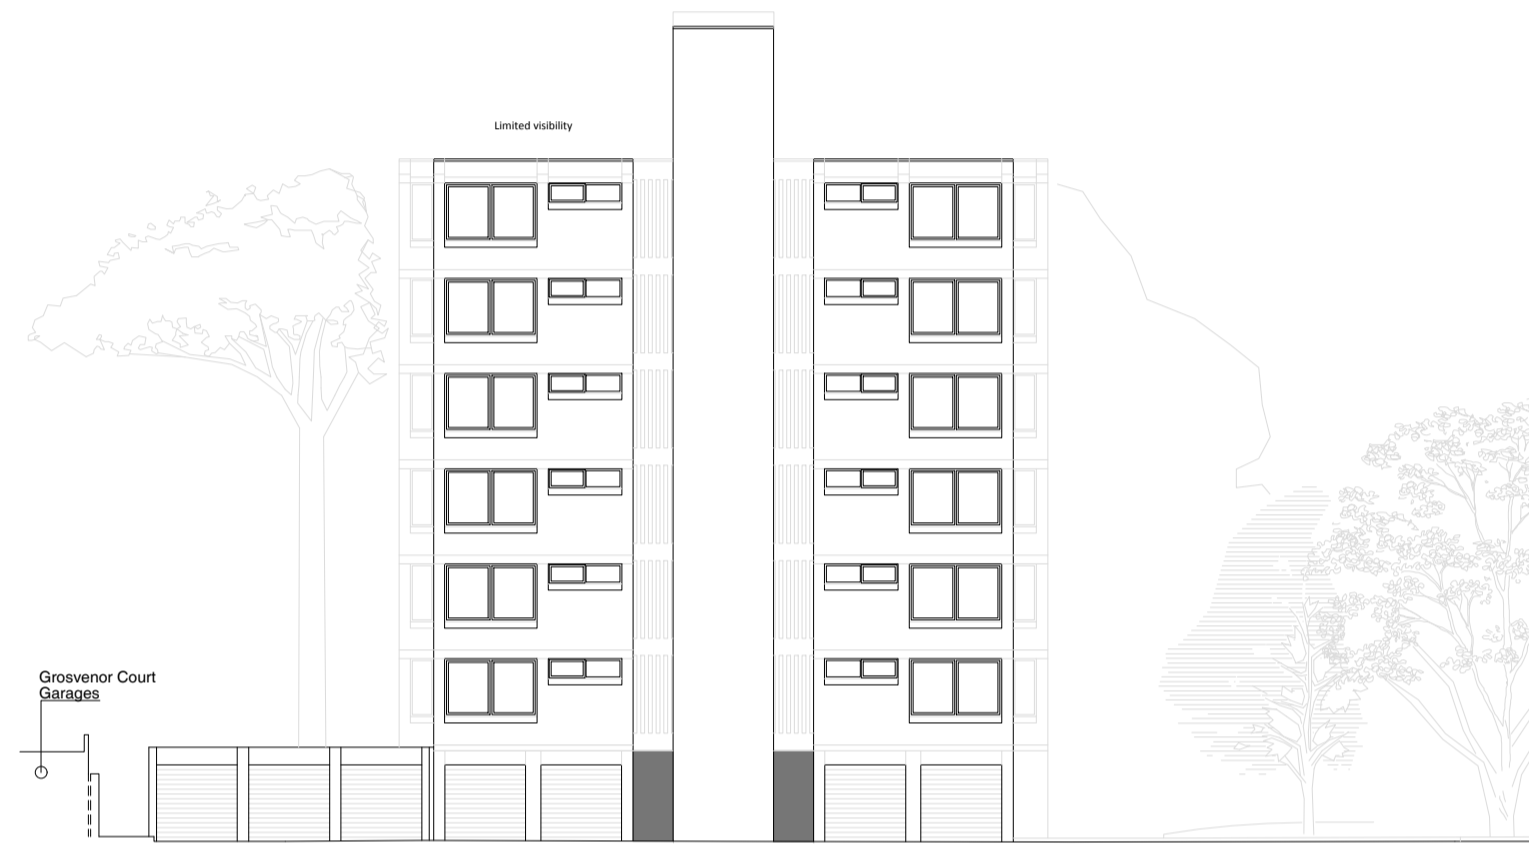
Sheldon House  
Front Elevation

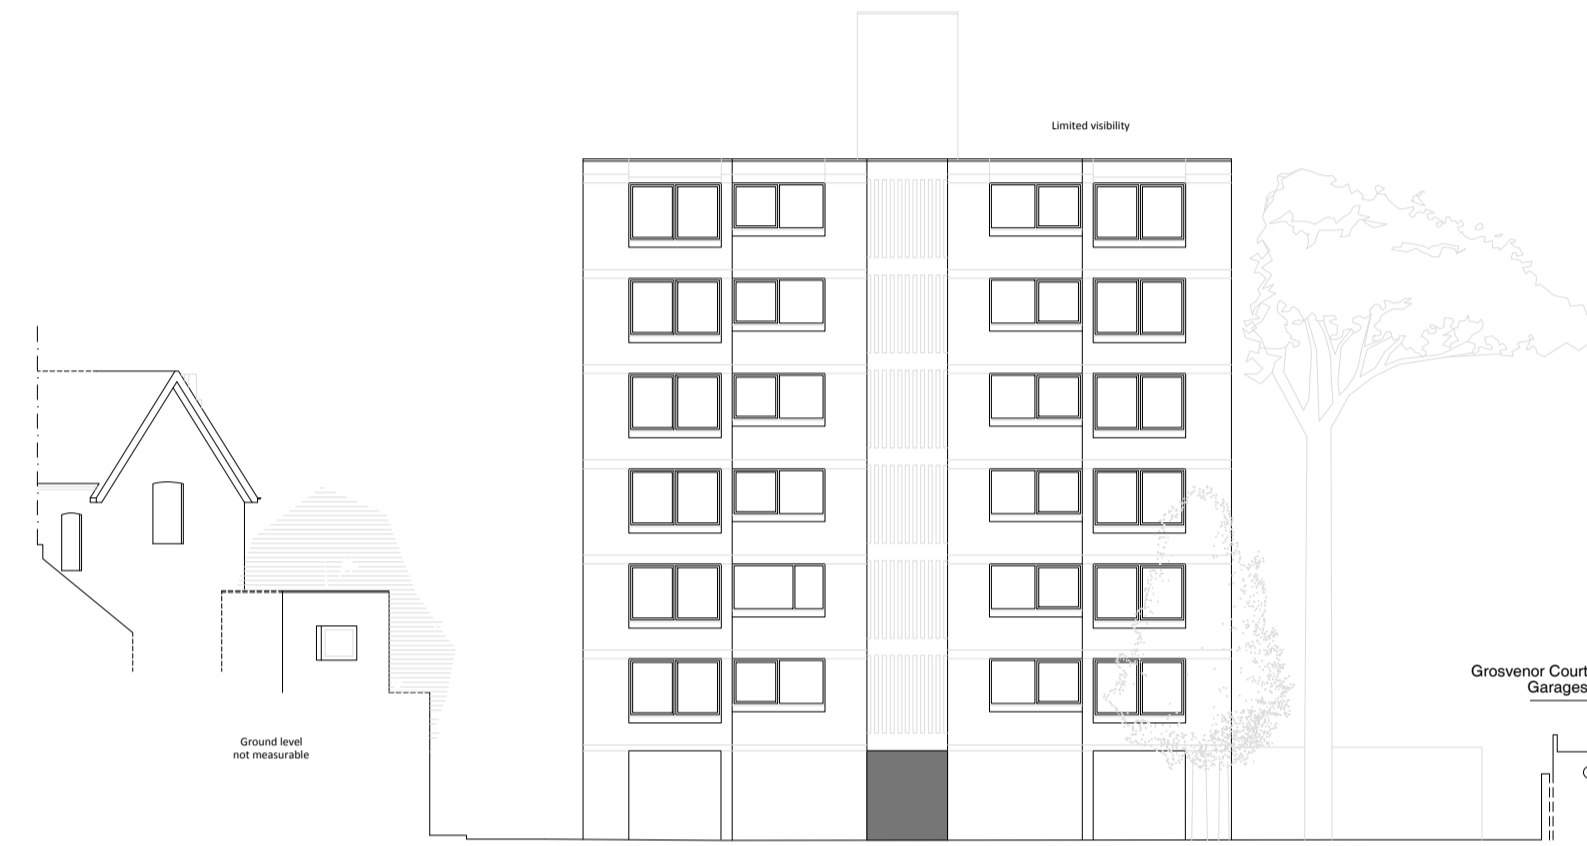
Sheldon House  
Rear Elevation

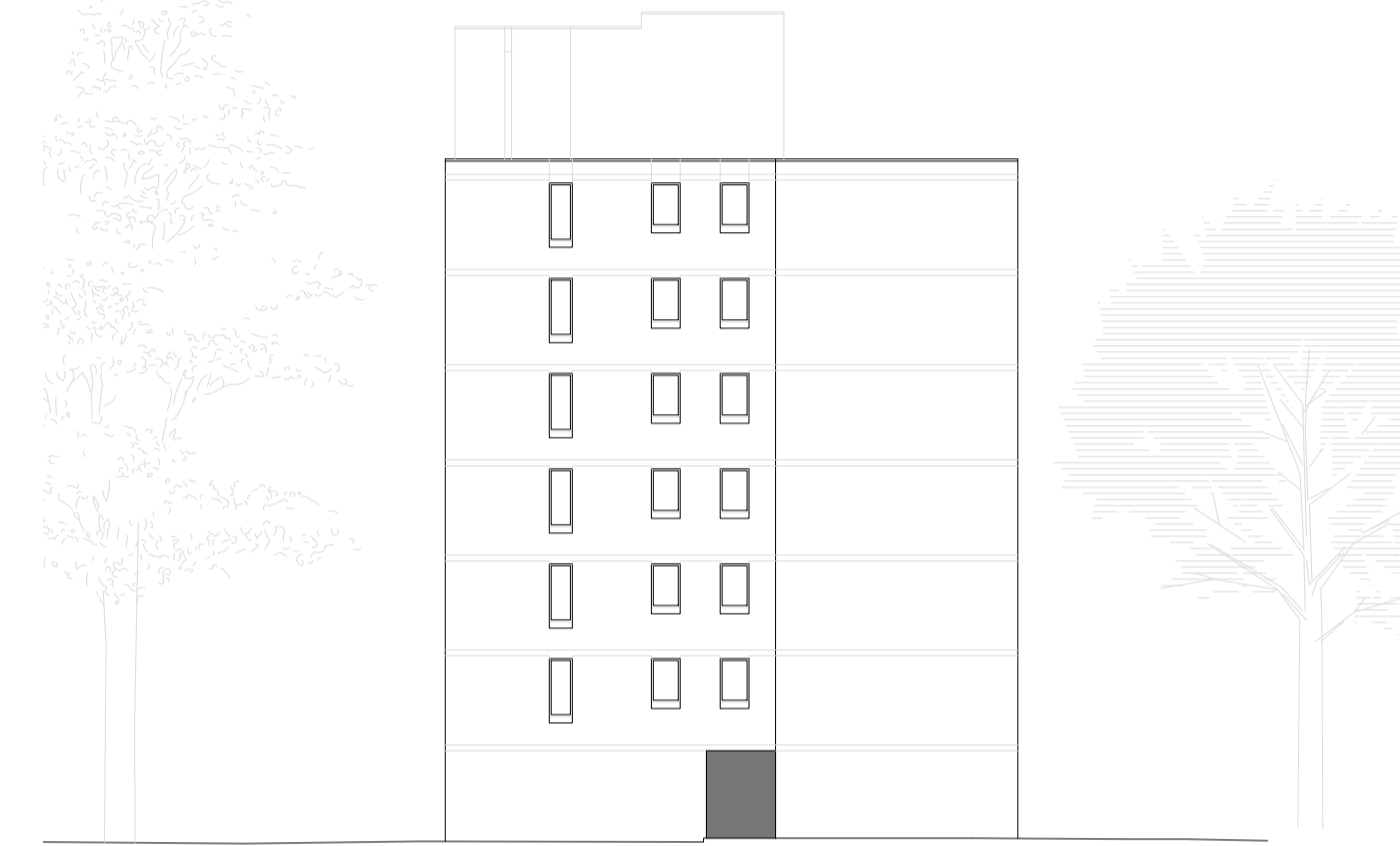
Sheldon House  
North-West Side Elevation

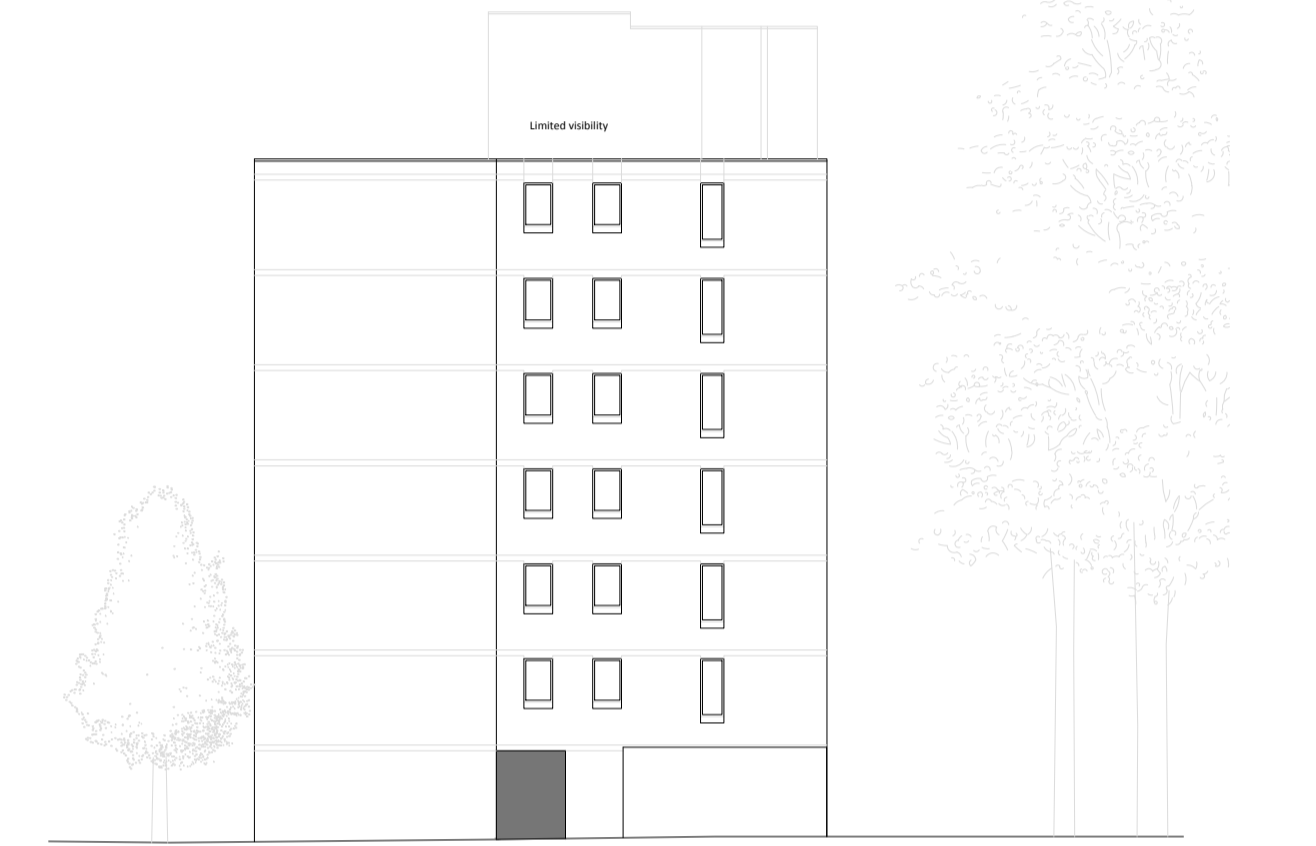
Sheldon House  
South-East Side Elevation
