Planning Statement

For the installation of an external lift and refurbishment works at:

Blocks M and L
St Mary's University
Waldegrave Road
Strawberry Hill
Twickenham
TW1 4SX

Document Ref. 220896-0210

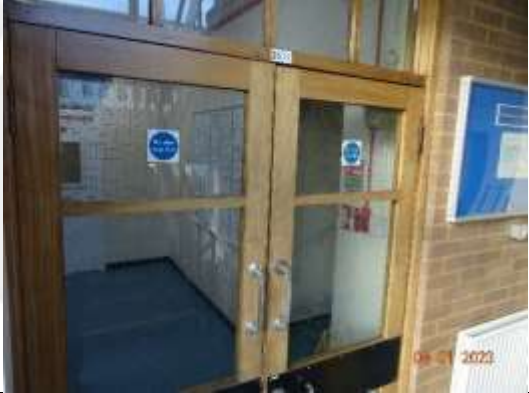
1 Q8	Significant Findings

<p>The fire doors leading directly onto the protected staircase for L block are in poor condition and are not sufficient to control smoke seepage and other products of combustion from entering the staircase enclosure.</p>		
	Proposed Measures		
	<p>The doors to the staircase on the upper floors in L block require attention to ensure they are able to create a fire barrier to protect the escape staircase. It's essential that the doors close fully to engage the passive fire protection and maintain the fire separation design within the building.</p>		
	Risk Level & Action By Date		
<p>Medium One Month</p>		<p>Location</p> <p>1st and 2nd floor lab entrance in L Block</p>

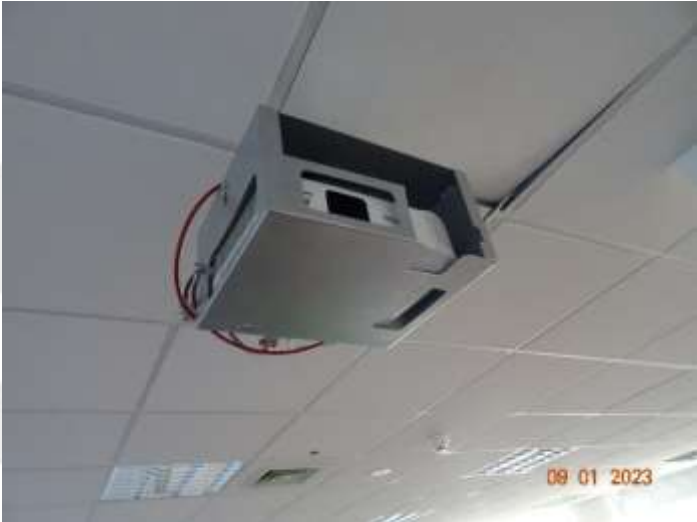
3 Q13	Significant Findings

Pat testing completed by onsite maintenance staff 06/2022 however the overhead projector in room M102 does not appear to have been tested within the current schedule.		
	Proposed Measures		
	Please confirm that all portable electrical items within the classrooms are included within the test.		
	Risk Level & Action By Date		
Medium	One Month	Location Room M102

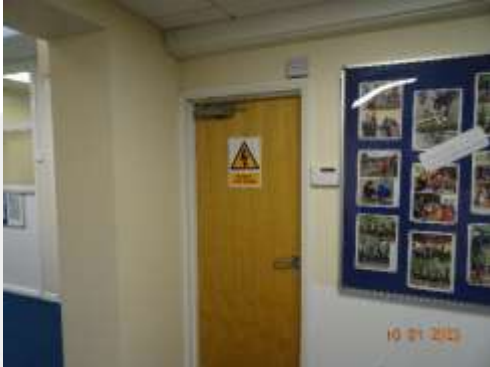
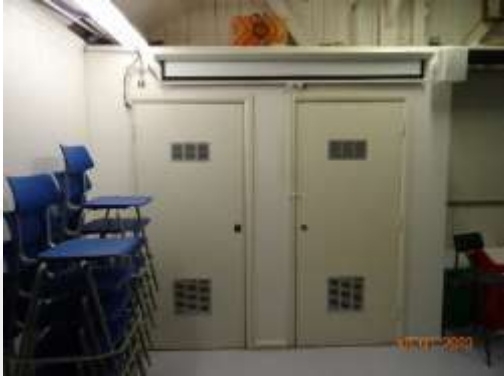
4 Q51	Significant Findings

Fire alarm System installed to BS5839 L2m with coverage to all internal open space facilities however the detection in the L block single storey extension does not cover the electrical cupboard opposite L38 or the boiler cupboard in L28 classroom.		
	Proposed Measures		
	The fire alarm system should be extended to provide smoke detection to the identified risk areas in the L block extension.		
	Risk Level & Action By Date		
Medium	One Month	Location	
		Electrical cupboard and boiler cupboard L Block

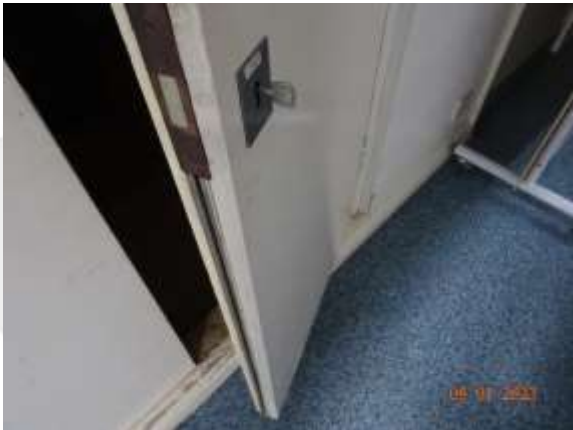
7 Q65	Significant Findings

<p>There are some passive fire protection issues which require attention,</p> <ul style="list-style-type: none"> • Boiler house door bottom smoke seal missing • Smoke seals missing Room M201 door to link corridor • Gas Shut off room, intumescent strips have been overpainted. 		
	Proposed Measures		 
	<p>The identified passive fire protection requires replacement to control the spread of products of combustion between compartments.</p>		
	Risk Level & Action By Date		Location
Medium	One Month	Boiler house and room M102

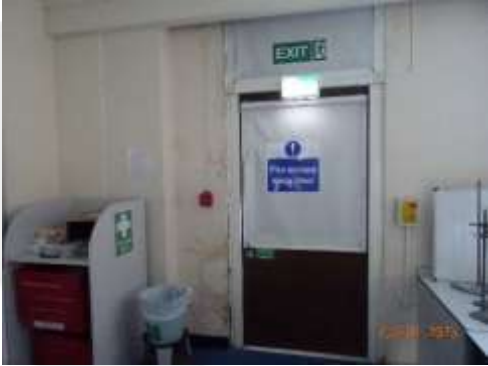
8 Q69	Significant Findings

Fire exit door from the from L102 was found to be stiff and difficult to open.		
	Proposed Measures		
	The identified fire exit door must be maintained to ensure they can be easily opened by persons escaping the building.		
	Risk Level & Action By Date		
High	One Week	Location Room L102

68	Do all final exits lead to a place of safety in the open-air?	Yes	Reviewed and satisfactory	No measures required		
69	Do all external fire doors open freely?	No	Fire exit door from the from L102 was found to be stiff and difficult to open.	The identified fire exit door must be maintained to ensure they can be easily opened by persons escaping the building.	High	One Week

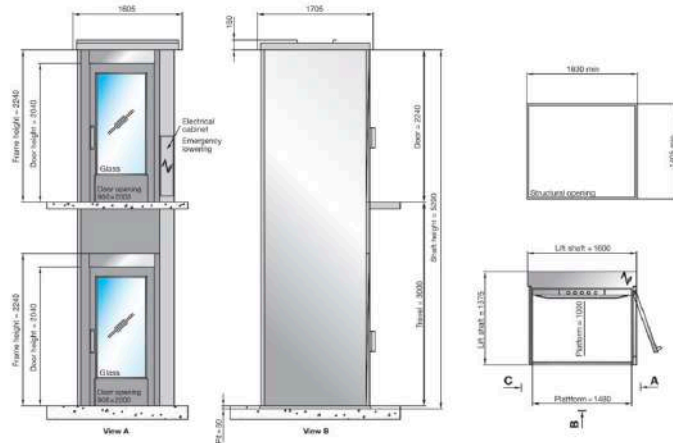
Prime 7000 XT

The lift is capable of travelling up to 13 metres in height and has two platform sizes; 1000 x 1480 and 1100 x 1480 mm. The range of options and accessories available are similar to that of the internal Prime 7000 model and the lift can be customised with a number of alternative finishes and colours to blend into any external environment.

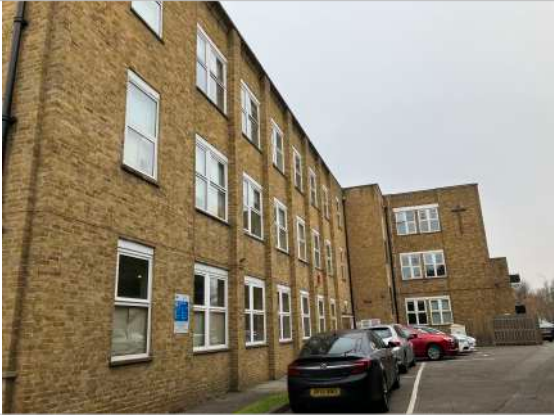
View of West Elevation

The proposed Lift System is to be located on the Block M West Elevation facing Waldegrave Road.

The external lift is proposed to be installed on the West Elevation of the building and will serve all floors, providing level access to Blocks M and L. Siting the lift externally reduces the extent of internal alterations and subsequent loss of floor space which an internal lift would entail. It will meet the requirements of Part M and BS 8300, as well as helping to meet the requirements of the Equality Act (formerly the DDA) to make reasonable adjustments for ease of access.

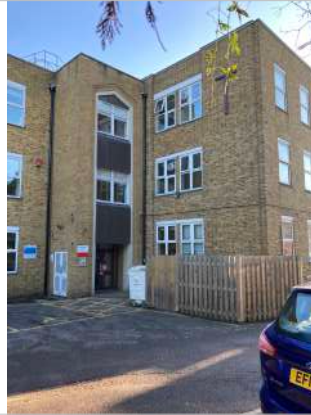
Location of proposed lift
