Richmond Hill Campus

Addendum to Stage 3 Report

Project no. 1399

Document no. 1399-INT-ZZ-ZZ-RP-S-0004

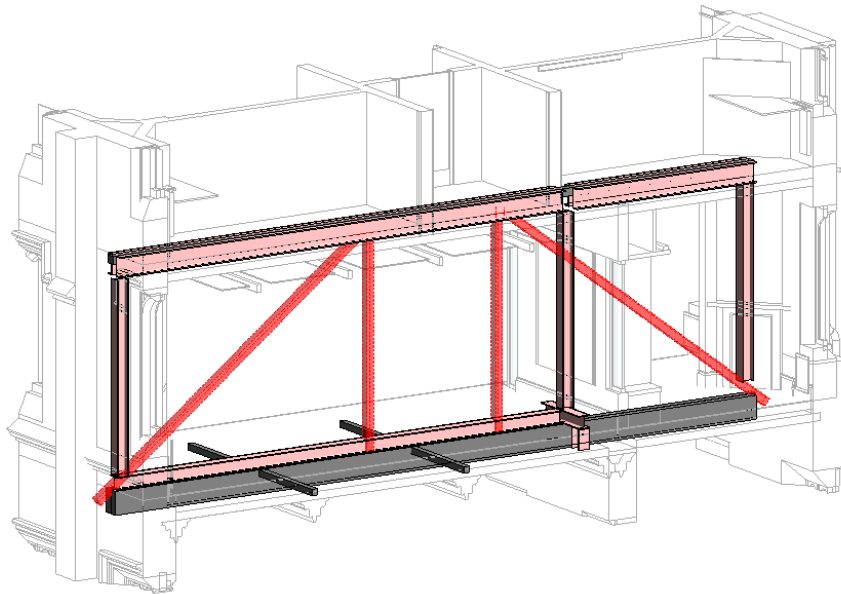
A design has been developed to allow the removal of the stud walls and the struts within. This requires the propping of the existing floors. Once propped the struts are to be removed and new steel installed.

Proposed overlaid with members to be removed

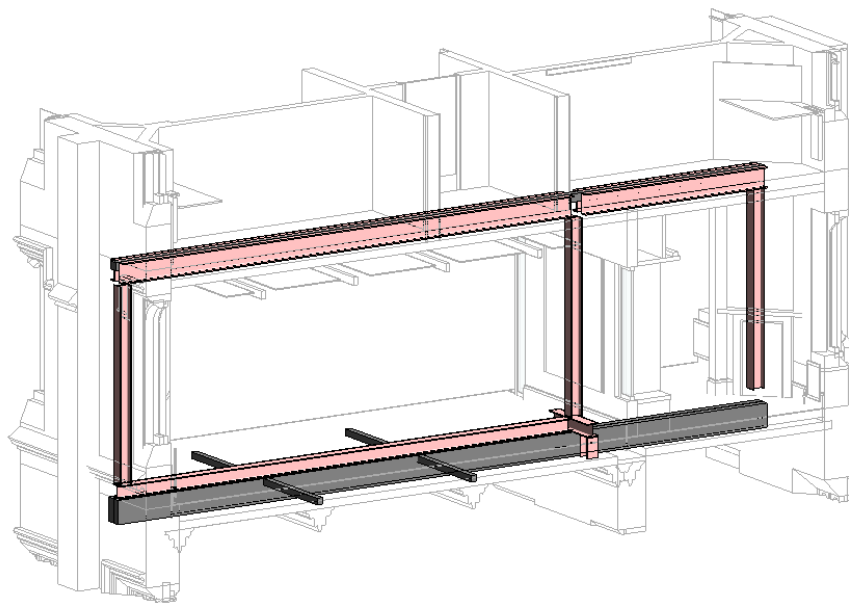
To the 2nd floor the strengthening is to be installed from above the existing timber beams. At 3rd floor the strengthening is simply installed to the underside of the floors.

Final condition

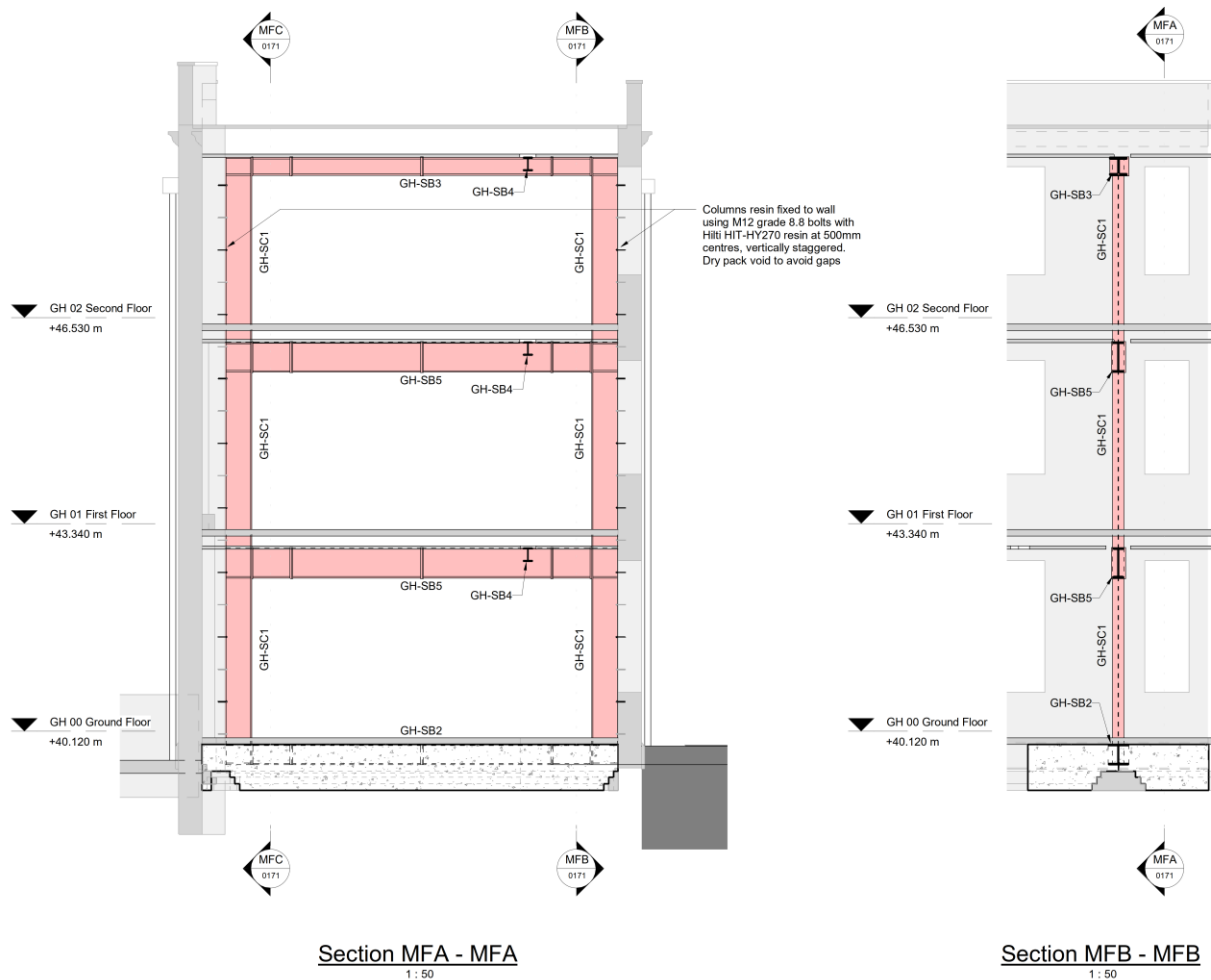
Once the slabs are propped and supported the walls can be removed and the new frames installed. Openings for columns to pass through floors are to be minimised to reduce the amount of infill required. Once dry packed the temporary propping can be removed and the load transfer is complete.

Section through proposed moment frames with propping indicated

The slab will act as a diaphragm and temporarily distribute stability forces into the remaining walls. The moment frame restores the original load paths once the works are complete.

The size of the opening for the columns is to be agreed with the contractor. It is proposed these are kept as small as possible so that a new infill stitch can be cast to transfer load in the final condition.
