The House 145a, Petersham Road, Richmond, Surrey TW10 7AG  
Heritage and Design and Access Statement  
HOU-P-05(B)

REV -: Issued for comment (11.06.24)  
REV A: Issued for comment(20.06.24)  
REV B: Issued for comment(02.07.24)

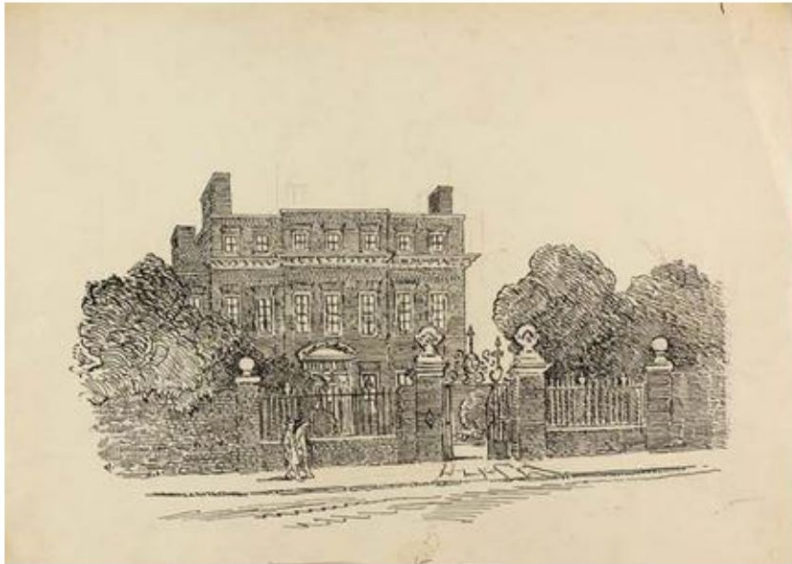
a. exterior view of Rutland Lodge, showing the front elevation and the entrance gate and piers. 1898-1933 CG Harper Collection

145a Petersham Road  
(Built late 60s)

Retained facade of 1660 Rutland Lodge

The House, 145a Petersham Road, is a Grade 2\* listed residential dwelling. It is listed by virtue of being in the curtilage of Rutland Lodge. It adjoins this historically significant property. The property 145a Petersham Road, is relatively 'new build'. See Figure 1b.

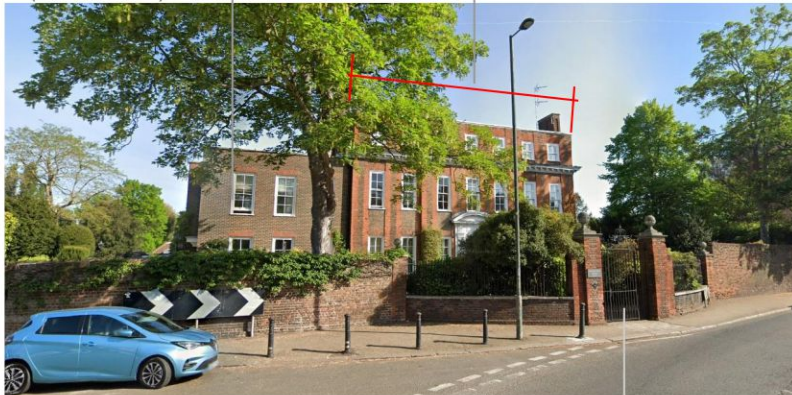
listed gate and piers

b. Petersham Road boundary

The listed entrance gate, piers and the retained facade are shown in figure 2 a+b. This proposal will not impact the features of heritage significance or the views onto them. Whilst the styling of the doors, architraves and windows are that of a period property the existing interior and its materiality is entirely modern, therefore, the proposals defined here are of the same heritage significance as the existing but allow a better layout.

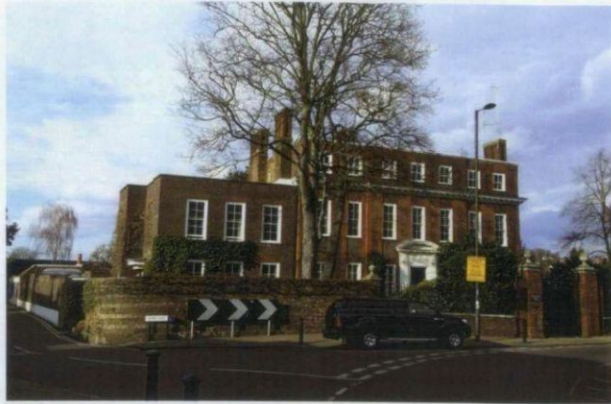
THE HOUSE 145 PETERSHAM ROAD RICHMOND  
PHOTOSHEET MARCH 2012

Rutland Lodge and the side wing now known as "The House", seen from Petersham Road

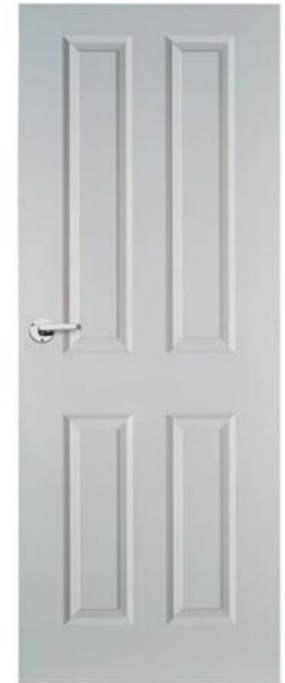
#### 8. FOUR PANEL DOOR

Howdens Donnington White Smooth 4 Panel Moulded FD30 Fire Door or similar

Figure 4 indicates the existing doors, skirtings and architraves. The existing doors shown in figure 4b are not of particularly good quality. The client would like to replace all the doors to the first floor with a smooth 4 panel door see figure 8 . Figure 4c shows the existing ironmongery of no particular material quality. New ironmongery in a brushed brass finish will be fitted to the new doors.
